Date: 30 August 2023
Project No: LTC21220-A
Revision: B

**RE: SHALLOW SOIL TEST REPORT
FUTURE RESIDENTIAL FOUNDATIONS
LOT 23, 115 EUREKA STREET, ARANUI**

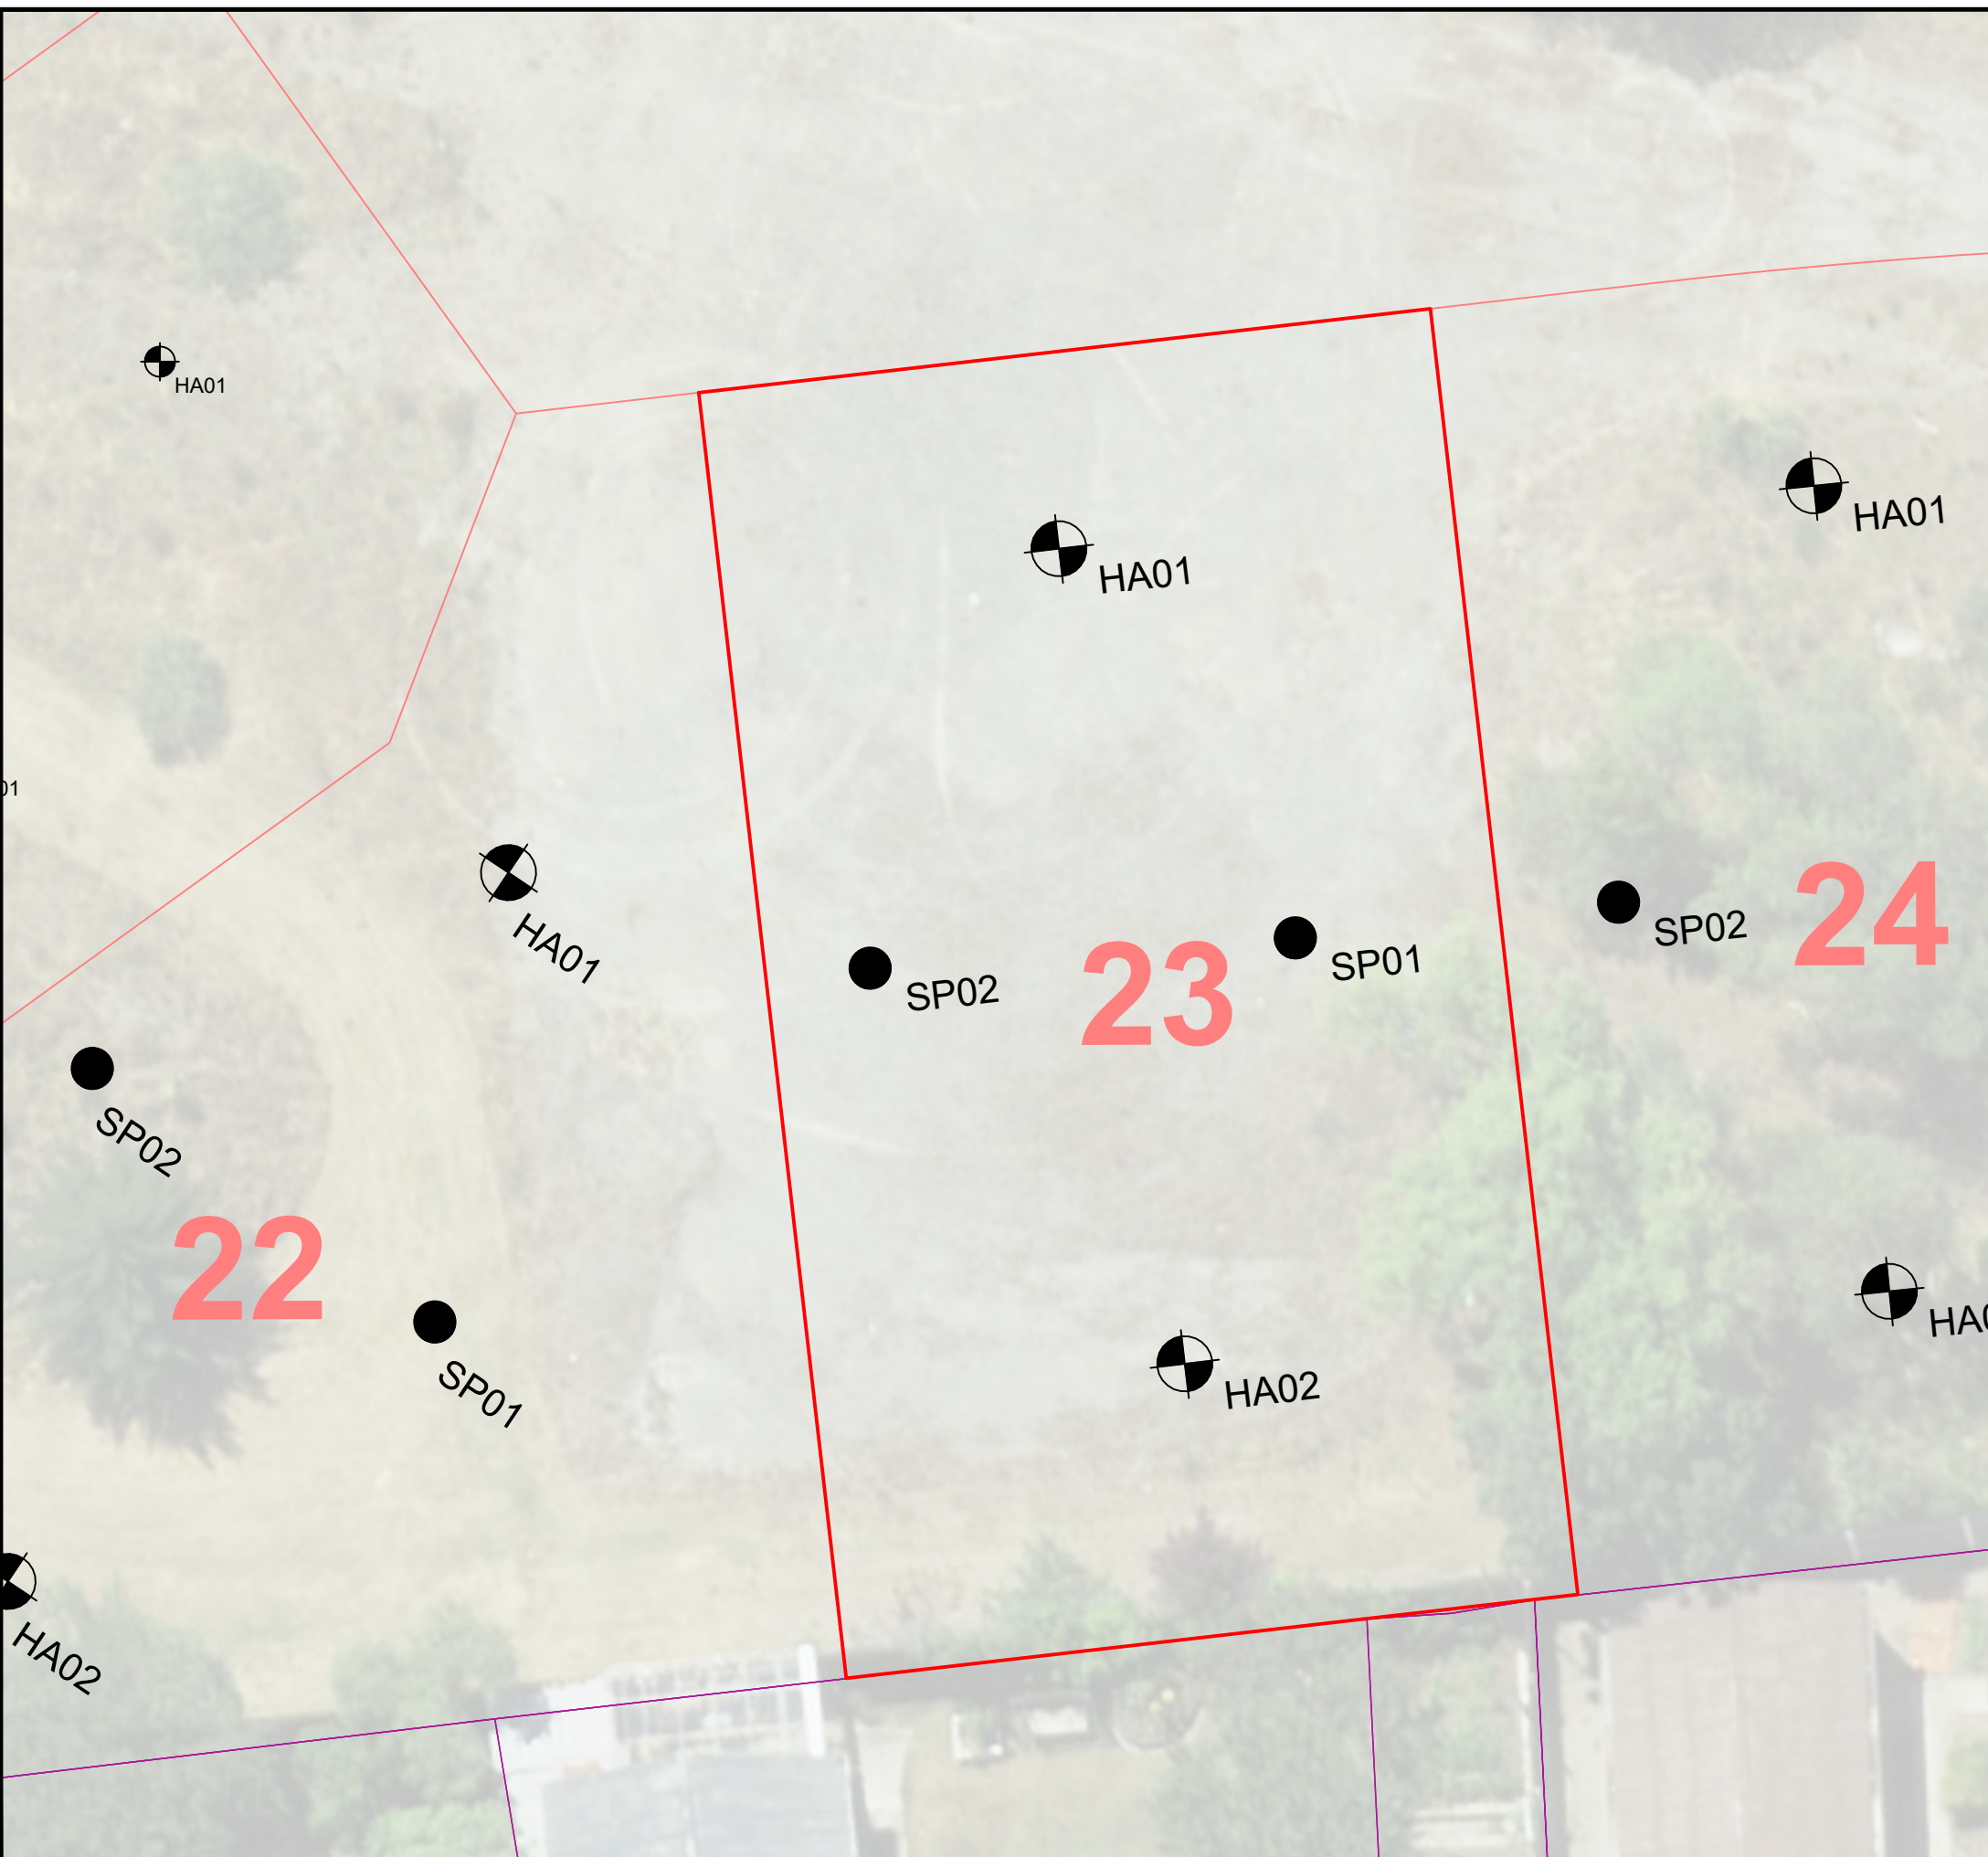
Test Location Plan
 Lot 23, 115 Eureka Street,
 ARANUI, CHRISTCHURCH

LandTech investigated the site on 23 March 2023, conducting two hand augers with corresponding Scala Penetrometer tests (SPs) and two additional SPs. The locations of the hand auger and SPs were measured using inferred lot boundaries and are approximate only. The test locations are shown on our LandTech *Test Location Plan*, Drawing No. Lot 23/ TLP, attached to this report.

The ground improvement could not extend all the way up to the southeastern boundary of the lot on account of temporary batters of approximately 1V :1H being formed down from the boundaries during construction to allow for the formation of the engineered fill raft. Therefore, a no-build setback to the greater of 2.0m, the depth of ground remediation, or the sum of the permanent cut face (existing ground level to finished ground level) plus the depth of ground remediation along these boundaries, shall be created along the corresponding boundaries. With reference to the Davie Lovell-Smith As-Built Earthworks Plans completed for the subdivision, the maximum depth of ground remediation was 1.4m, while the maximum permanent cut face is 0.4m high along some of the boundaries. Therefore, the 2.0m no-build setback governs along these boundaries to external neighbouring properties.

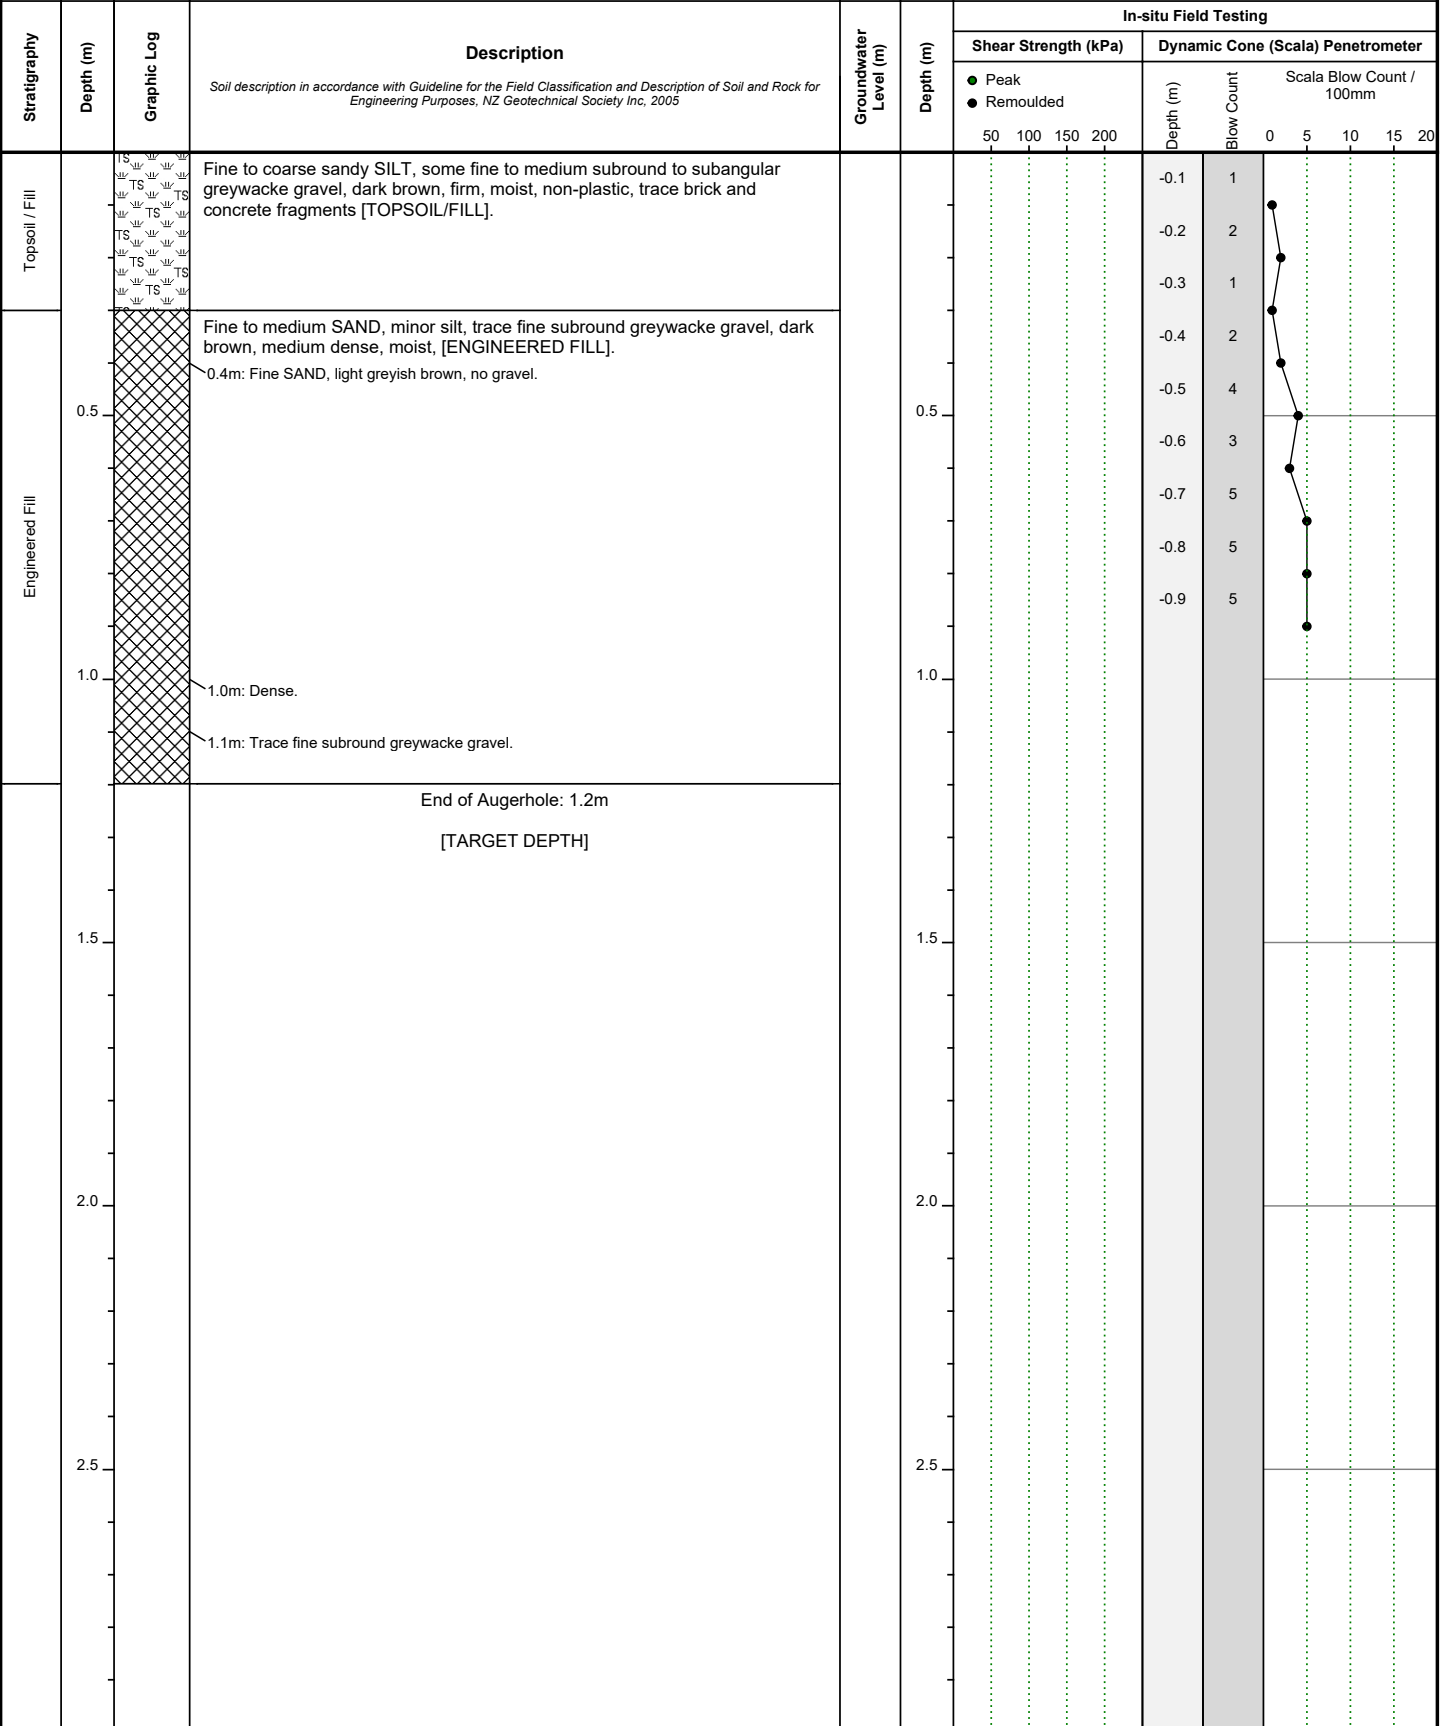
Augerhole No.: LOT 23- HA02

Topsoil was encountered within the hand augers from the ground surface to 0.2m and 0.3m depths, which was typically a dark brown sandy silt material with some gravel. Engineered fill was encountered below the topsoil to the base of auger holes, which was a compacted light brown sand material with minor silt. The hand augers were terminated at 1.2m depth below ground level to avoid damage to the geotextile layer which was installed at 1.5m depth below ground level. Groundwater was not encountered during testing.

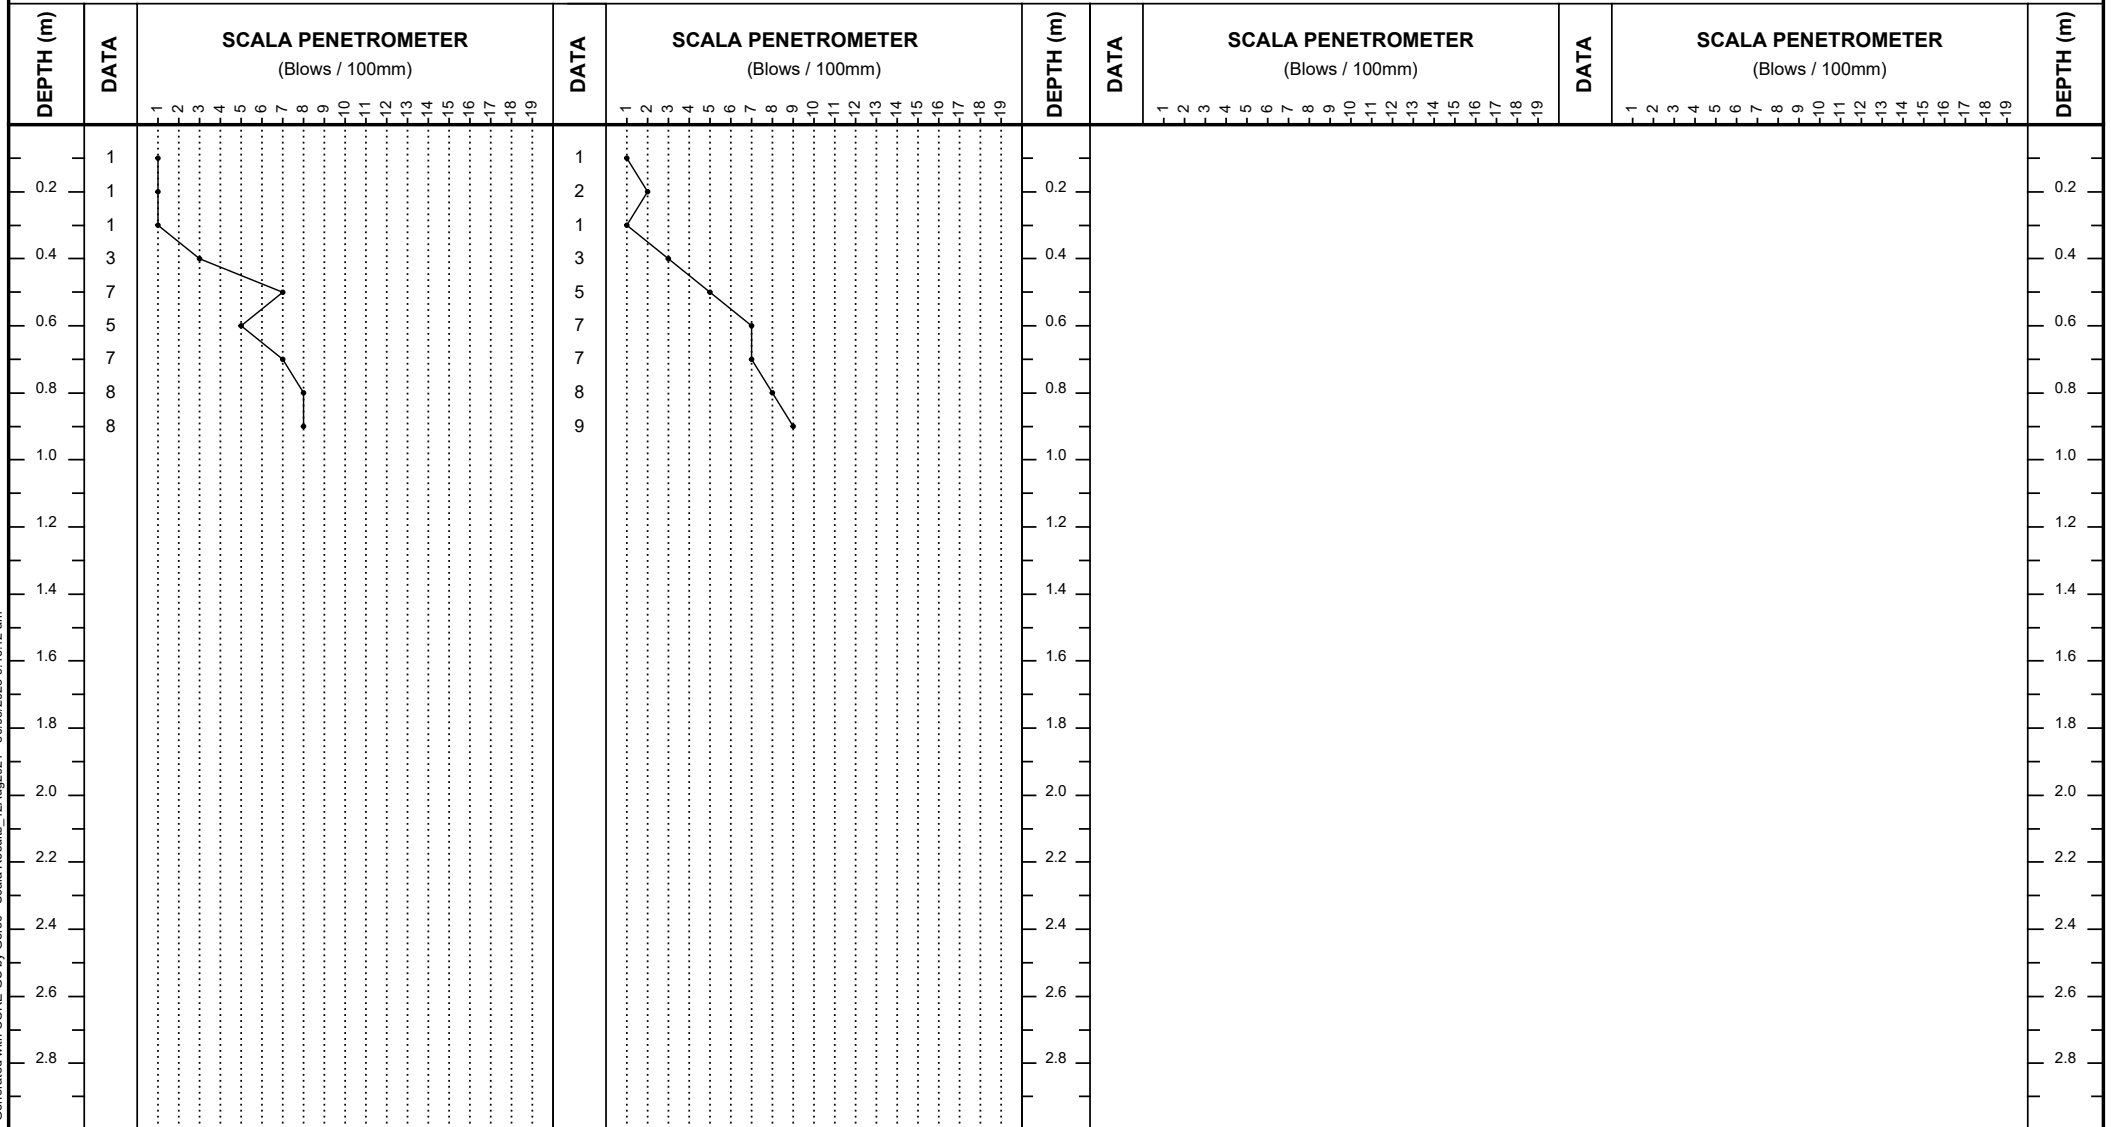
SPs at each of the four locations returned results between 2 and 10 blows per 100mm penetration below the topsoil and within the engineered fill layer. SPs were terminated at 0.9m depth to confirm near surface bearing capacities, and to avoid damage to the geogrids and geotextile. In addition, the density of the engineered fill and bearing capacity of its underlying subgrade have been confirmed via extensive geotechnical inspection and fill compaction testing during subdivision earthworks.
