Date: 30 August 2023
Project No: LTC21220-A
Revision: B

**RE: SHALLOW SOIL TEST REPORT
FUTURE RESIDENTIAL FOUNDATIONS
LOT 1, 115 EUREKA STREET, ARANUI**

Test Location Plan
 Lot 1, 115 Eureka Street,
 ARANUI, CHRISTCHURCH

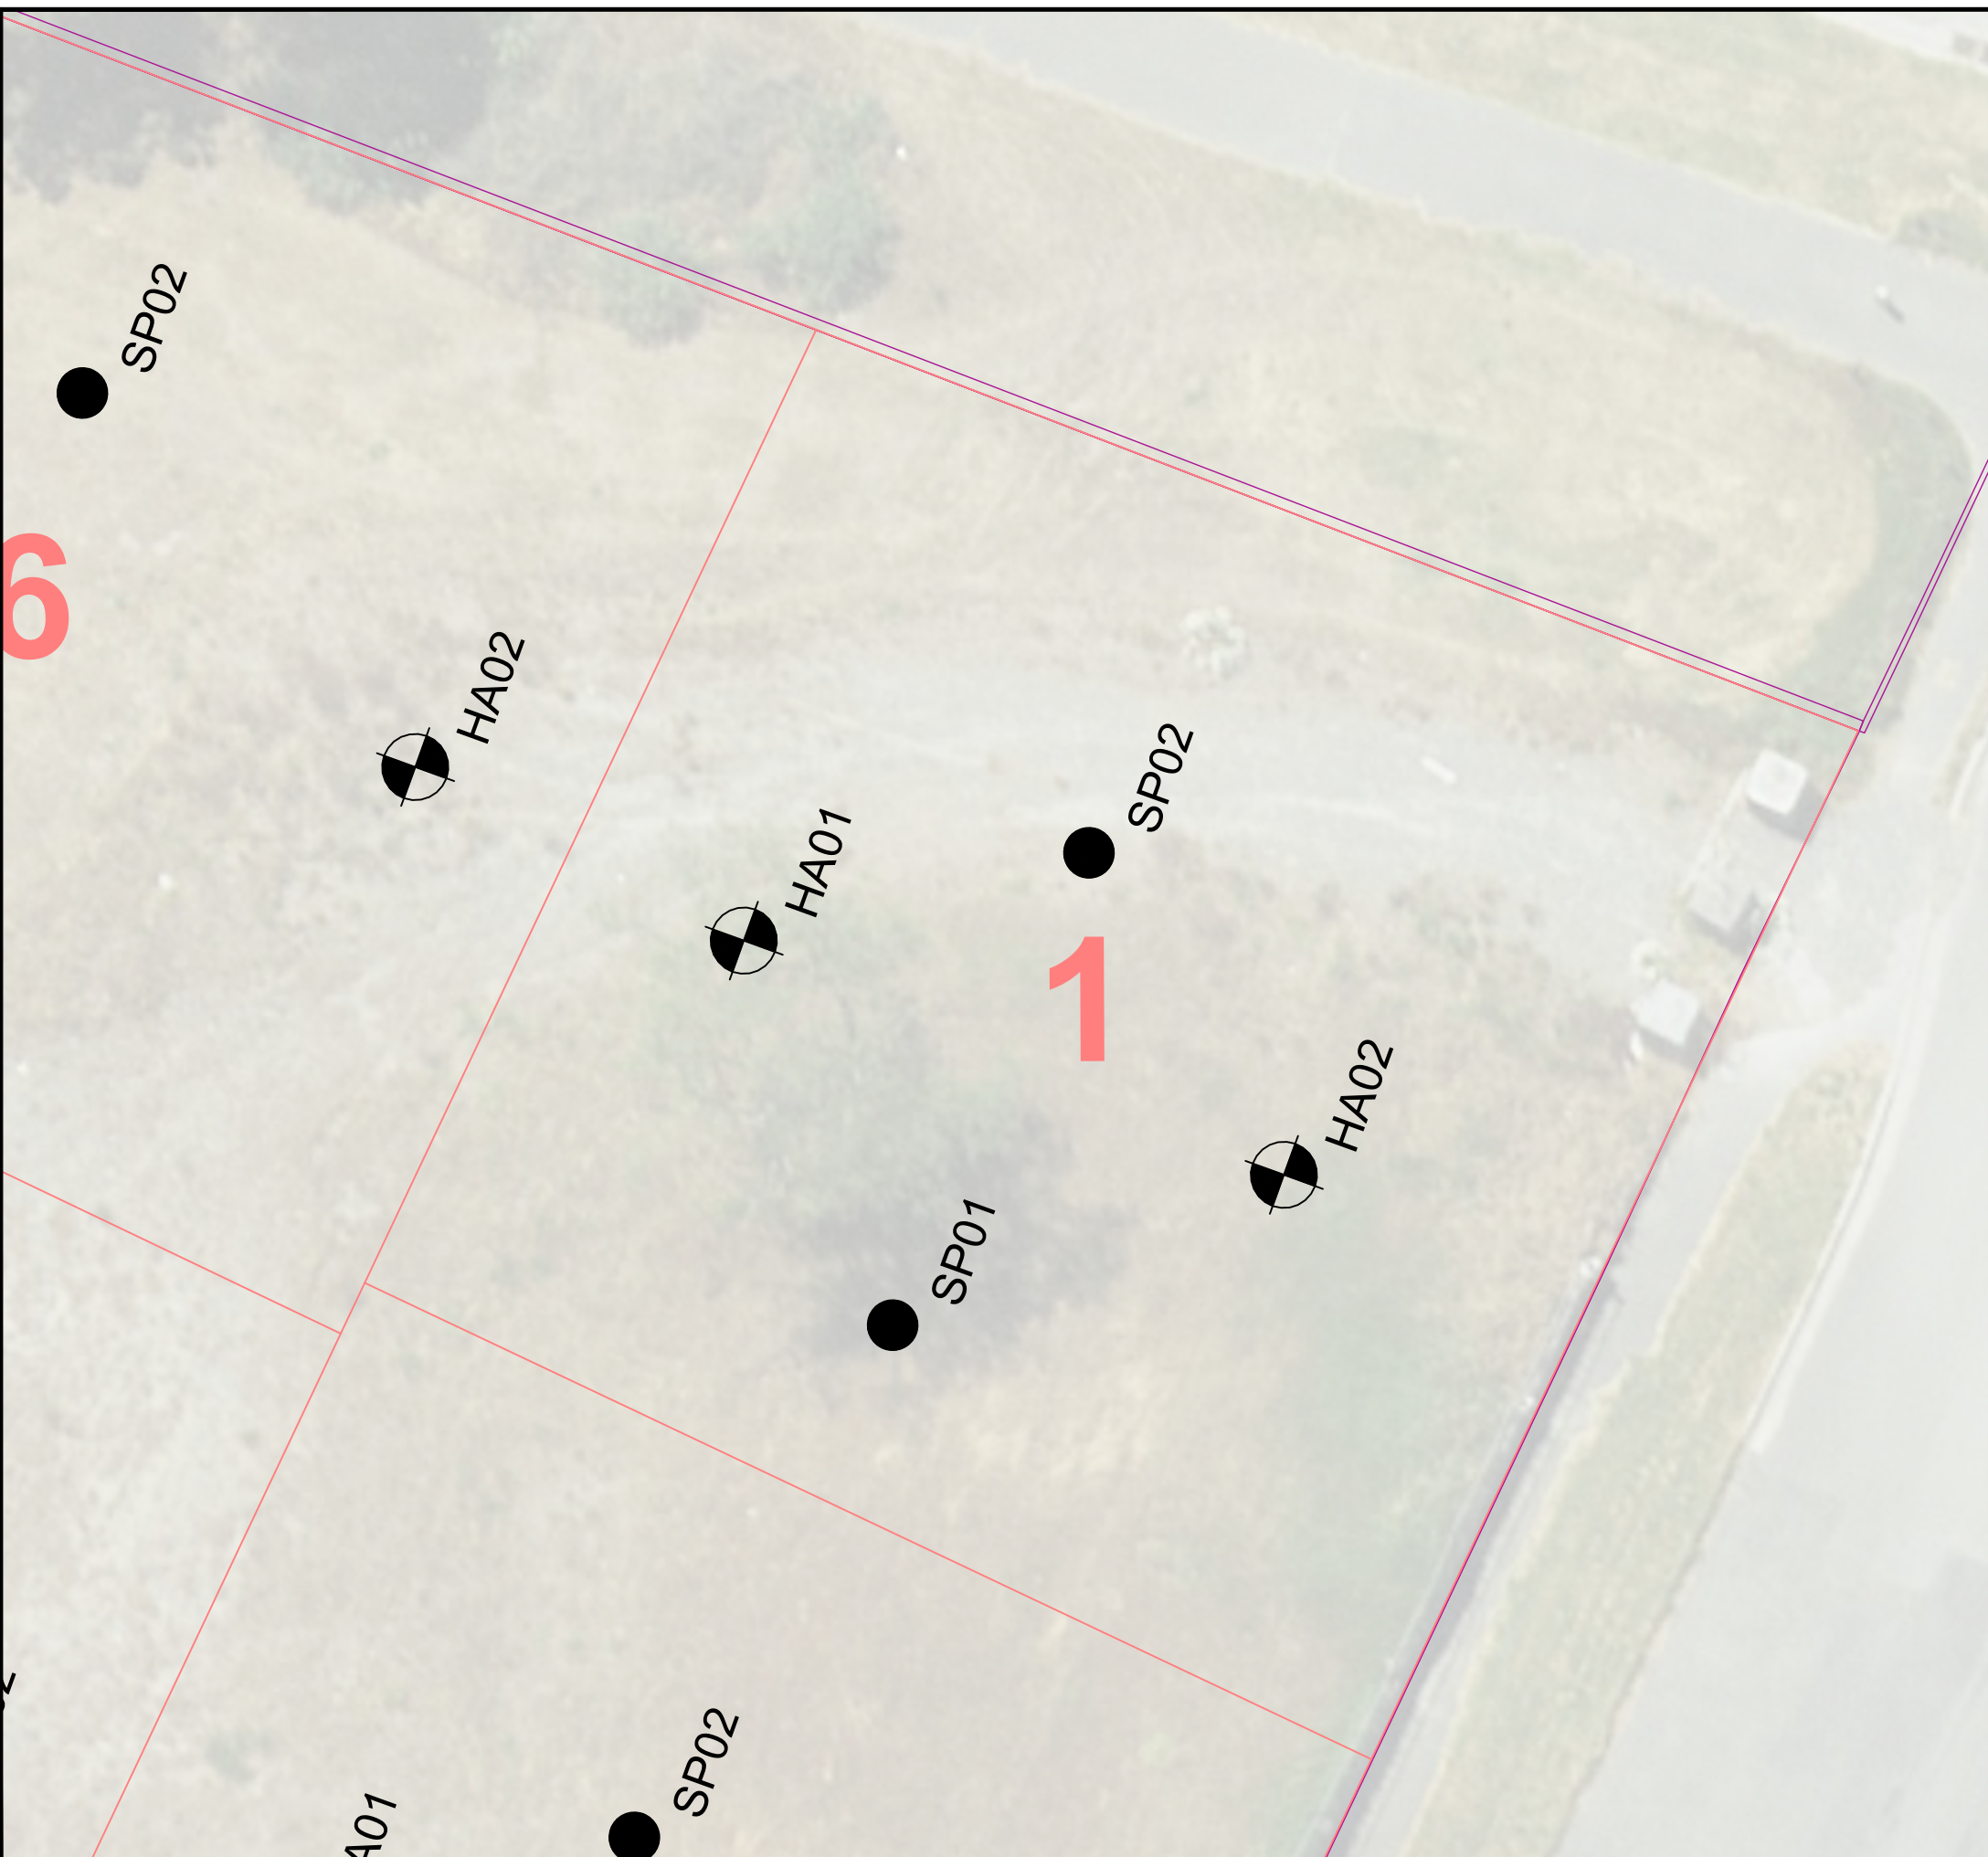
LandTech investigated the site on 8 June 2023, conducting two hand augers with corresponding Scala Penetrometer tests (SPs) and two additional SPs. The locations of the hand auger and SPs were measured using inferred lot boundaries and are approximate only. The test locations are shown on our LandTech *Test Location Plan*, Drawing No. Lot 1/ TLP, attached to this report.

HA01 LandTech Consulting Ltd. augerhole locations, drilled 08 June 2023
-

SP01 LandTech Consulting Ltd. DCP test location, tested 08 June 2023
-

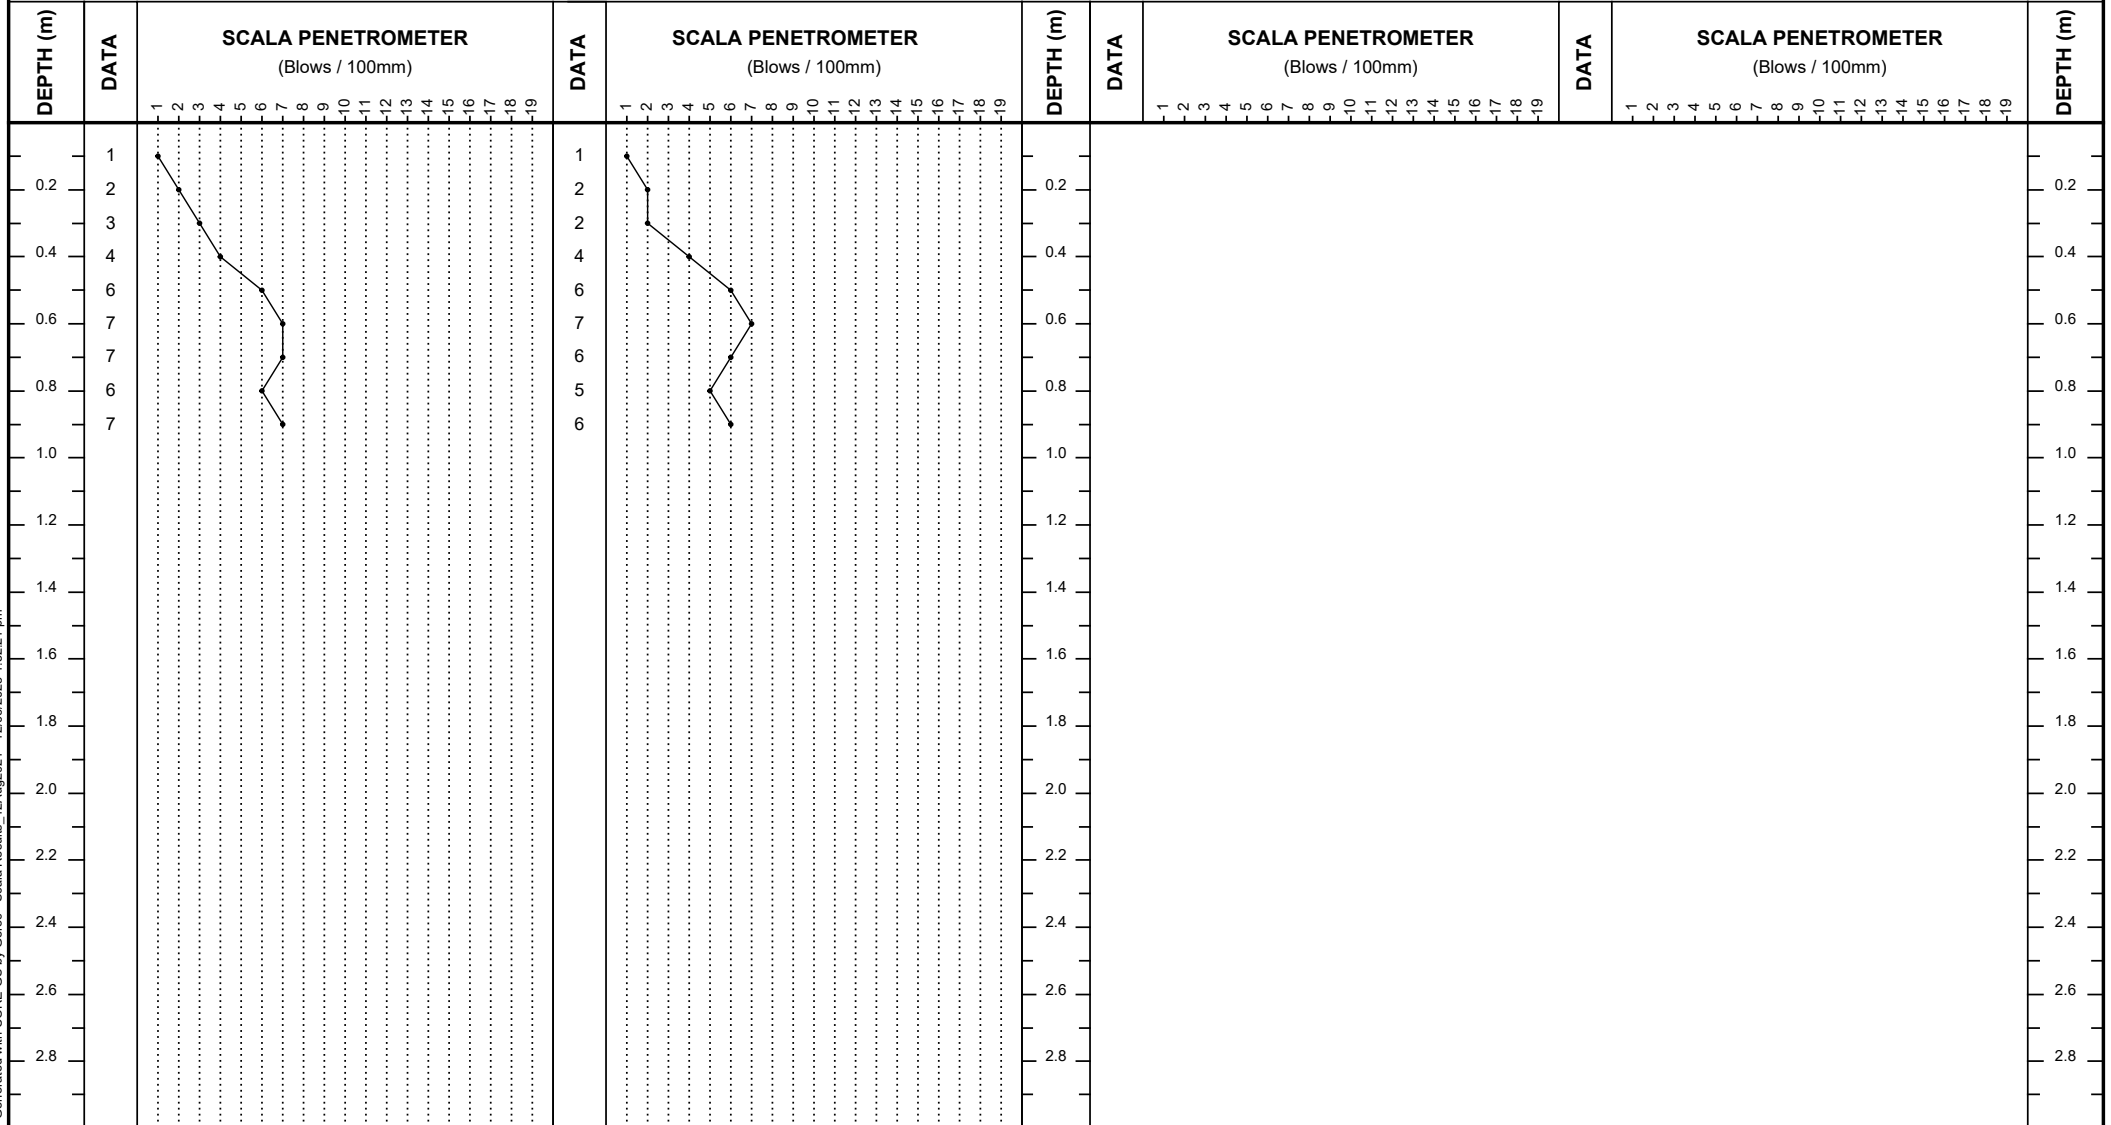
Lot 1 - SP01

Tested By: RM
Ground Conditions: Near level, Topsoil.
Coordinates: NZTM2000 E 1576454.21
 N 5183004.11
Test Date: 08-Jun-23

Tested By: RM
Ground Conditions: Near level, Topsoil.
Coordinates: NZTM2000 E 1576457.93
 N 5183012.81
Test Date: 08-Jun-23

SPs at each of the four locations returned results between 2 and 7 blows per 100mm penetration below the topsoil and within the engineered fill layer. SPs were terminated at 0.9m depth to confirm near surface bearing capacities, and to avoid damage to the geogrids and geotextile. In addition, the density of the engineered fill and bearing capacity of its underlying subgrade have been confirmed via extensive geotechnical inspection and fill compaction testing during subdivision earthworks.
