Date: 30 August 2023  
Project No: LTC21220-A  
Revision: B

**RE: SHALLOW SOIL TEST REPORT  
FUTURE RESIDENTIAL FOUNDATIONS  
LOT 15, 115 EUREKA STREET, ARANUI**

**Test Location Plan**  
 Lot 15, 115 Eureka Street,  
 ARANUI, CHRISTCHURCH

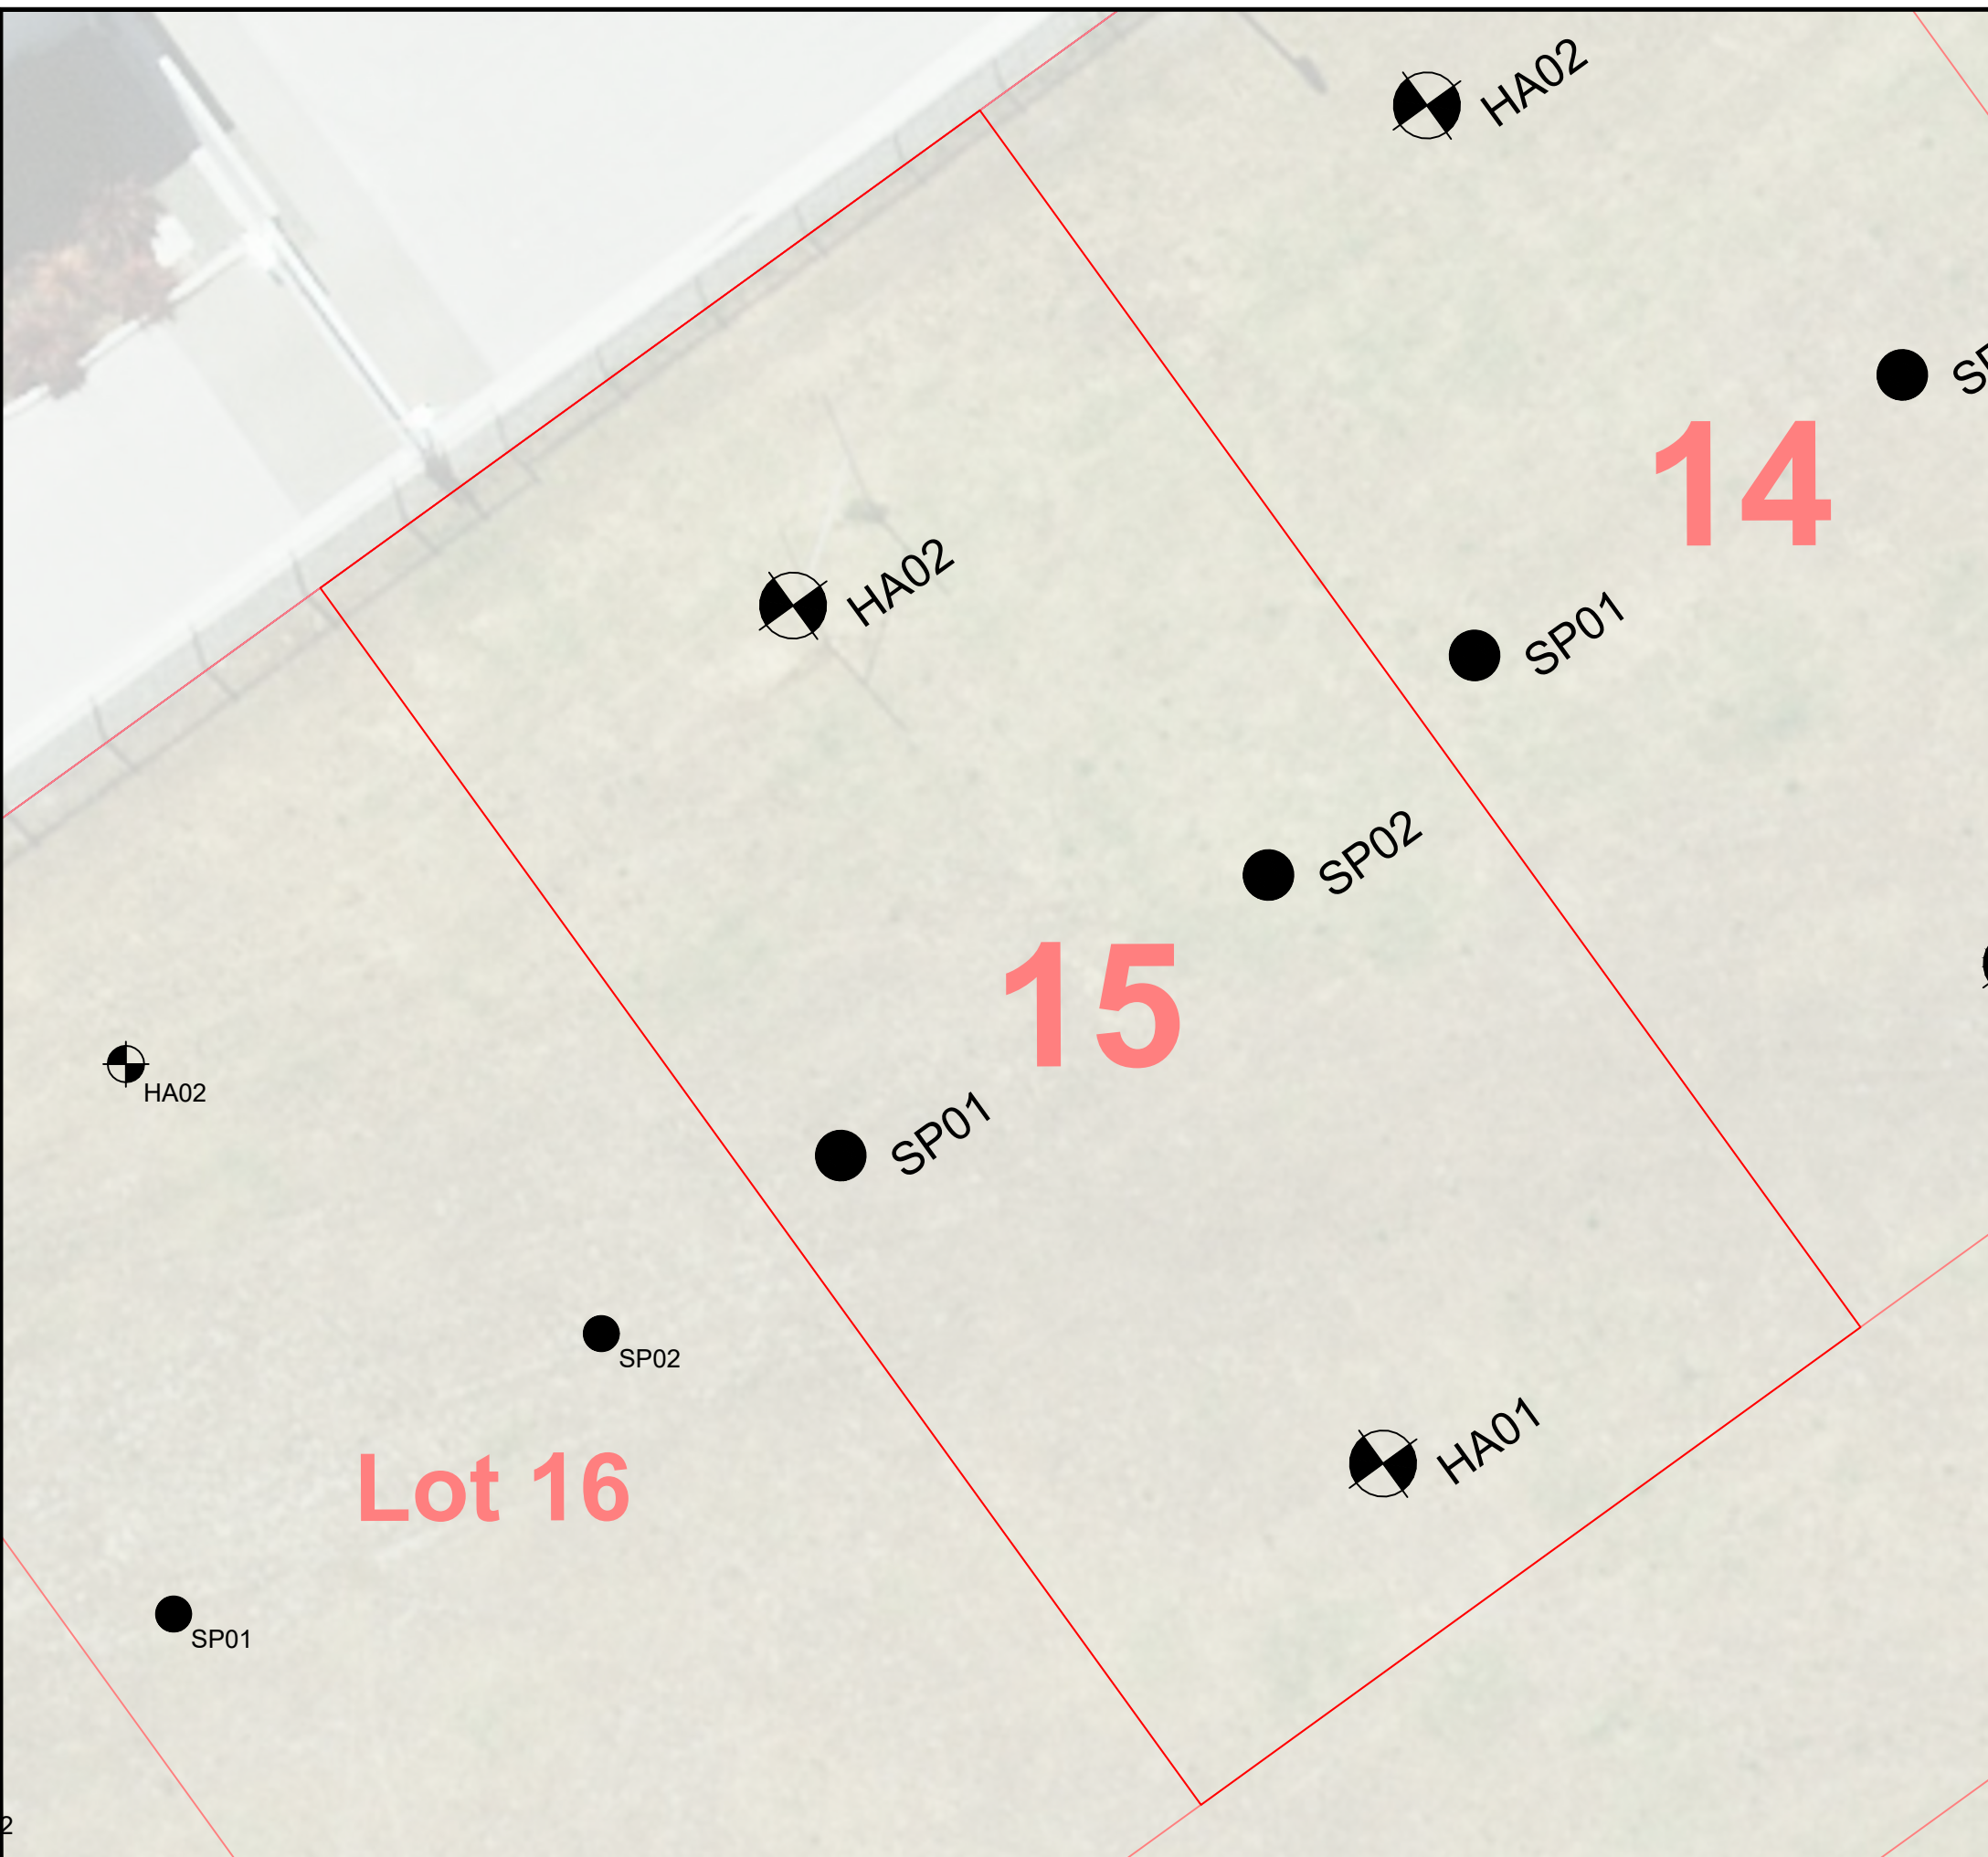
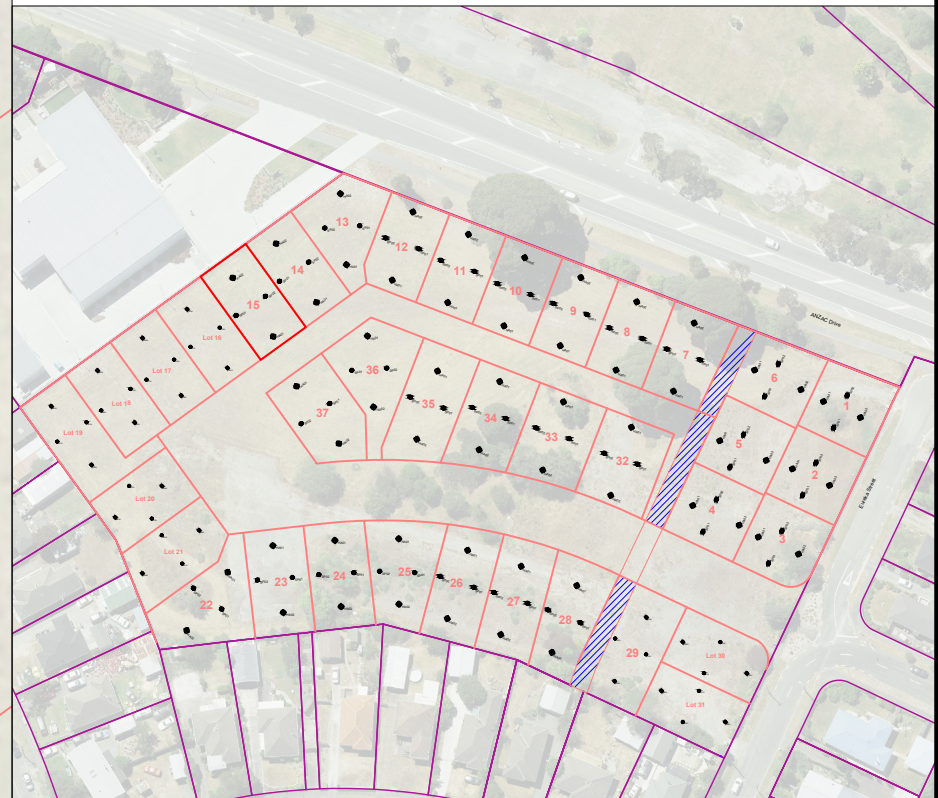
Drawing No: Lot 15/TLP	Drawn by: RM	Date: 30 August 2023
Scale: 1: 125 (A3) 1: 2000 (A3)	Checked by: D Wilson	Revision: B
Filename: LTC21220 - A - Drawings.dwg

LandTech investigated the site on 1 June 2023, conducting two hand augers with corresponding Scala Penetrometer tests (SPs) and two additional SPs. The locations of the hand auger and SPs were measured using inferred lot boundaries and are approximate only. The test locations are shown on our LandTech *Test Location Plan*, Drawing No. Lot 15/ TLP, attached to this report.

HA01 LandTech Consulting Ltd. augerhole locations, drilled 01 June 2023
-   SP01 LandTech Consulting Ltd. DCP test location, tested 01 June 2023
-

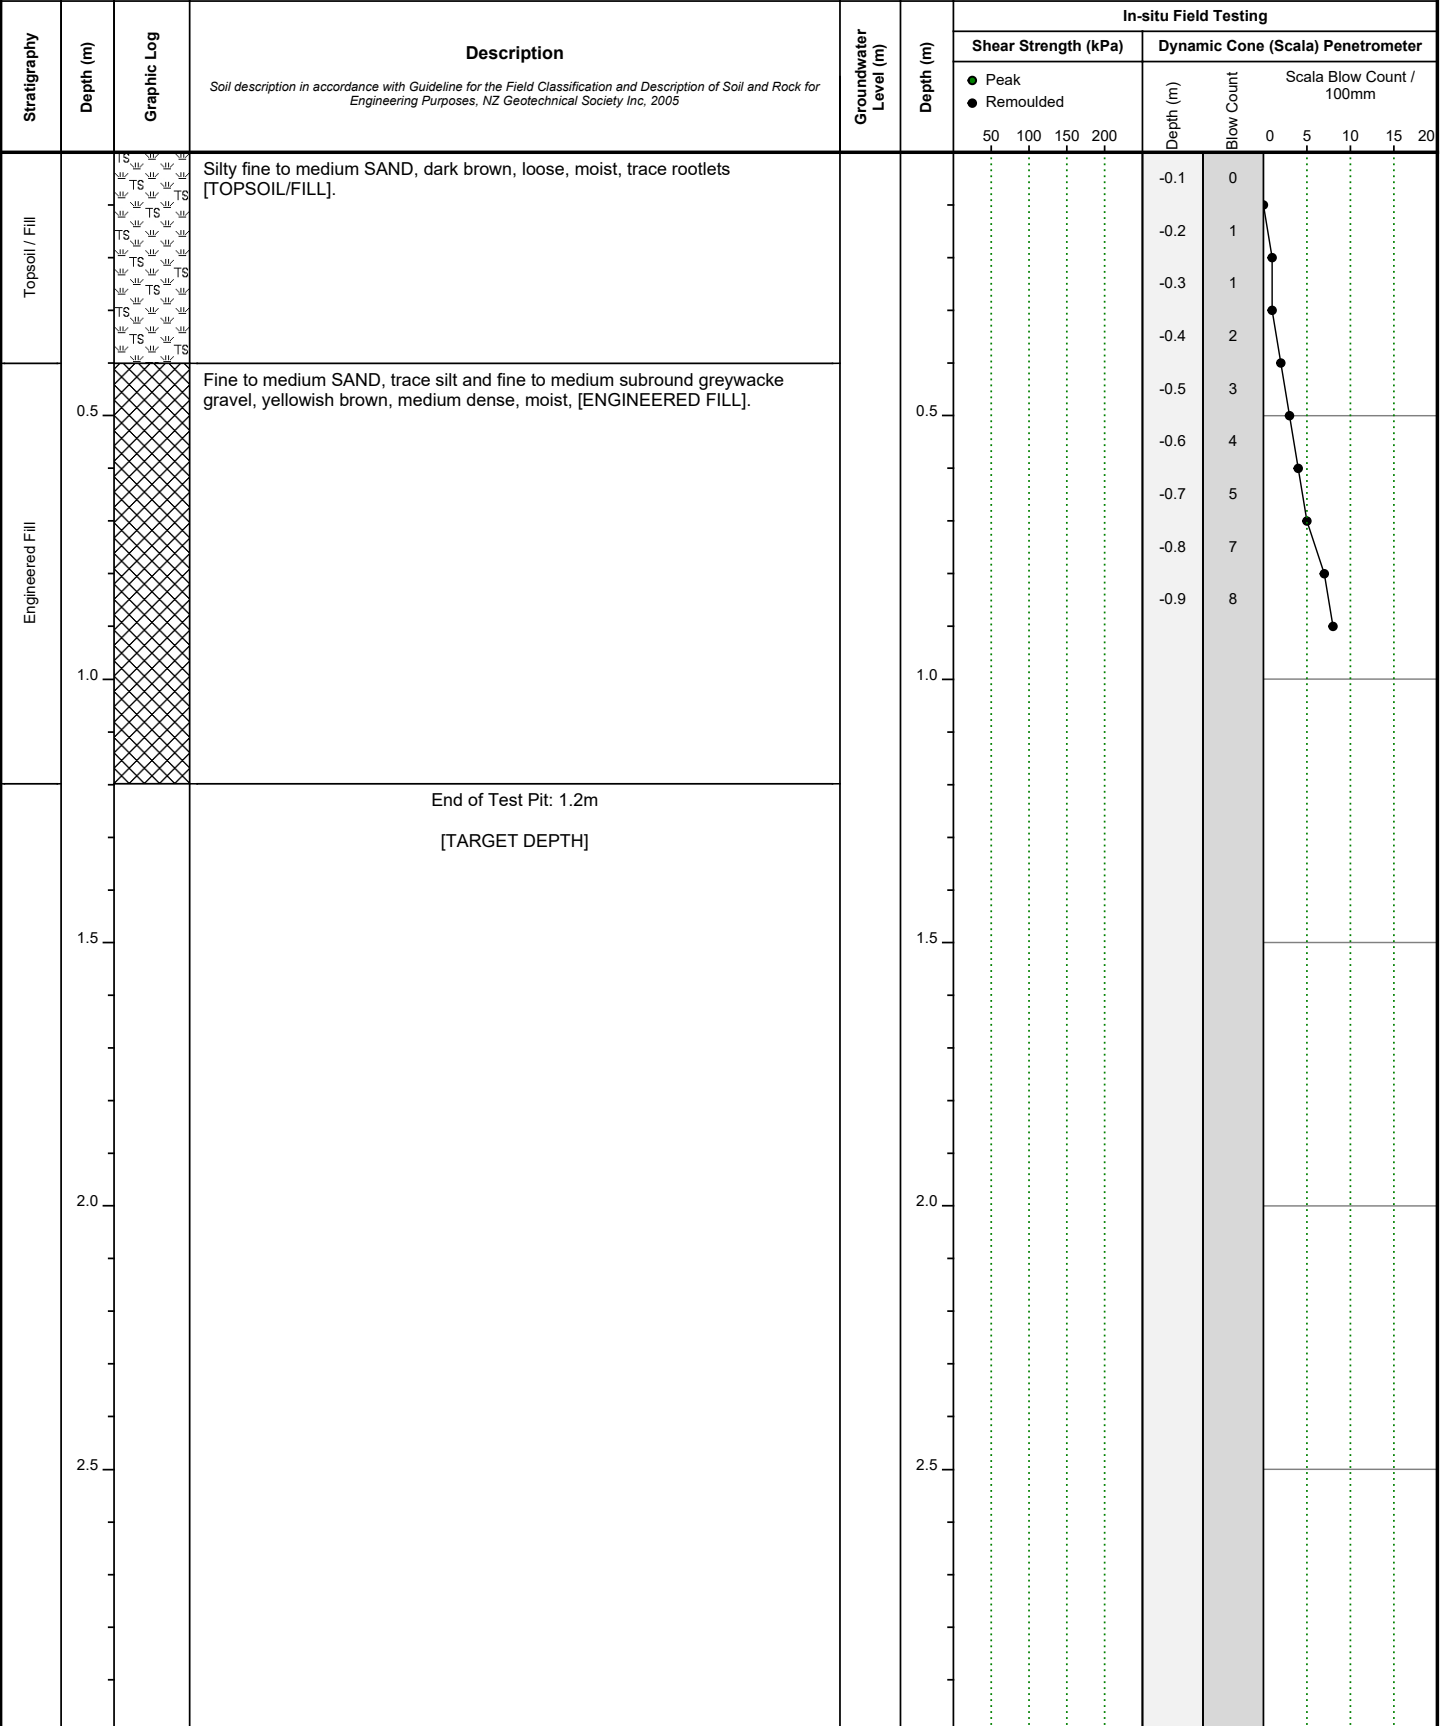
Test Pit No.: Lot 15 - HA01

Topsoil was encountered within the hand augers from the ground surface to 0.4m depth, which was typically a dark brown silty sand material. Engineered fill was encountered below the topsoil to the base of auger holes, which was a compacted yellowish brown sand material with a trace of silt. The hand augers were terminated at 1.2m depth below ground level to avoid damage to the geotextile layer which was installed at 1.5m depth below ground level. Groundwater was not encountered during testing.

Project No.: LTC21220-A      Coordinates: NZTM2000: E1576306.22, N5183028.08      Logged By: KY  
 Drill Type: 50mm Hand Auger      Reduced Level: 2.83m (LVD1937)      Shear Vane No.:  
 Date Started: 01-Jun-23      Ground Conditions: Near level, Topsoil.      Calibration Factor:  
 Date Finished: 01-Jun-23      Groundwater Level (m): Not Encountered      Calibration Date:

Target depth achieved.      In-situ testing in accordance with the following standards:  
 Scala Penetrometer Testing: NZS 4402:1988, Test 6.5.2, Dynamic Cone Penetrometer  
 Shear Vane Testing: Guideline for Hand Held Shear Vane Test, NZGS, August 2001

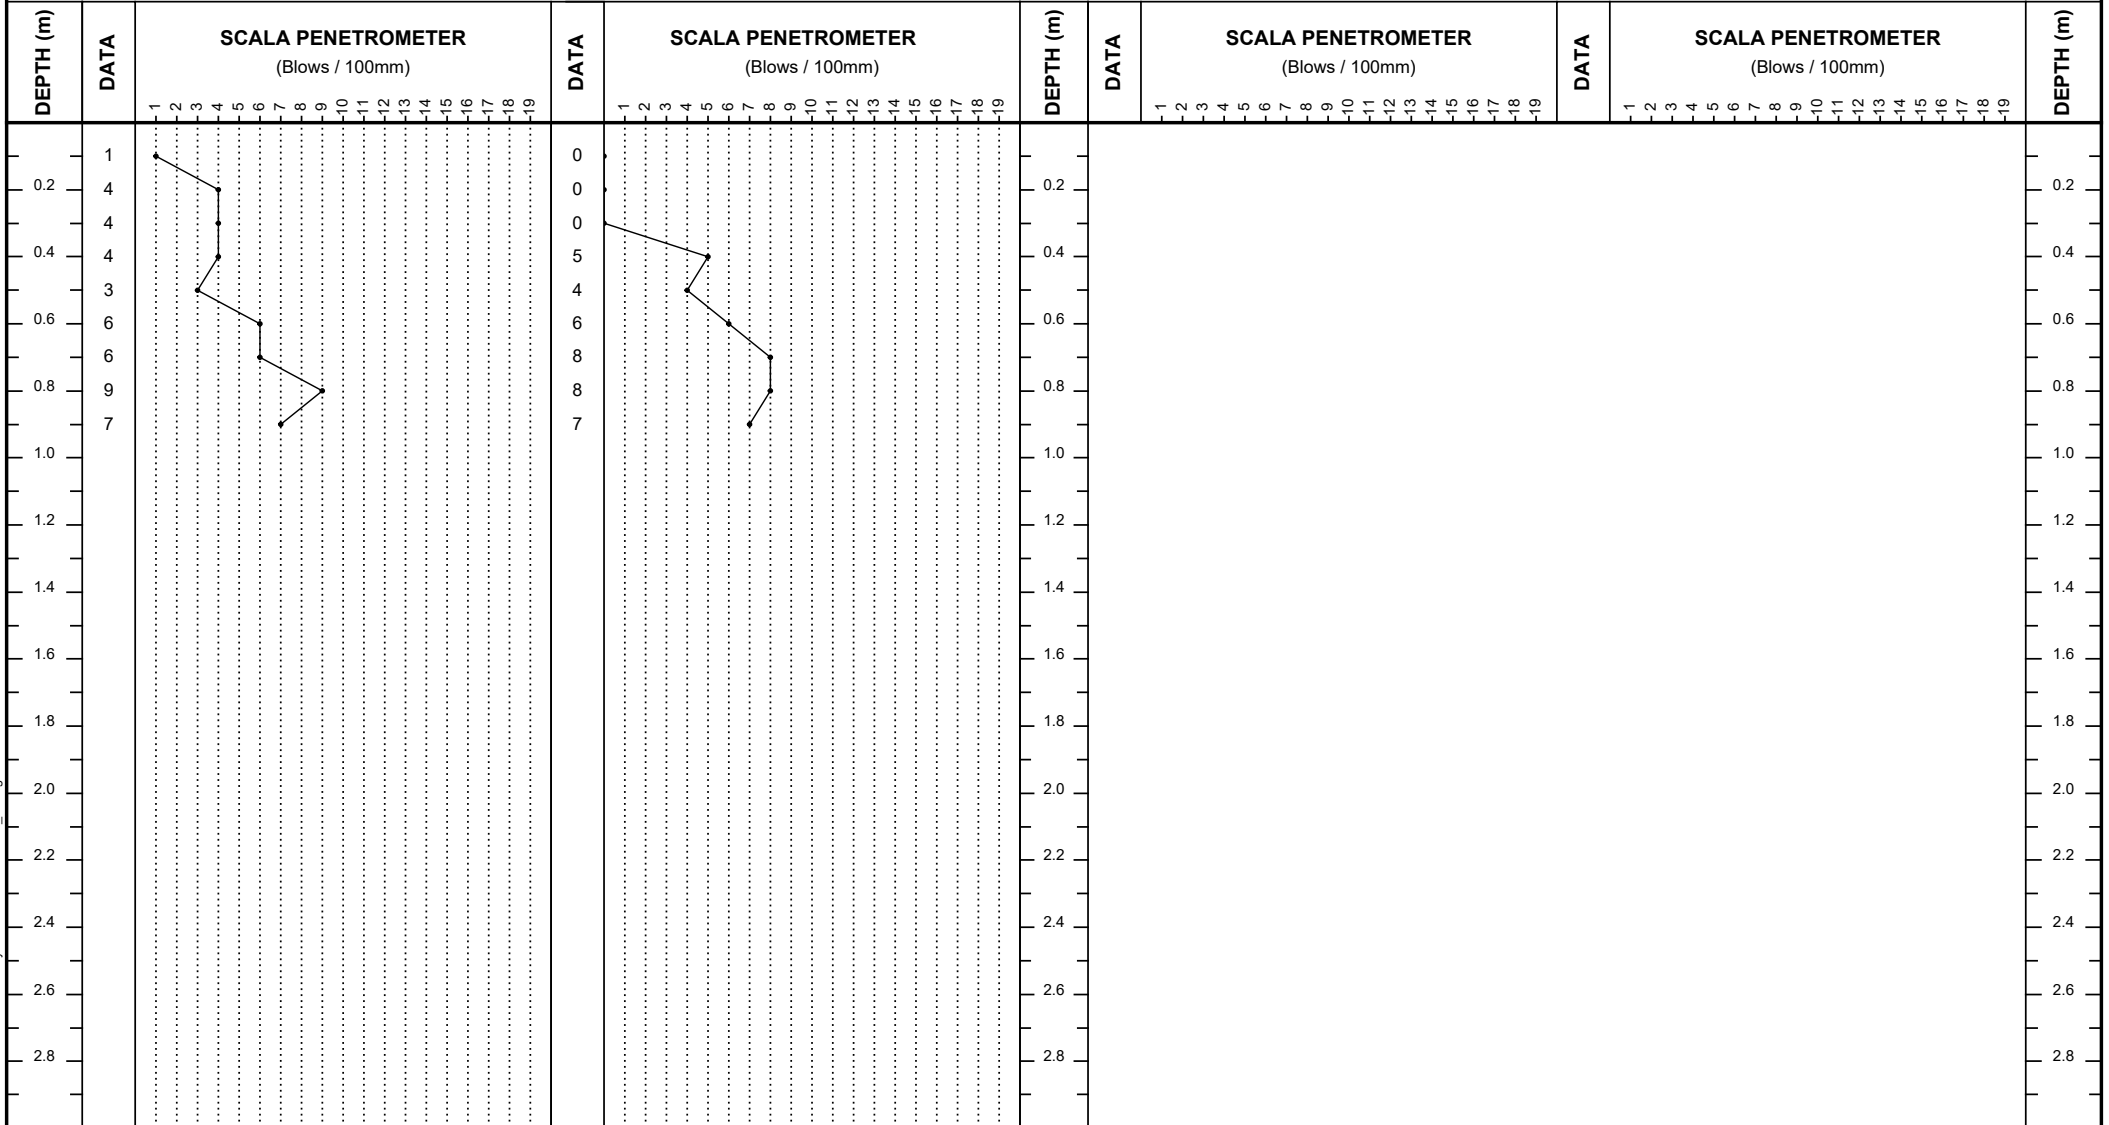
**LOT 15- SP01**

SPs at each of the four locations returned results between 2 and 10 blows per 100mm penetration below the topsoil and within the engineered fill layer. SPs were terminated at 0.9m depth to confirm near surface bearing capacities, and to avoid damage to the geogrids and geotextile. In addition, the density of the engineered fill and bearing capacity of its underlying subgrade have been confirmed via extensive geotechnical inspection and fill compaction testing during subdivision earthworks.

Tested By: KY  
 Ground Conditions: Near level, Topsoil.  
 Coordinates: NZTM2000 E 1576304.14  
 N 5183038.73  
 Test Date: 01-Jun-23

Tested By: KY  
 Ground Conditions: Near level, Topsoil.  
 Coordinates: NZTM2000 E 1576296.07  
 N 5183033.78  
 Test Date: 01-Jun-23
