Date: 30 August 2023
Project No: LTC21220-A
Revision: B

**RE: SHALLOW SOIL TEST REPORT
FUTURE RESIDENTIAL FOUNDATIONS
LOT 25, 115 EUREKA STREET, ARANUI**

Test Location Plan

Lot 25, 115 Eureka Street,
ARANUI, CHRISTCHURCH

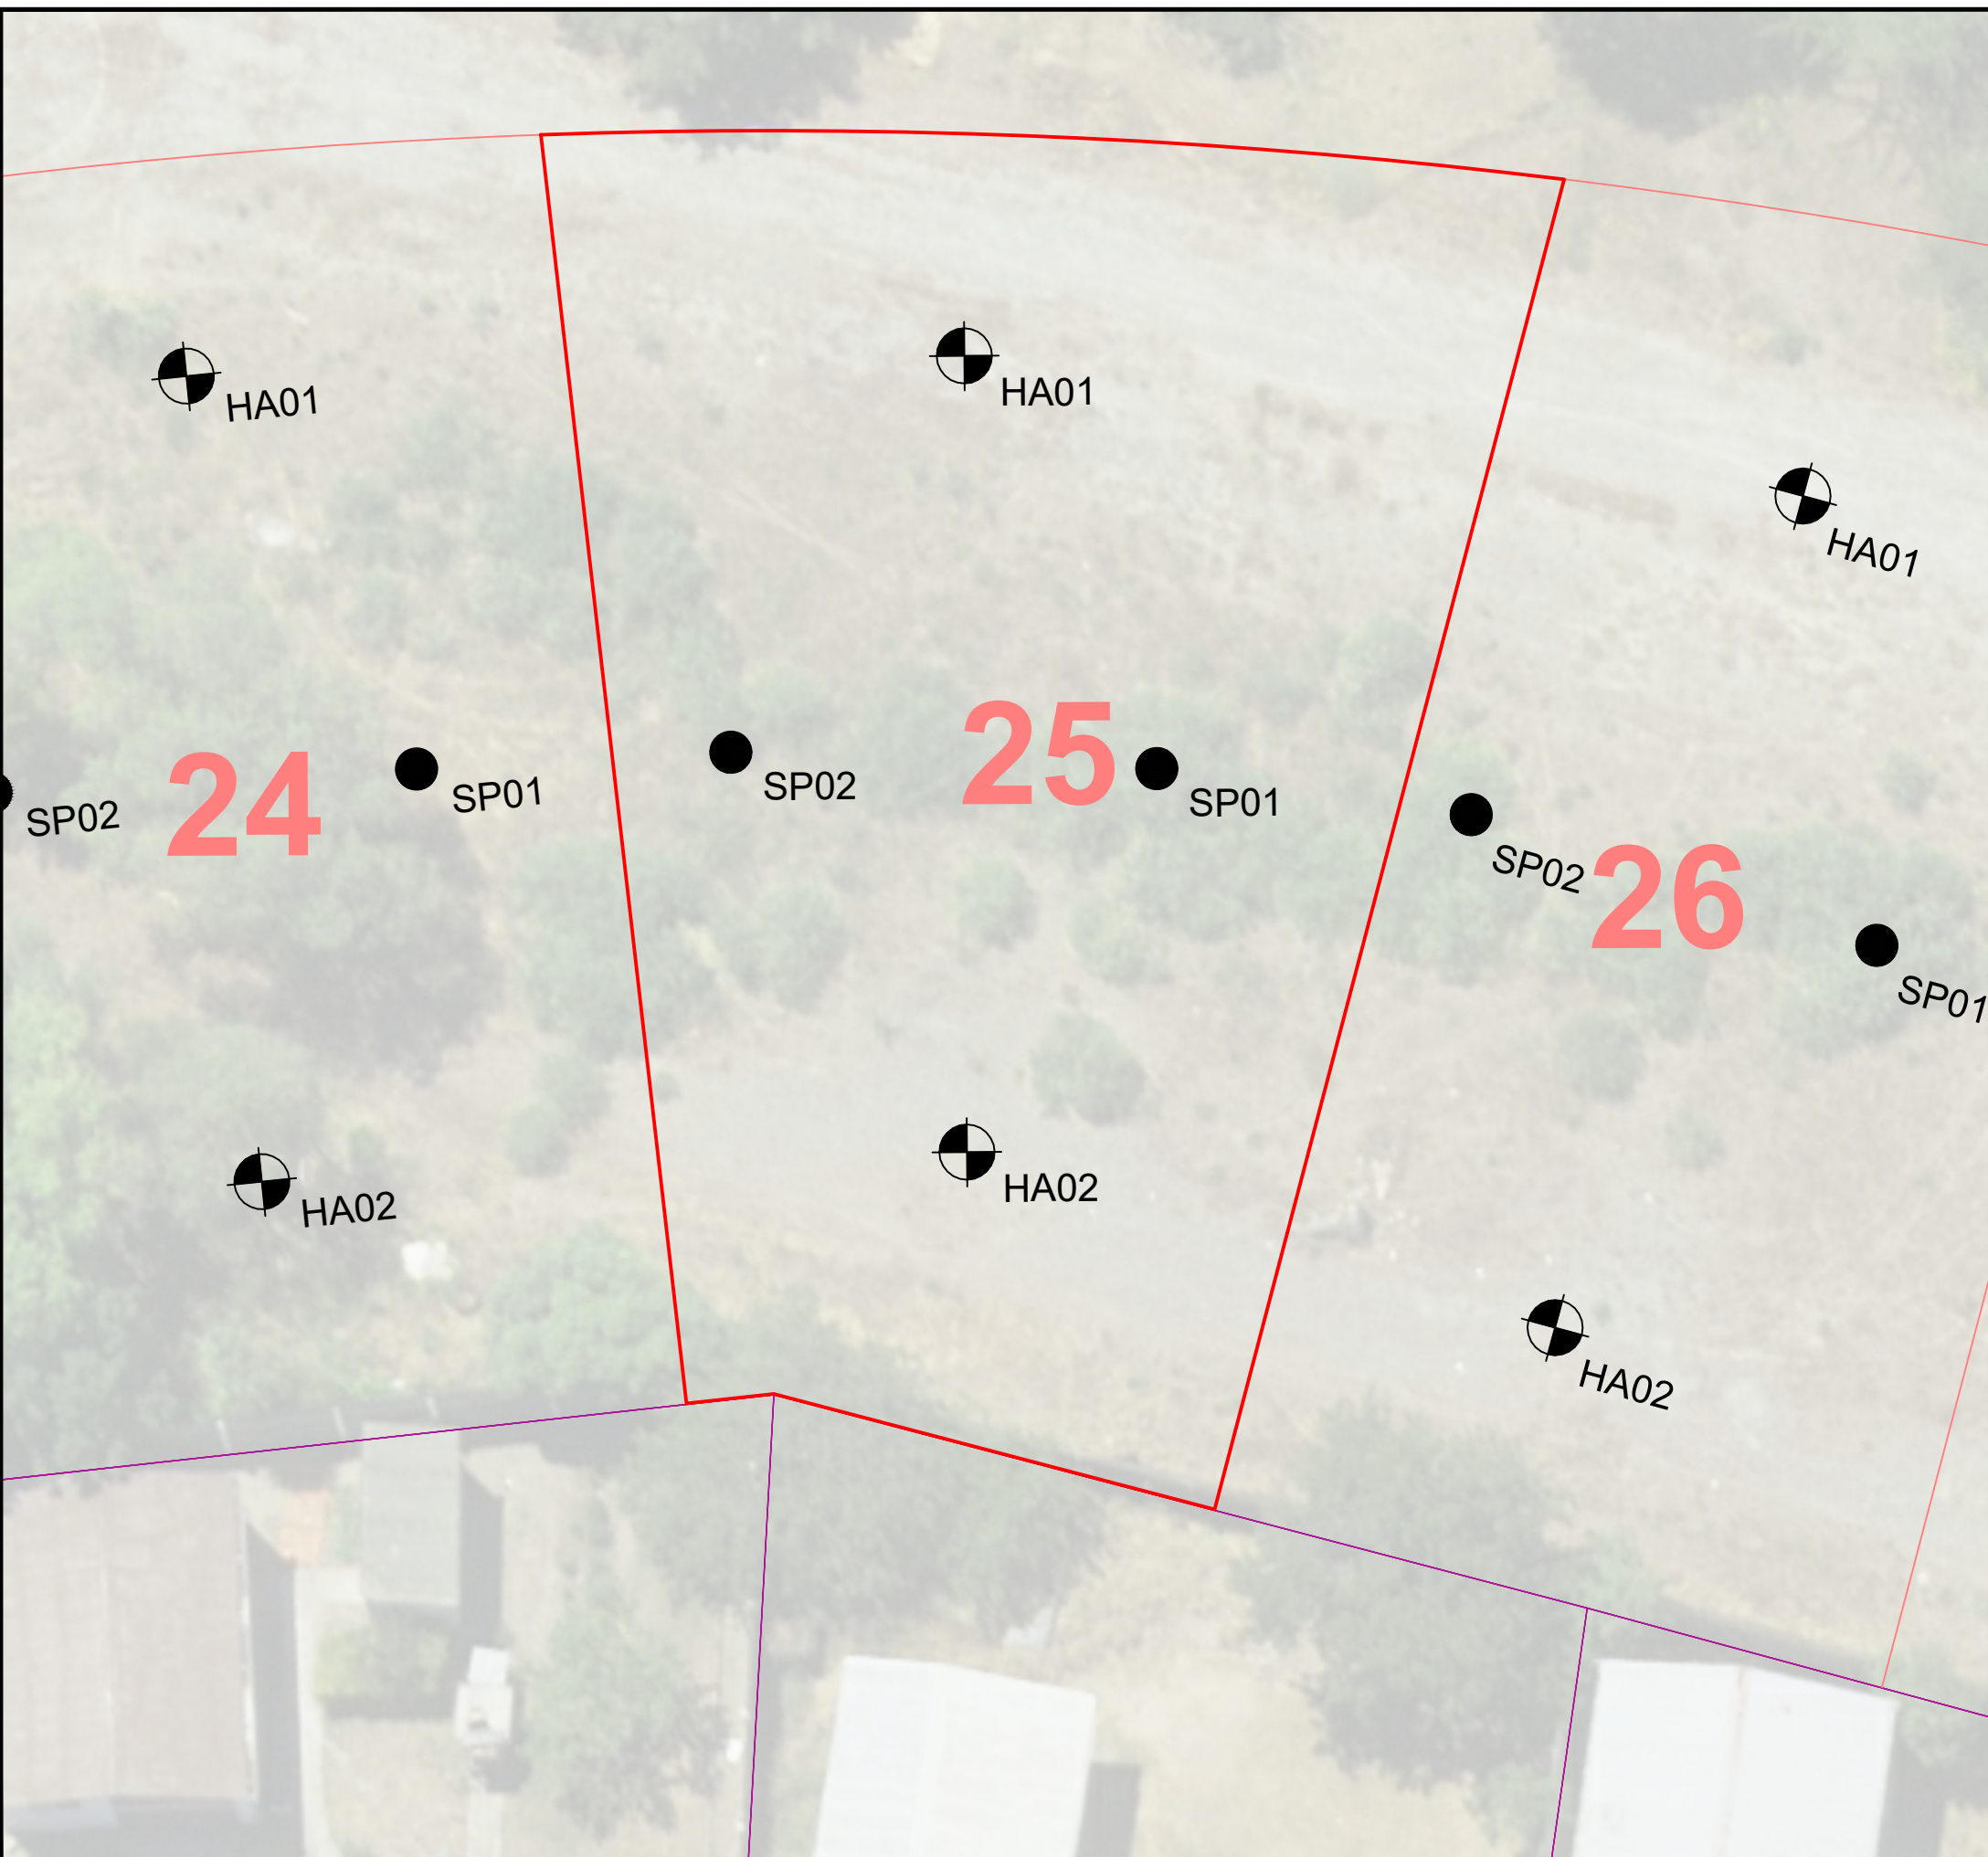
LandTech investigated the site on 23 March 2023, conducting two hand augers with corresponding Scala Penetrometer tests (SPs) and two additional SPs. The locations of the hand auger and SPs were measured using inferred lot boundaries and are approximate only. The test locations are shown on our LandTech *Test Location Plan*, Drawing No. Lot 25/ TLP, attached to this report.

HA01 LandTech Consulting Ltd. augerhole locations, drilled 23 March 2023
 -

SP01 LandTech Consulting Ltd. DCP test location, tested 23 March 2023
 -

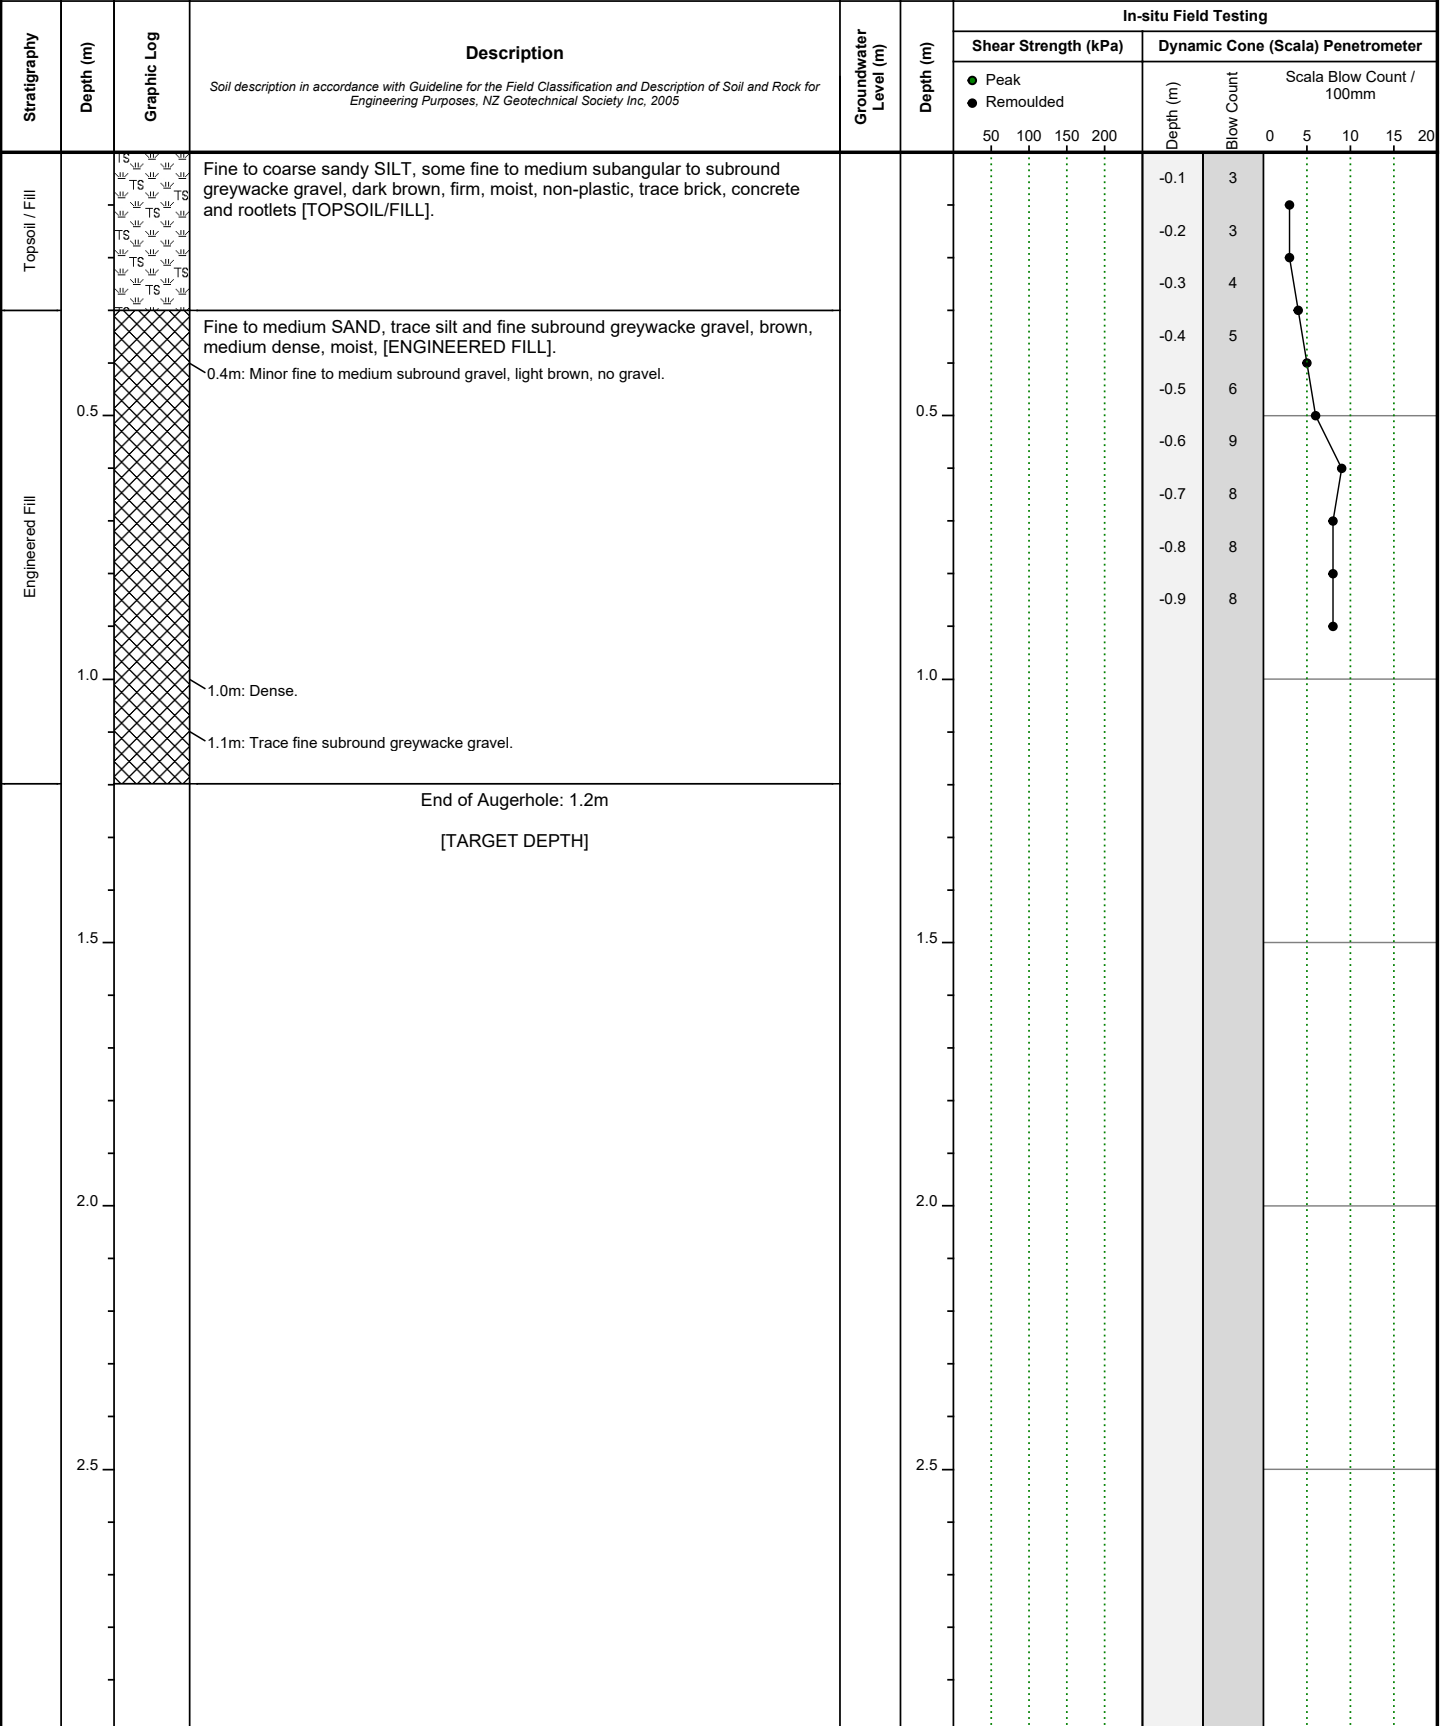
Augerhole No.: LOT 25- HA01

Project No.: LTC21220-A Coordinates: NZTM2000: E1576339.17, N5182974.72 Logged By: KY
 Drill Type: 50mm Hand Auger Reduced Level: 2.83m (LVD1937) Shear Vane No.:
 Date Started: 23-Mar-23 Ground Conditions: Near level, Topsoil. Calibration Factor:
 Date Finished: 23-Mar-23 Groundwater Level (m): Not Encountered Calibration Date:

Target depth achieved. In-situ testing in accordance with the following standards:
 Scala Penetrometer Testing: NZS 4402:1988, Test 6.5.2, Dynamic Cone Penetrometer
 Shear Vane Testing: Guideline for Hand Held Shear Vane Test, NZGS, August 2001

Topsoil was encountered within the hand augers from the ground surface to 0.2m and 0.3m depths, which was typically a dark brown sandy silt material with some gravel. Engineered fill was encountered below the topsoil to the base of auger holes, which was a compacted light brown sand material with a trace of silt and gravel. The hand augers were terminated at 1.2m depth below ground level to avoid damage to the geotextile layer which was installed at 1.5m depth below ground level. Groundwater was not encountered during testing.

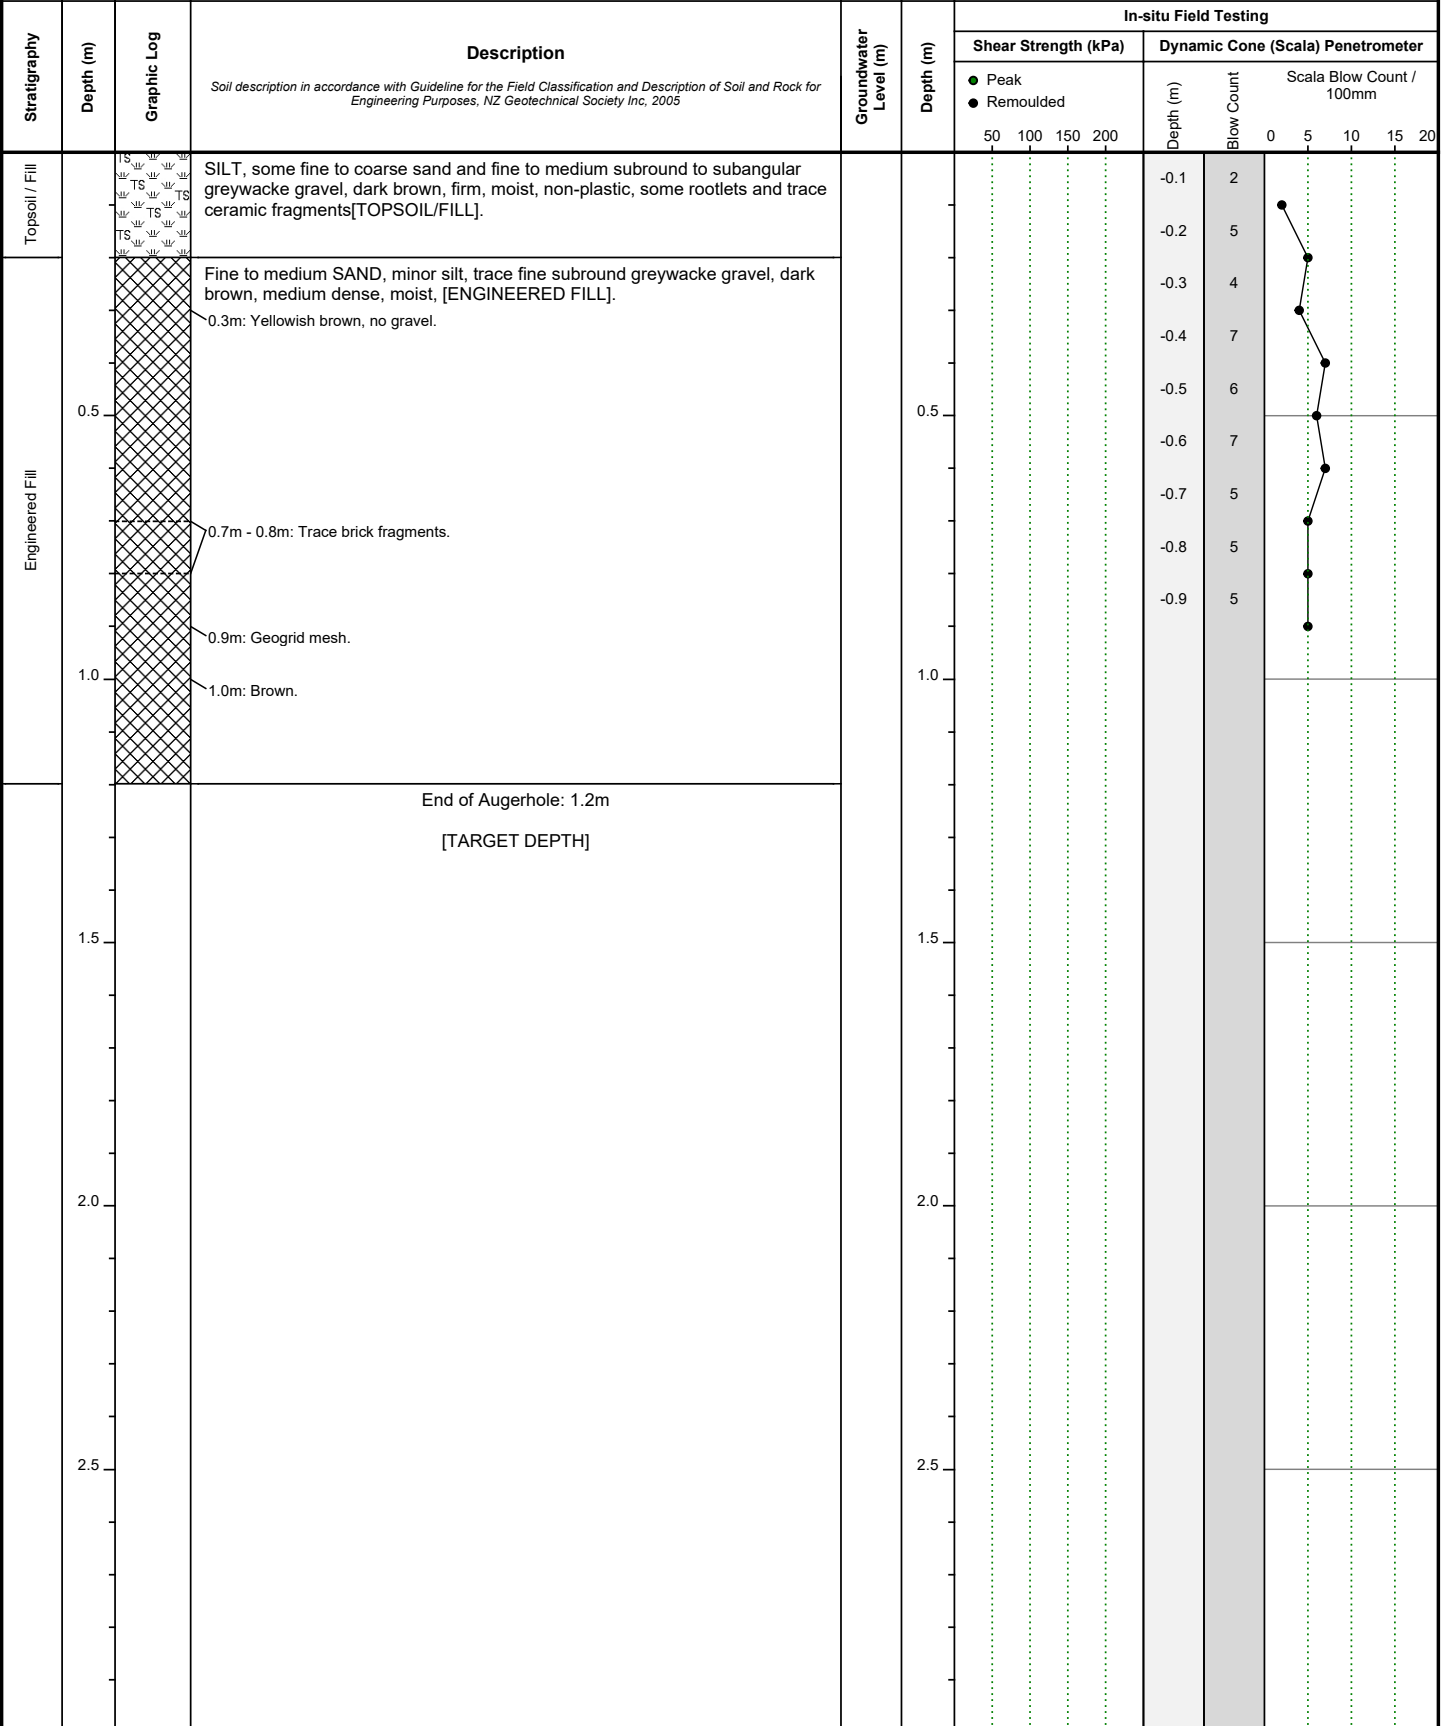
Augerhole No.: LOT 25- HA02

Project No.: LTC21220-A Coordinates: NZTM2000: E1576338.87, N5182955.88 Logged By: KY
 Drill Type: 50mm Hand Auger Reduced Level: 2.83m (LVD1937) Shear Vane No.:
 Date Started: 23-Mar-23 Ground Conditions: Near level, Topsoil. Calibration Factor:
 Date Finished: 23-Mar-23 Groundwater Level (m): Not Encountered Calibration Date:

Target depth achieved.

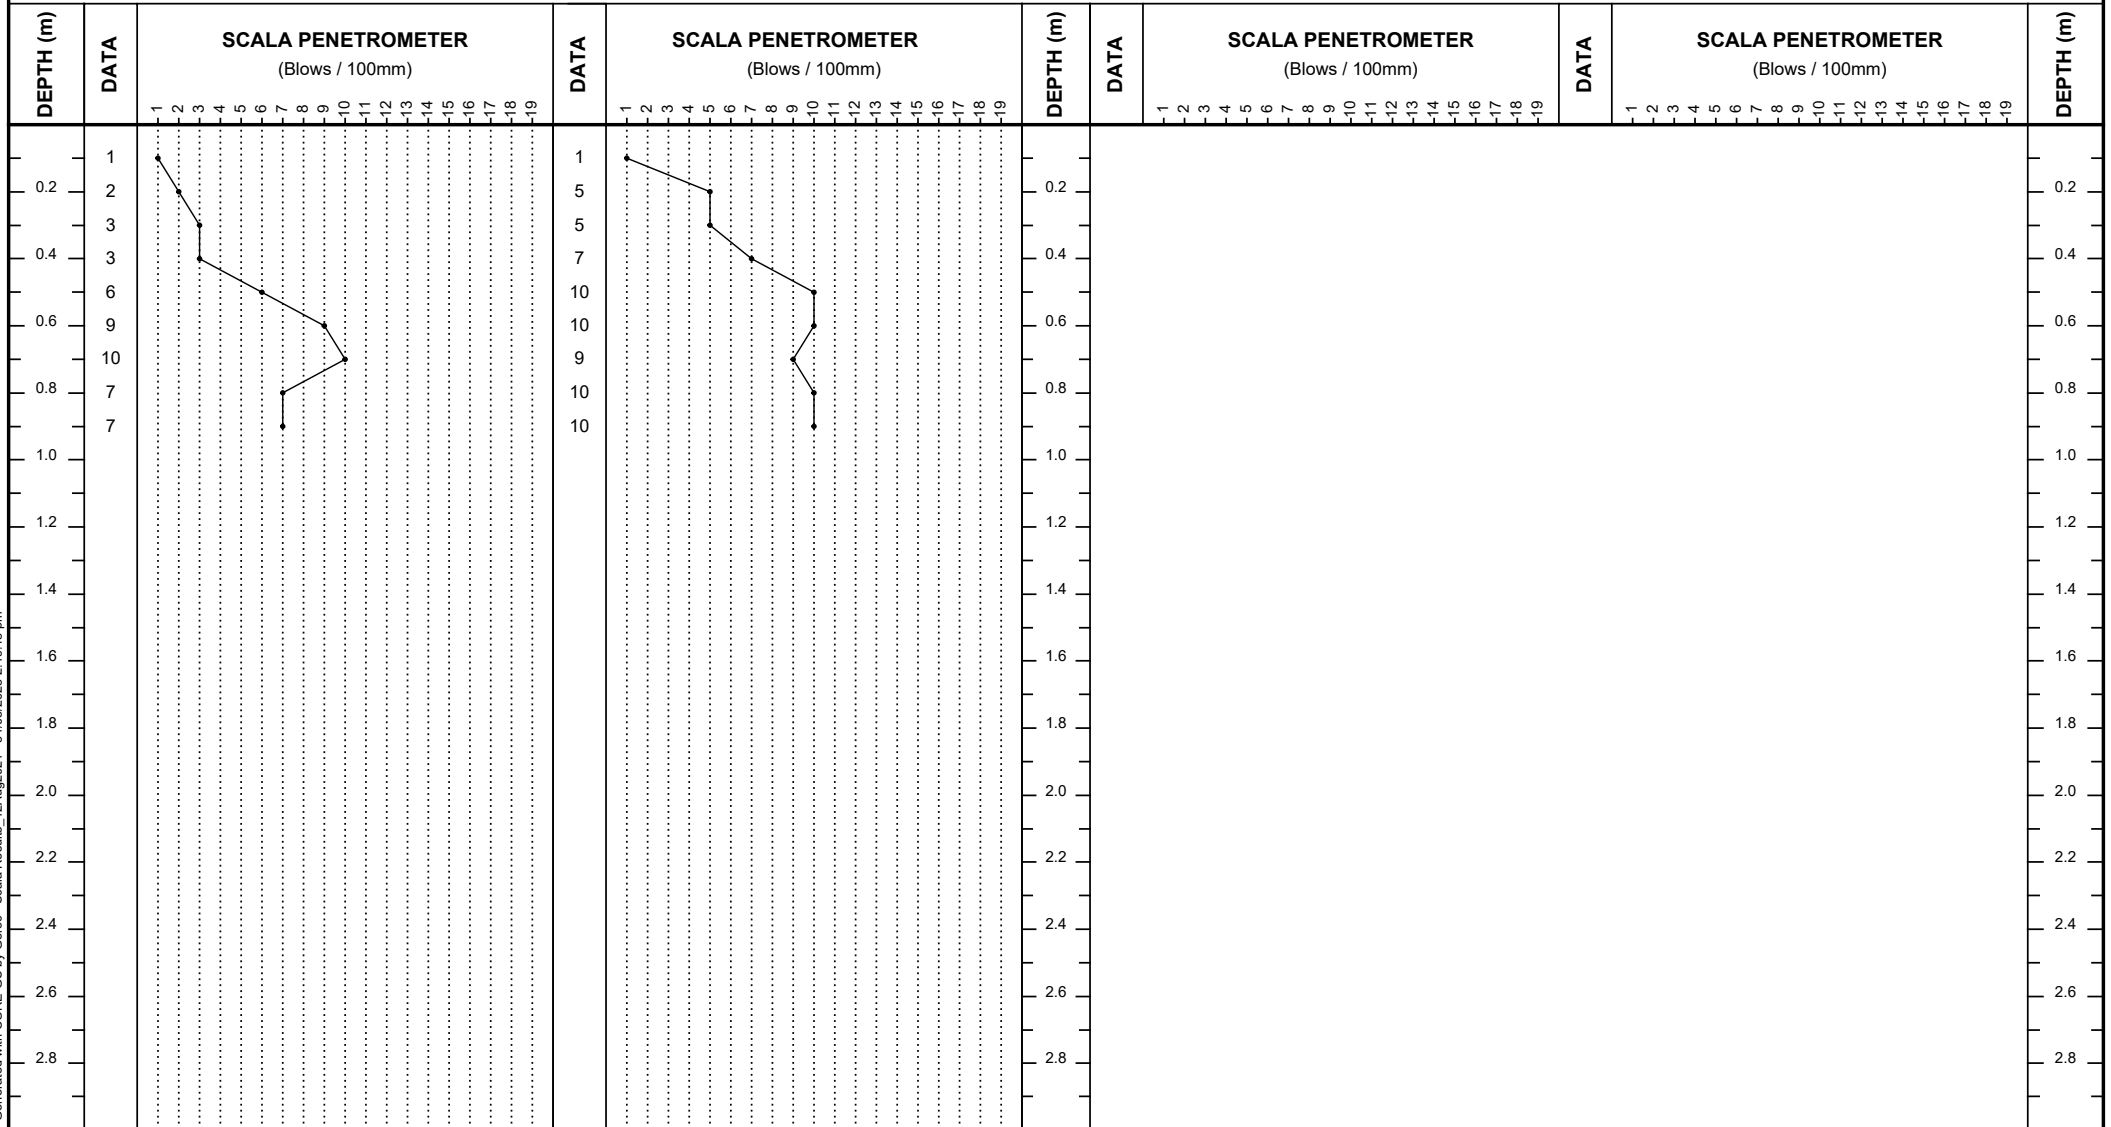
LOT 25- SP01

Tested By: KY
Ground Conditions: Near level, Topsoil.
Coordinates: NZTM2000 E 1576343.35
 N 5182965.76
Test Date: 23-Mar-23

Tested By: KY
Ground Conditions: Near level, Topsoil.
Coordinates: NZTM2000 E 1576334.10
 N 5182966.11
Test Date: 23-Mar-23

SPs at each of the four locations returned results between 3 and 10 blows per 100mm penetration below the topsoil and within the engineered fill layer. SPs were terminated at 0.9m depth to confirm near surface bearing capacities, and to avoid damage to the geogrids and geotextile. In addition, the density of the engineered fill and bearing capacity of its underlying subgrade have been confirmed via extensive geotechnical inspection and fill compaction testing during subdivision earthworks.
