Date: 30 August 2023
Project No: LTC21220-A
Revision: B

**RE: SHALLOW SOIL TEST REPORT
FUTURE RESIDENTIAL FOUNDATIONS
LOT 31, 115 EUREKA STREET, ARANUI**

Test Location Plan
 Lot 31, 115 Eureka Street,
 ARANUI, CHRISTCHURCH

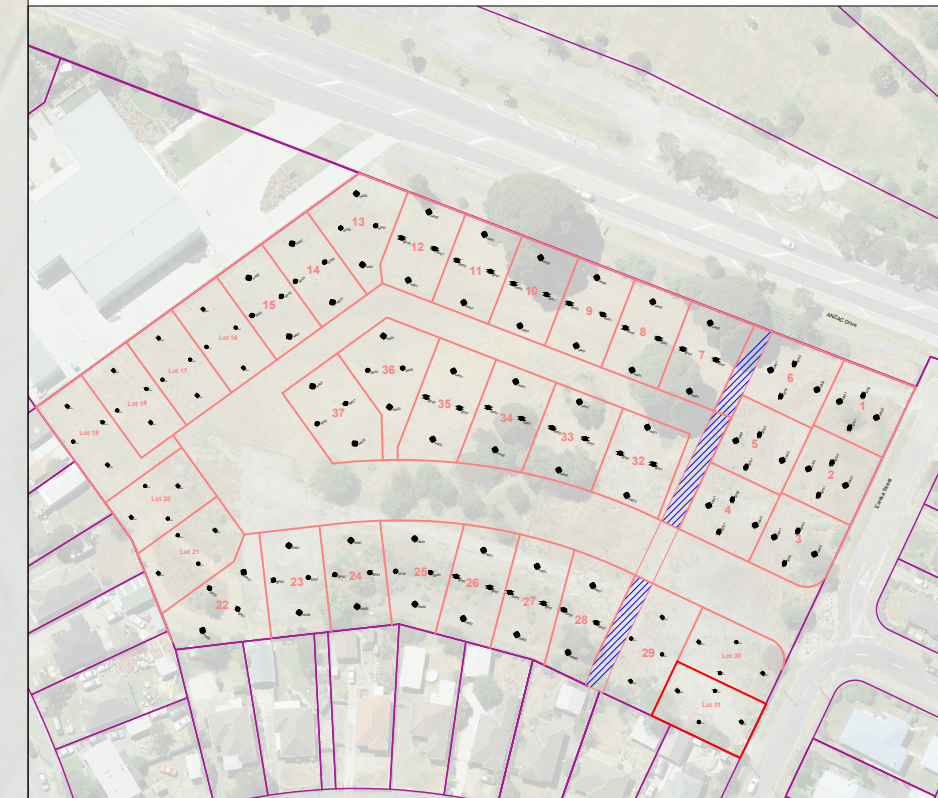
Drawing No: Lot 31/TLP	Drawn by: RM	Date: 30 August 2023
Scale: 1: 125 (A3) 1: 2000 (A3)	Checked by: D Wilson	Revision: B
Filename: LTC21220 - A - Drawings.dwg

LandTech investigated the site on 8 June 2023, conducting two hand augers with corresponding Scala Penetrometer tests (SPs) and two additional SPs. The locations of the hand auger and SPs were measured using inferred lot boundaries and are approximate only. The test locations are shown on our LandTech *Test Location Plan*, Drawing No. Lot 31/ TLP, attached to this report.

-   HA01 LandTech Consulting Ltd. augerhole locations, drilled 08 June 2023
-   SP01 LandTech Consulting Ltd. DCP test location, tested 08 June 2023
-   Proposed boundary
-   Existing boundary

The ground improvement could not extend all the way up to the southwestern boundary of the lot on account of temporary batters of approximately 1V :1H being formed down from the boundaries during construction to allow for the formation of the engineered fill raft. Therefore, a no-build setback to the greater of 2.0m, the depth of ground remediation, or the sum of the permanent cut face (existing ground level to finished ground level) plus the depth of ground remediation along these boundaries, shall be created along the corresponding boundaries. With reference to the Davie Lovell-Smith As-Built Earthworks Plans completed for the subdivision, the maximum depth of ground remediation was 1.4m, while the maximum permanent cut face is 0.4m high along some of the boundaries. Therefore, the 2.0m no-build setback governs along these boundaries to external neighbouring properties.

The external boundaries of the lot to the southeastern side, and internal northeastern side by the driveway, are to the rear of a circa 0.6m tall retaining wall, which we understand has not been designed for surcharge loading from future housing within the lots. Should any building foundations, permanent earthworks, or additional retaining walls be constructed within 3.5 x wall height to the rear of the boundary retainer constructed during subdivision works, then these shall be subject to specific engineering design to make sure no undue surcharge is applied to the rear of the existing subdivision retaining wall.

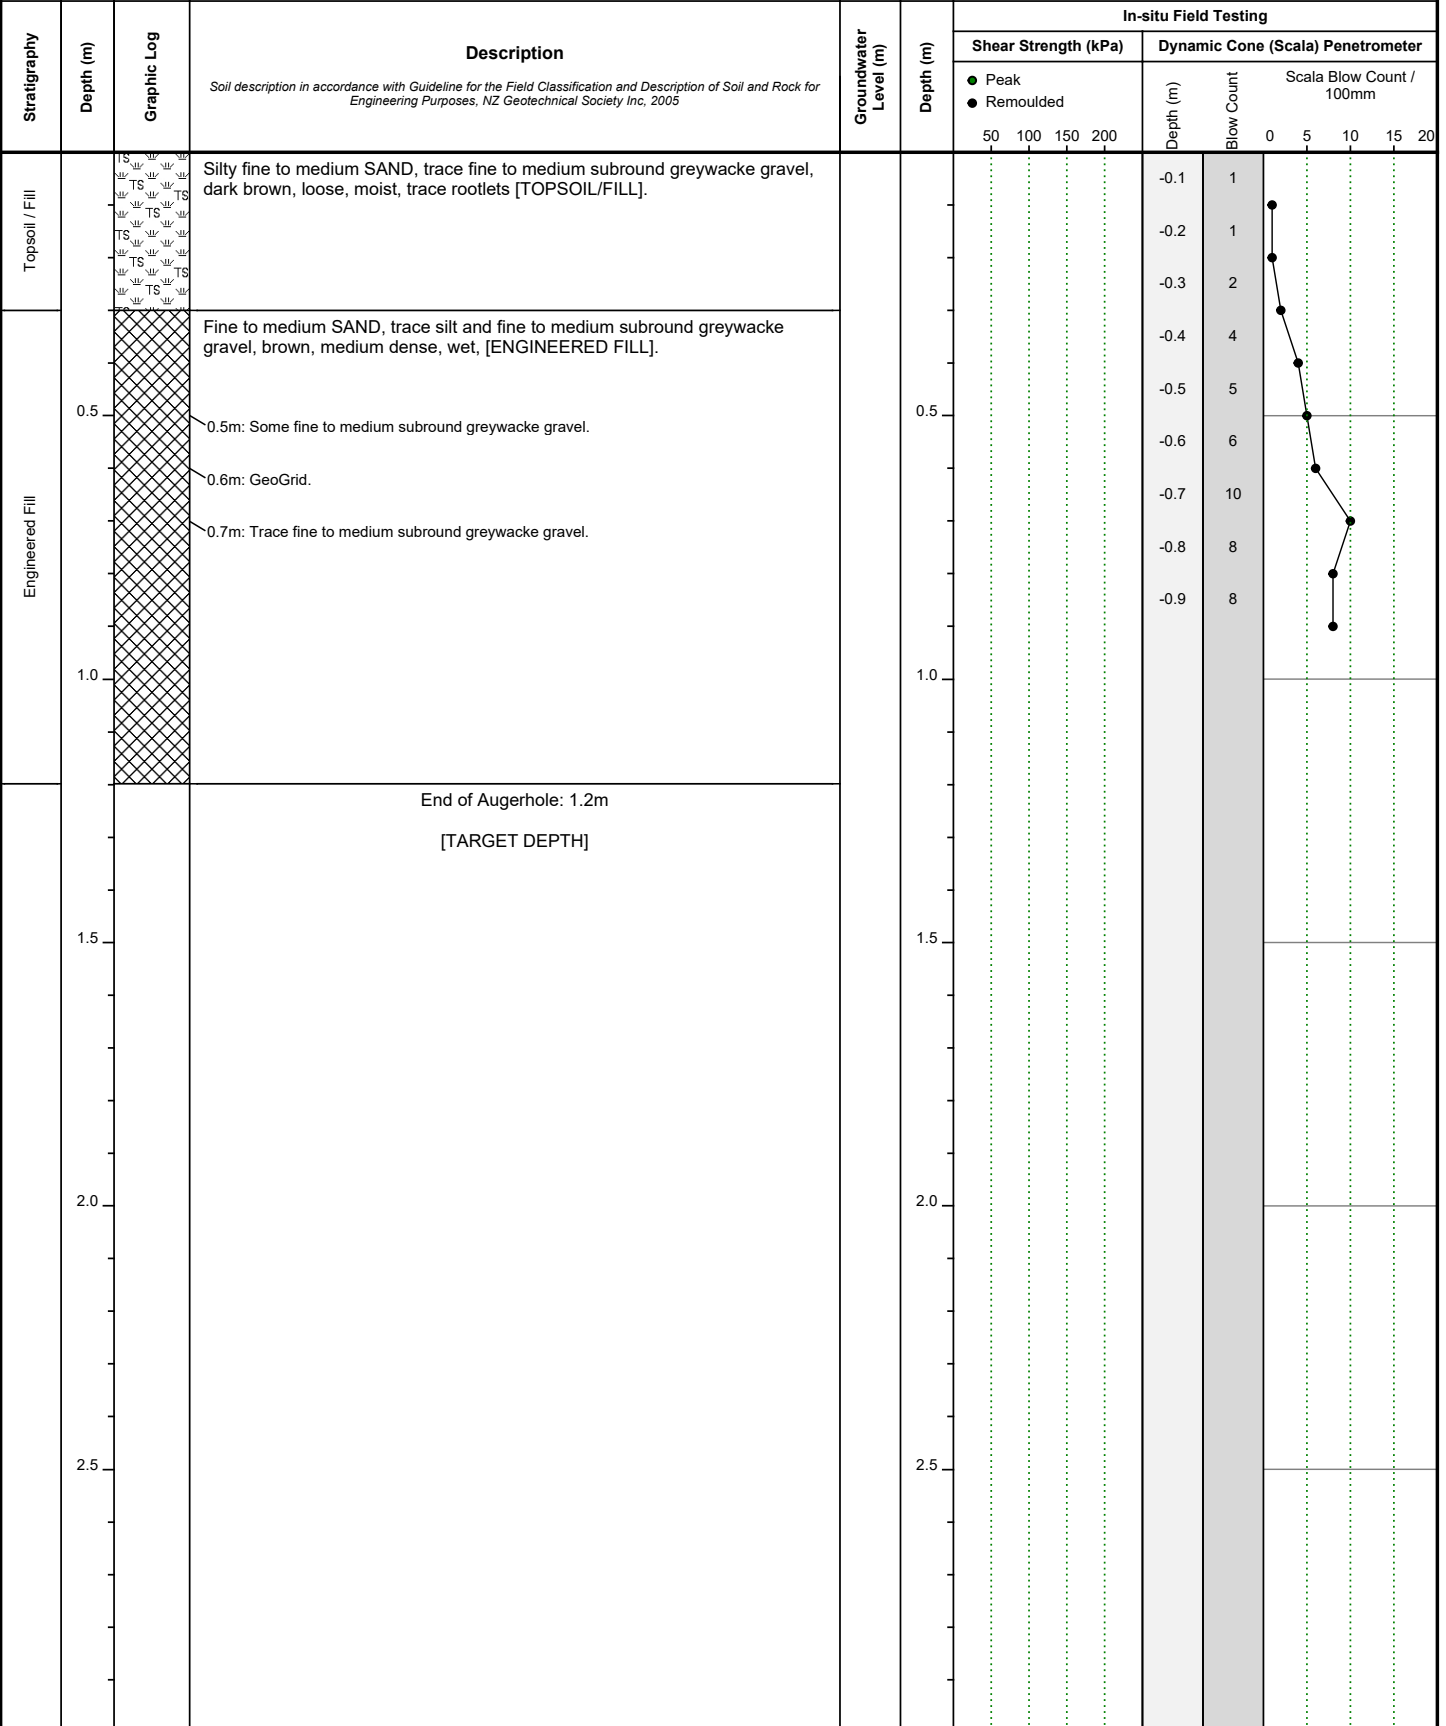
Augerhole No.: Lot 31 - HA01

Topsoil was encountered within the hand augers from the ground surface to depths between 0.3m to 0.4m, which was typically a dark brown silty sand material. Engineered fill was encountered below the topsoil to the base of auger holes, which was a compacted brown sand material with a trace of silt and gravel. The hand augers were terminated at 1.2m depth below ground level to avoid damage to the geotextile layer which was installed at 1.5m depth below ground level. Groundwater was not encountered during testing.

Project No.: LTC21220-A Coordinates: NZTM2000: E1576425.57, N5182926.27 Logged By: KP
 Drill Type: 50mm Hand Auger Reduced Level: 2.83m (LVD1937) Shear Vane No.:
 Date Started: 08-Jun-23 Ground Conditions: Near level, Topsoil. Calibration Factor:
 Date Finished: 08-Jun-23 Groundwater Level (m): Not Encountered Calibration Date:

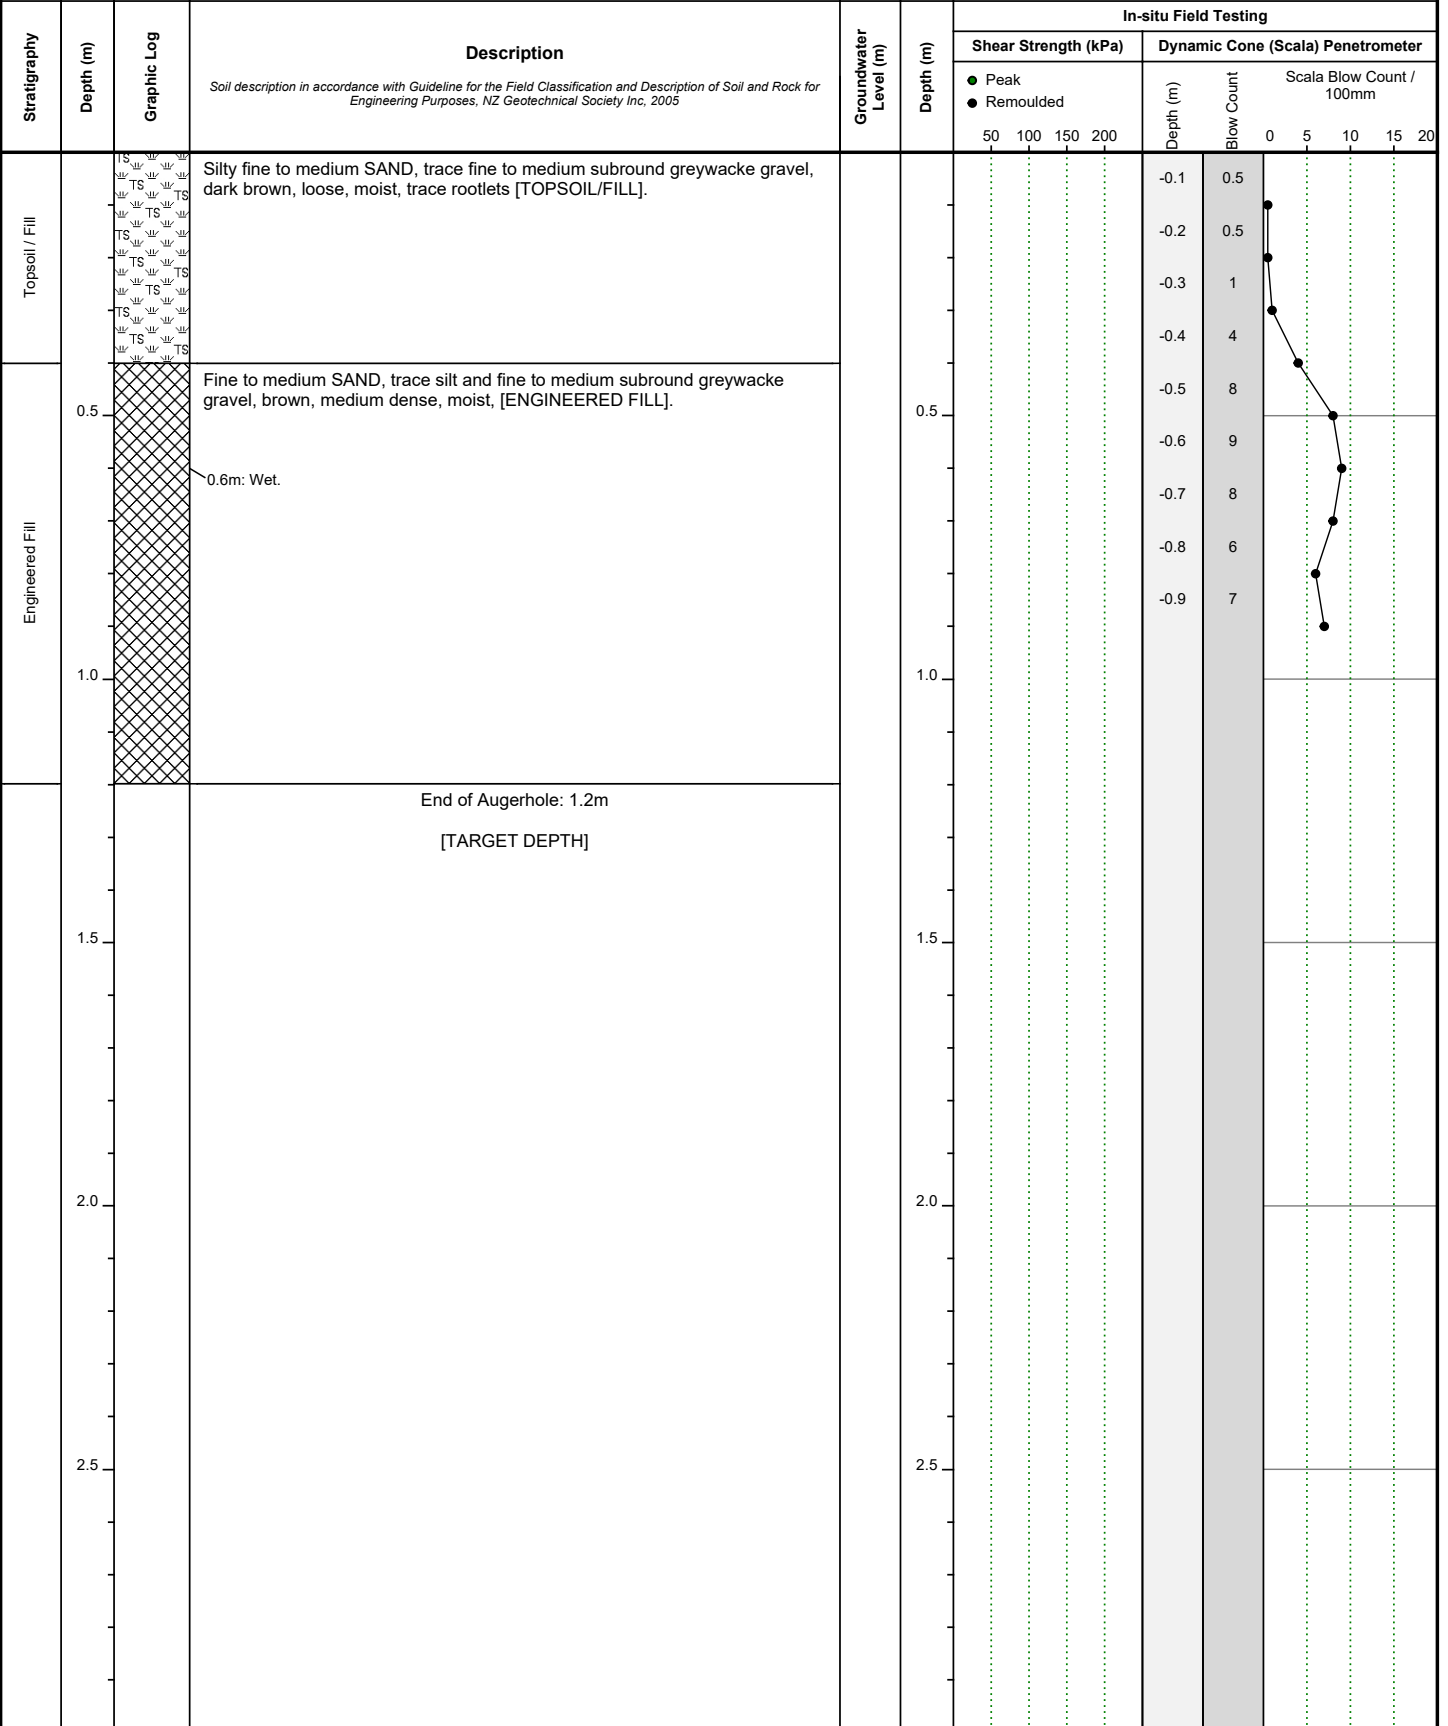
Augerhole No.: Lot 31 - HA02

Project No.: LTC21220-A Coordinates: NZTM2000: E1576408.68, N5182934.55 Logged By: KP
 Drill Type: 50mm Hand Auger Reduced Level: 2.83m (LVD1937) Shear Vane No.:
 Date Started: 08-Jun-23 Ground Conditions: Near level, Topsoil. Calibration Factor:
 Date Finished: 08-Jun-23 Groundwater Level (m): Not Encountered Calibration Date:

Target depth achieved. In-situ testing in accordance with the following standards:
 Scala Penetrometer Testing: NZS 4402:1988, Test 6.5.2, Dynamic Cone Penetrometer
 Shear Vane Testing: Guideline for Hand Held Shear Vane Test, NZGS, August 2001

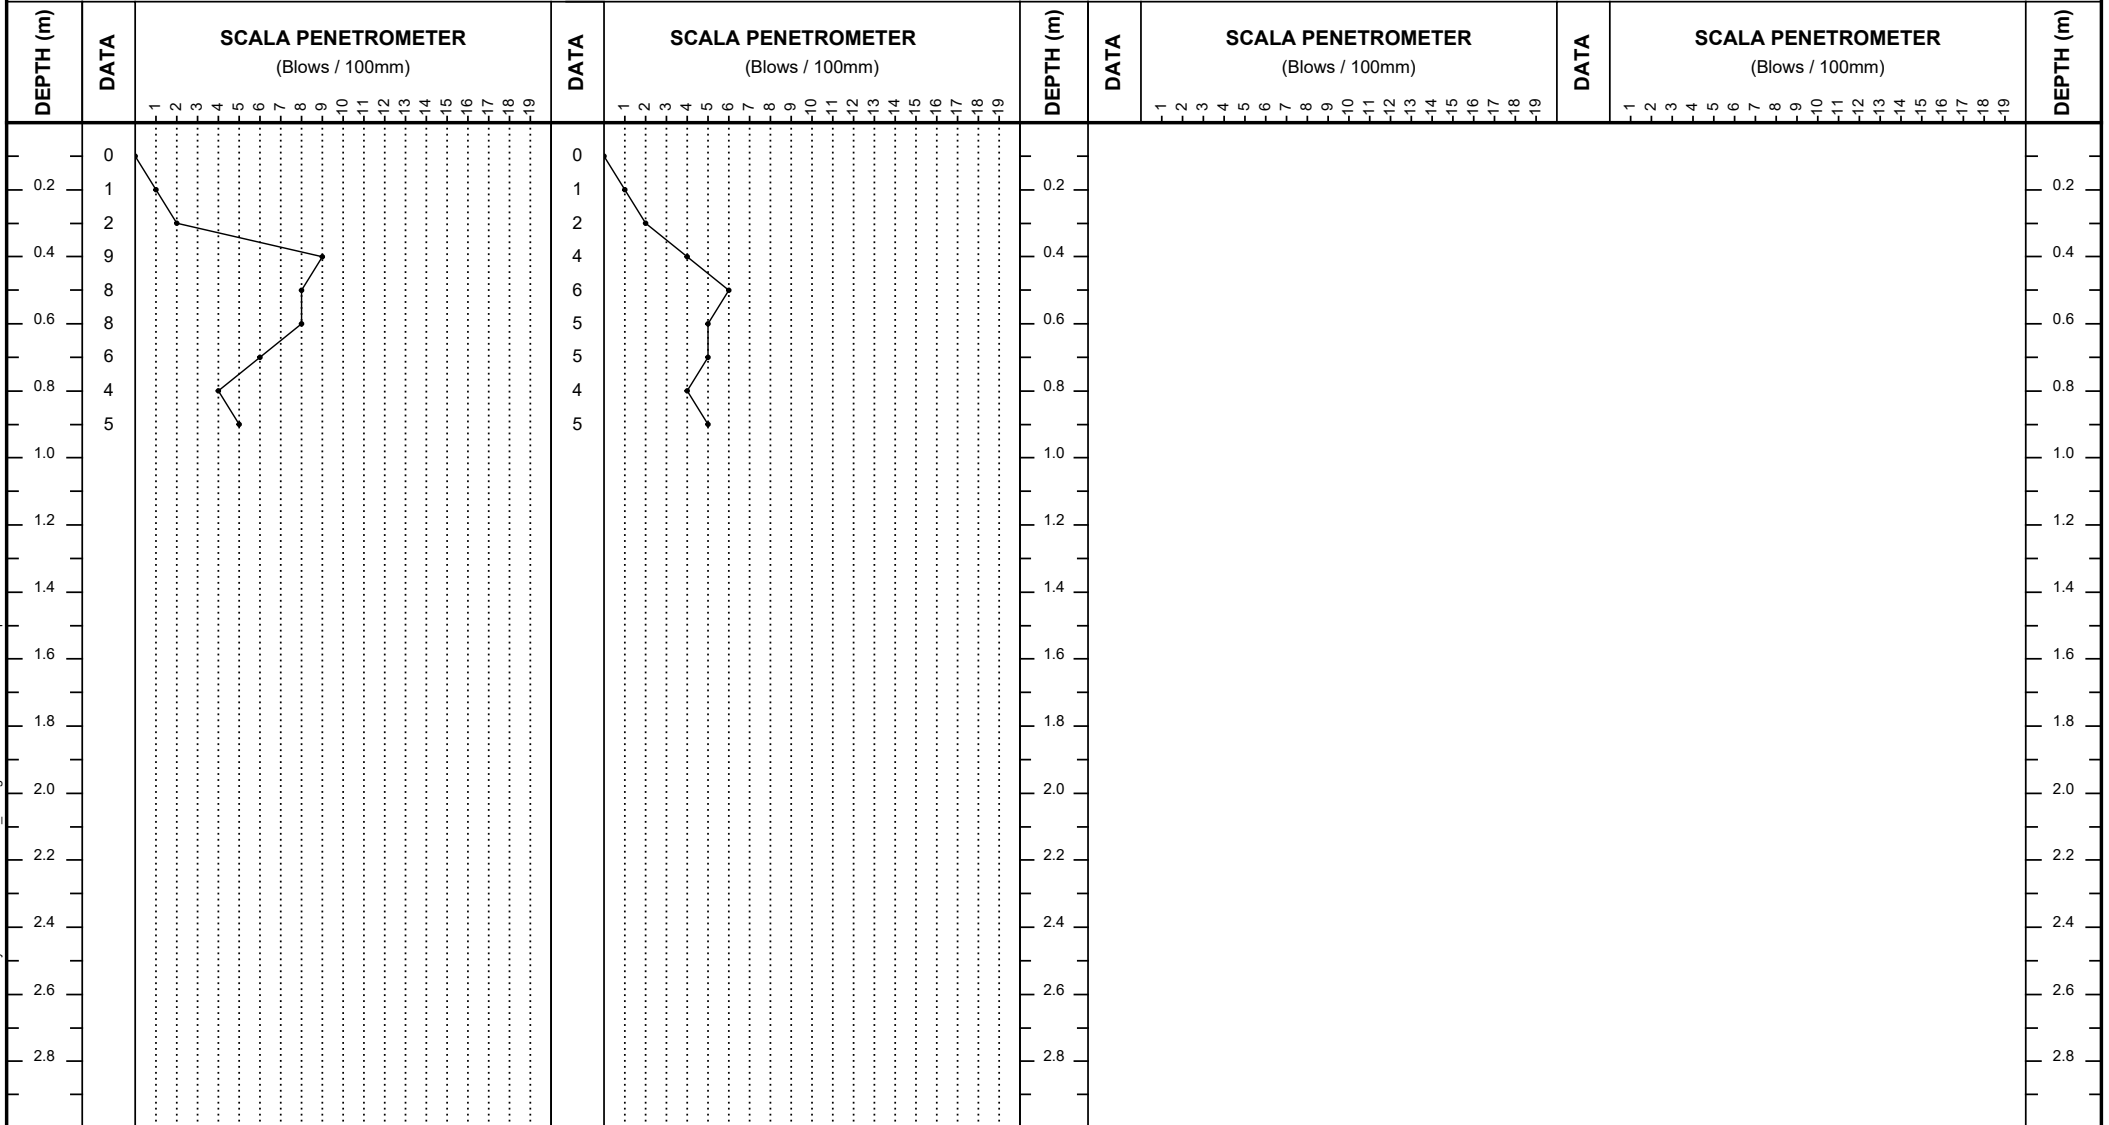
Lot 31 - SP01

SPs at each of the four locations returned results between 2 and 10 blows per 100mm penetration below the topsoil and within the engineered fill layer. SPs were terminated at 0.9m depth to confirm near surface bearing capacities, and to avoid damage to the geogrids and geotextile. In addition, the density of the engineered fill and bearing capacity of its underlying subgrade have been confirmed via extensive geotechnical inspection and fill compaction testing during subdivision earthworks.

Tested By: KP
 Ground Conditions: Near level, Topsoil.
 Coordinates: NZTM2000 E 1576414.30
 N 5182926.32
 Test Date: 08-Jun-23

Tested By: KP
 Ground Conditions: Near level, Topsoil.
 Coordinates: NZTM2000 E 1576418.52
 N 5182934.57
 Test Date: 08-Jun-23
