Date: 16 May 2023  
Project No: LTC21220-A

**RE: SHALLOW SOIL TEST REPORT  
FUTURE RESIDENTIAL FOUNDATIONS  
LOT 37, 115 EUREKA STREET, ARANUI**

**Test Location Plan**  
 Lot 37, 115 Eureka Street,  
 ARANUI, CHRISTCHURCH

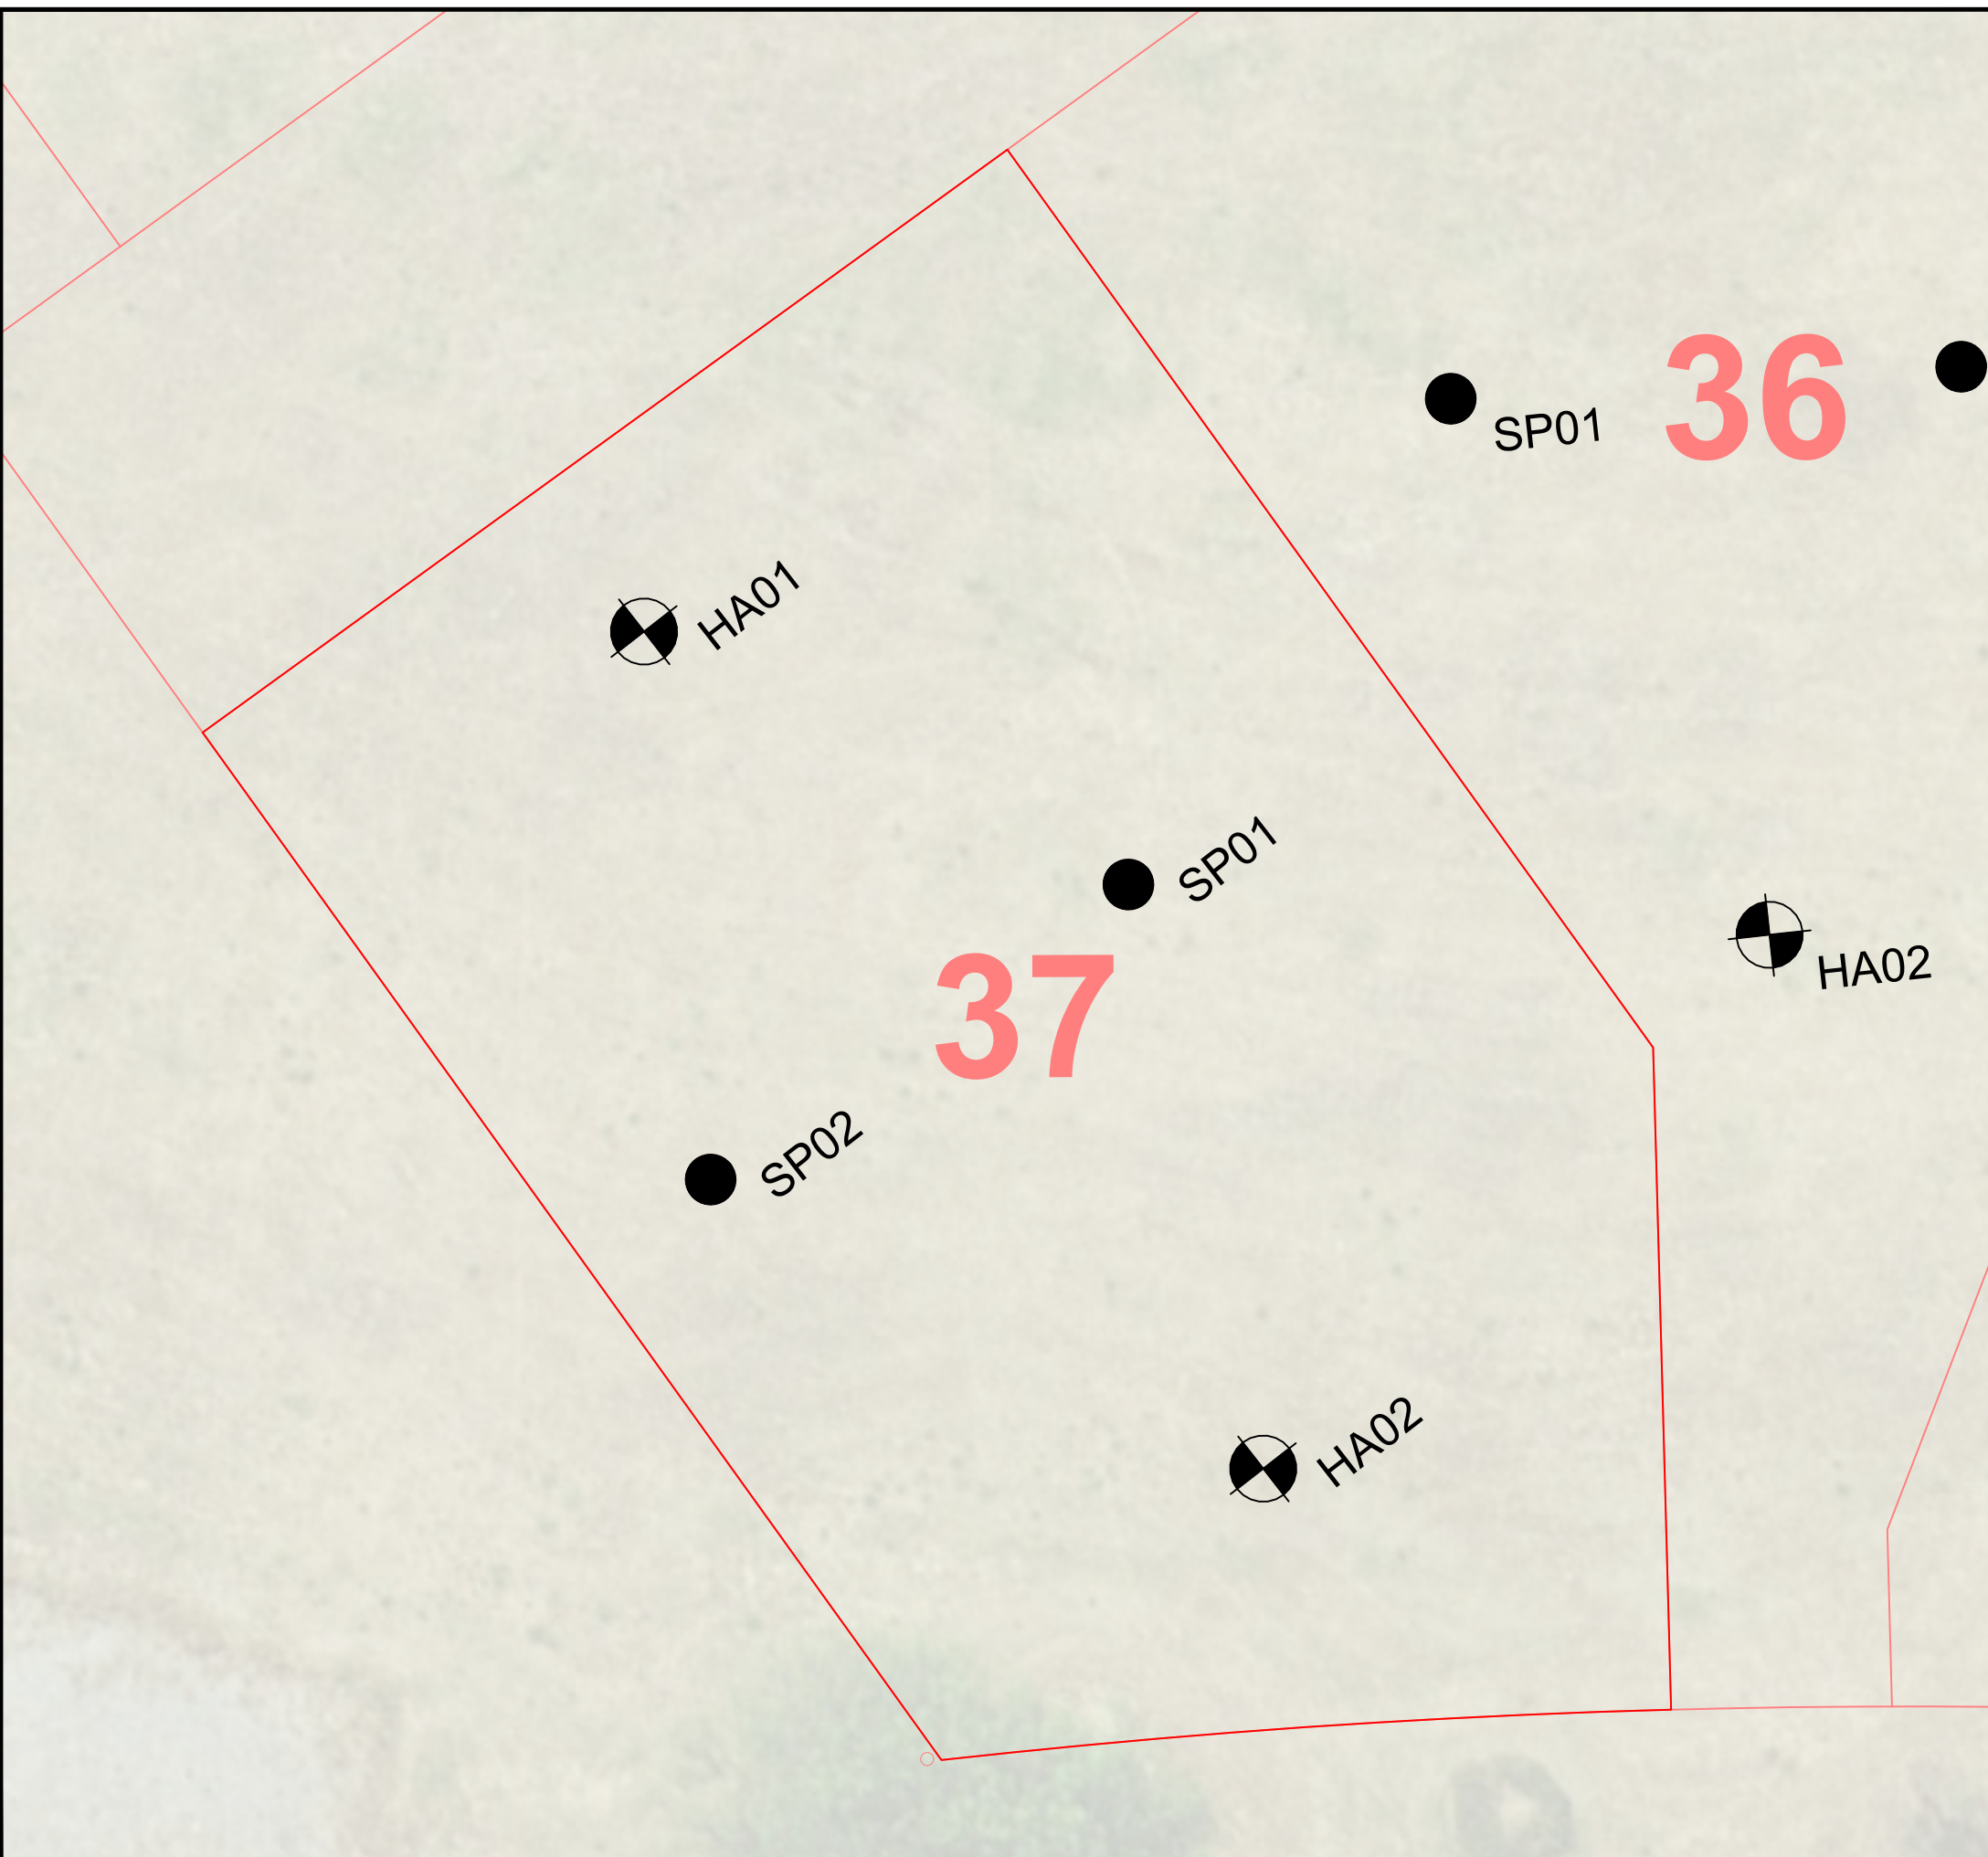
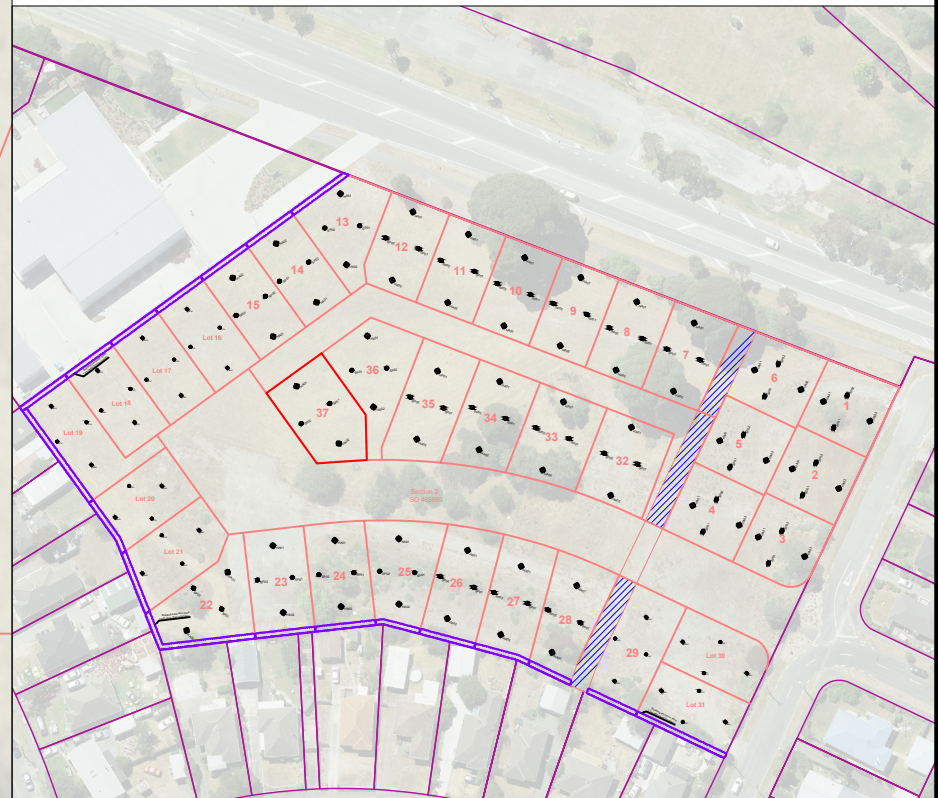
| Drawing No:<br>Lot 37/TLP | Drawn by:<br>KY | Date:<br>15 May 2023 |

LandTech investigated the site on 12 May 2023, conducting two hand augers with corresponding Scala Penetrometer tests (SPs) and two additional SPs. The locations of the hand auger and SPs were measured using inferred lot boundaries and are approximate only. The test locations are shown on our LandTech *Test Location Plan*, Drawing No. Lot 37/ TLP, attached to this report.

HA01 LandTech Consulting Ltd. augerhole locations, drilled 12 May 2023
-

SP01 LandTech Consulting Ltd. DCP test location, tested 12 May 2023
-

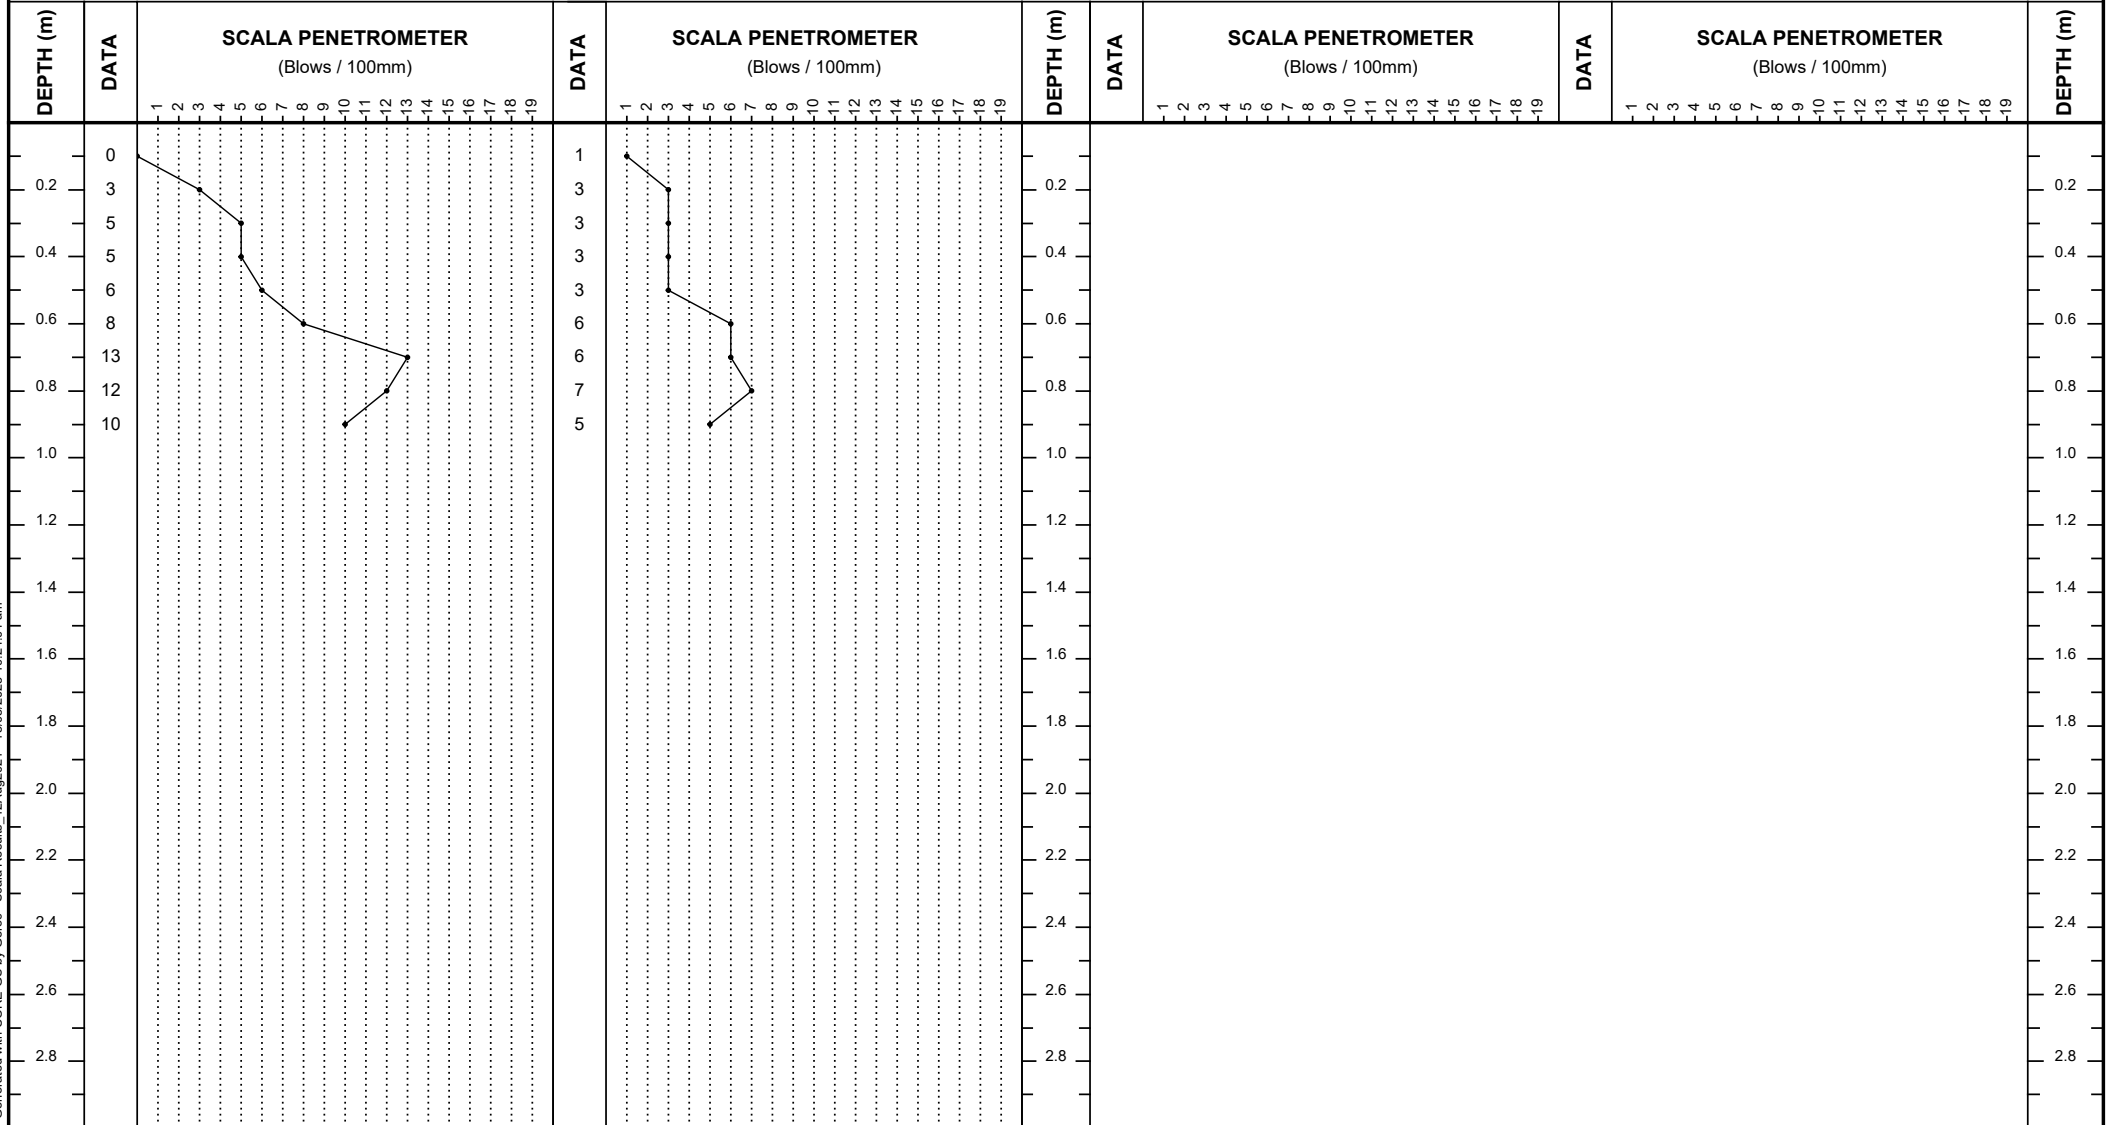
**LOT 37- SP01**

SPs at each of the four locations returned results between 3 and 13 blows per 100mm penetration below the topsoil and within the engineered fill layer. SPs were terminated at 0.9m depth to confirm near surface bearing capacities, and to avoid damage to the geogrids and geotextile. In addition, the density of the engineered fill and bearing capacity of its underlying subgrade have been confirmed via extensive geotechnical inspection and fill compaction testing during subdivision earthworks.

**Tested By:** KY  
**Ground Conditions:** Near level, Topsoil.  
**Coordinates:** NZTM2000 E 1576320.89  
 N 5183010.47  
**Test Date:** 12-May-23

**Tested By:** KY  
**Ground Conditions:** Near level, Topsoil.  
**Coordinates:** NZTM2000 E 1576313.33  
 N 5183005.13  
**Test Date:** 12-May-23
