Date: 13 June 2023
Project No: LTC21220-A

**RE: SHALLOW SOIL TEST REPORT
FUTURE RESIDENTIAL FOUNDATIONS
LOT 4, 115 EUREKA STREET, ARANUI**

Test Location Plan
 Lot 4, 115 Eureka Street,
 ARANUI, CHRISTCHURCH

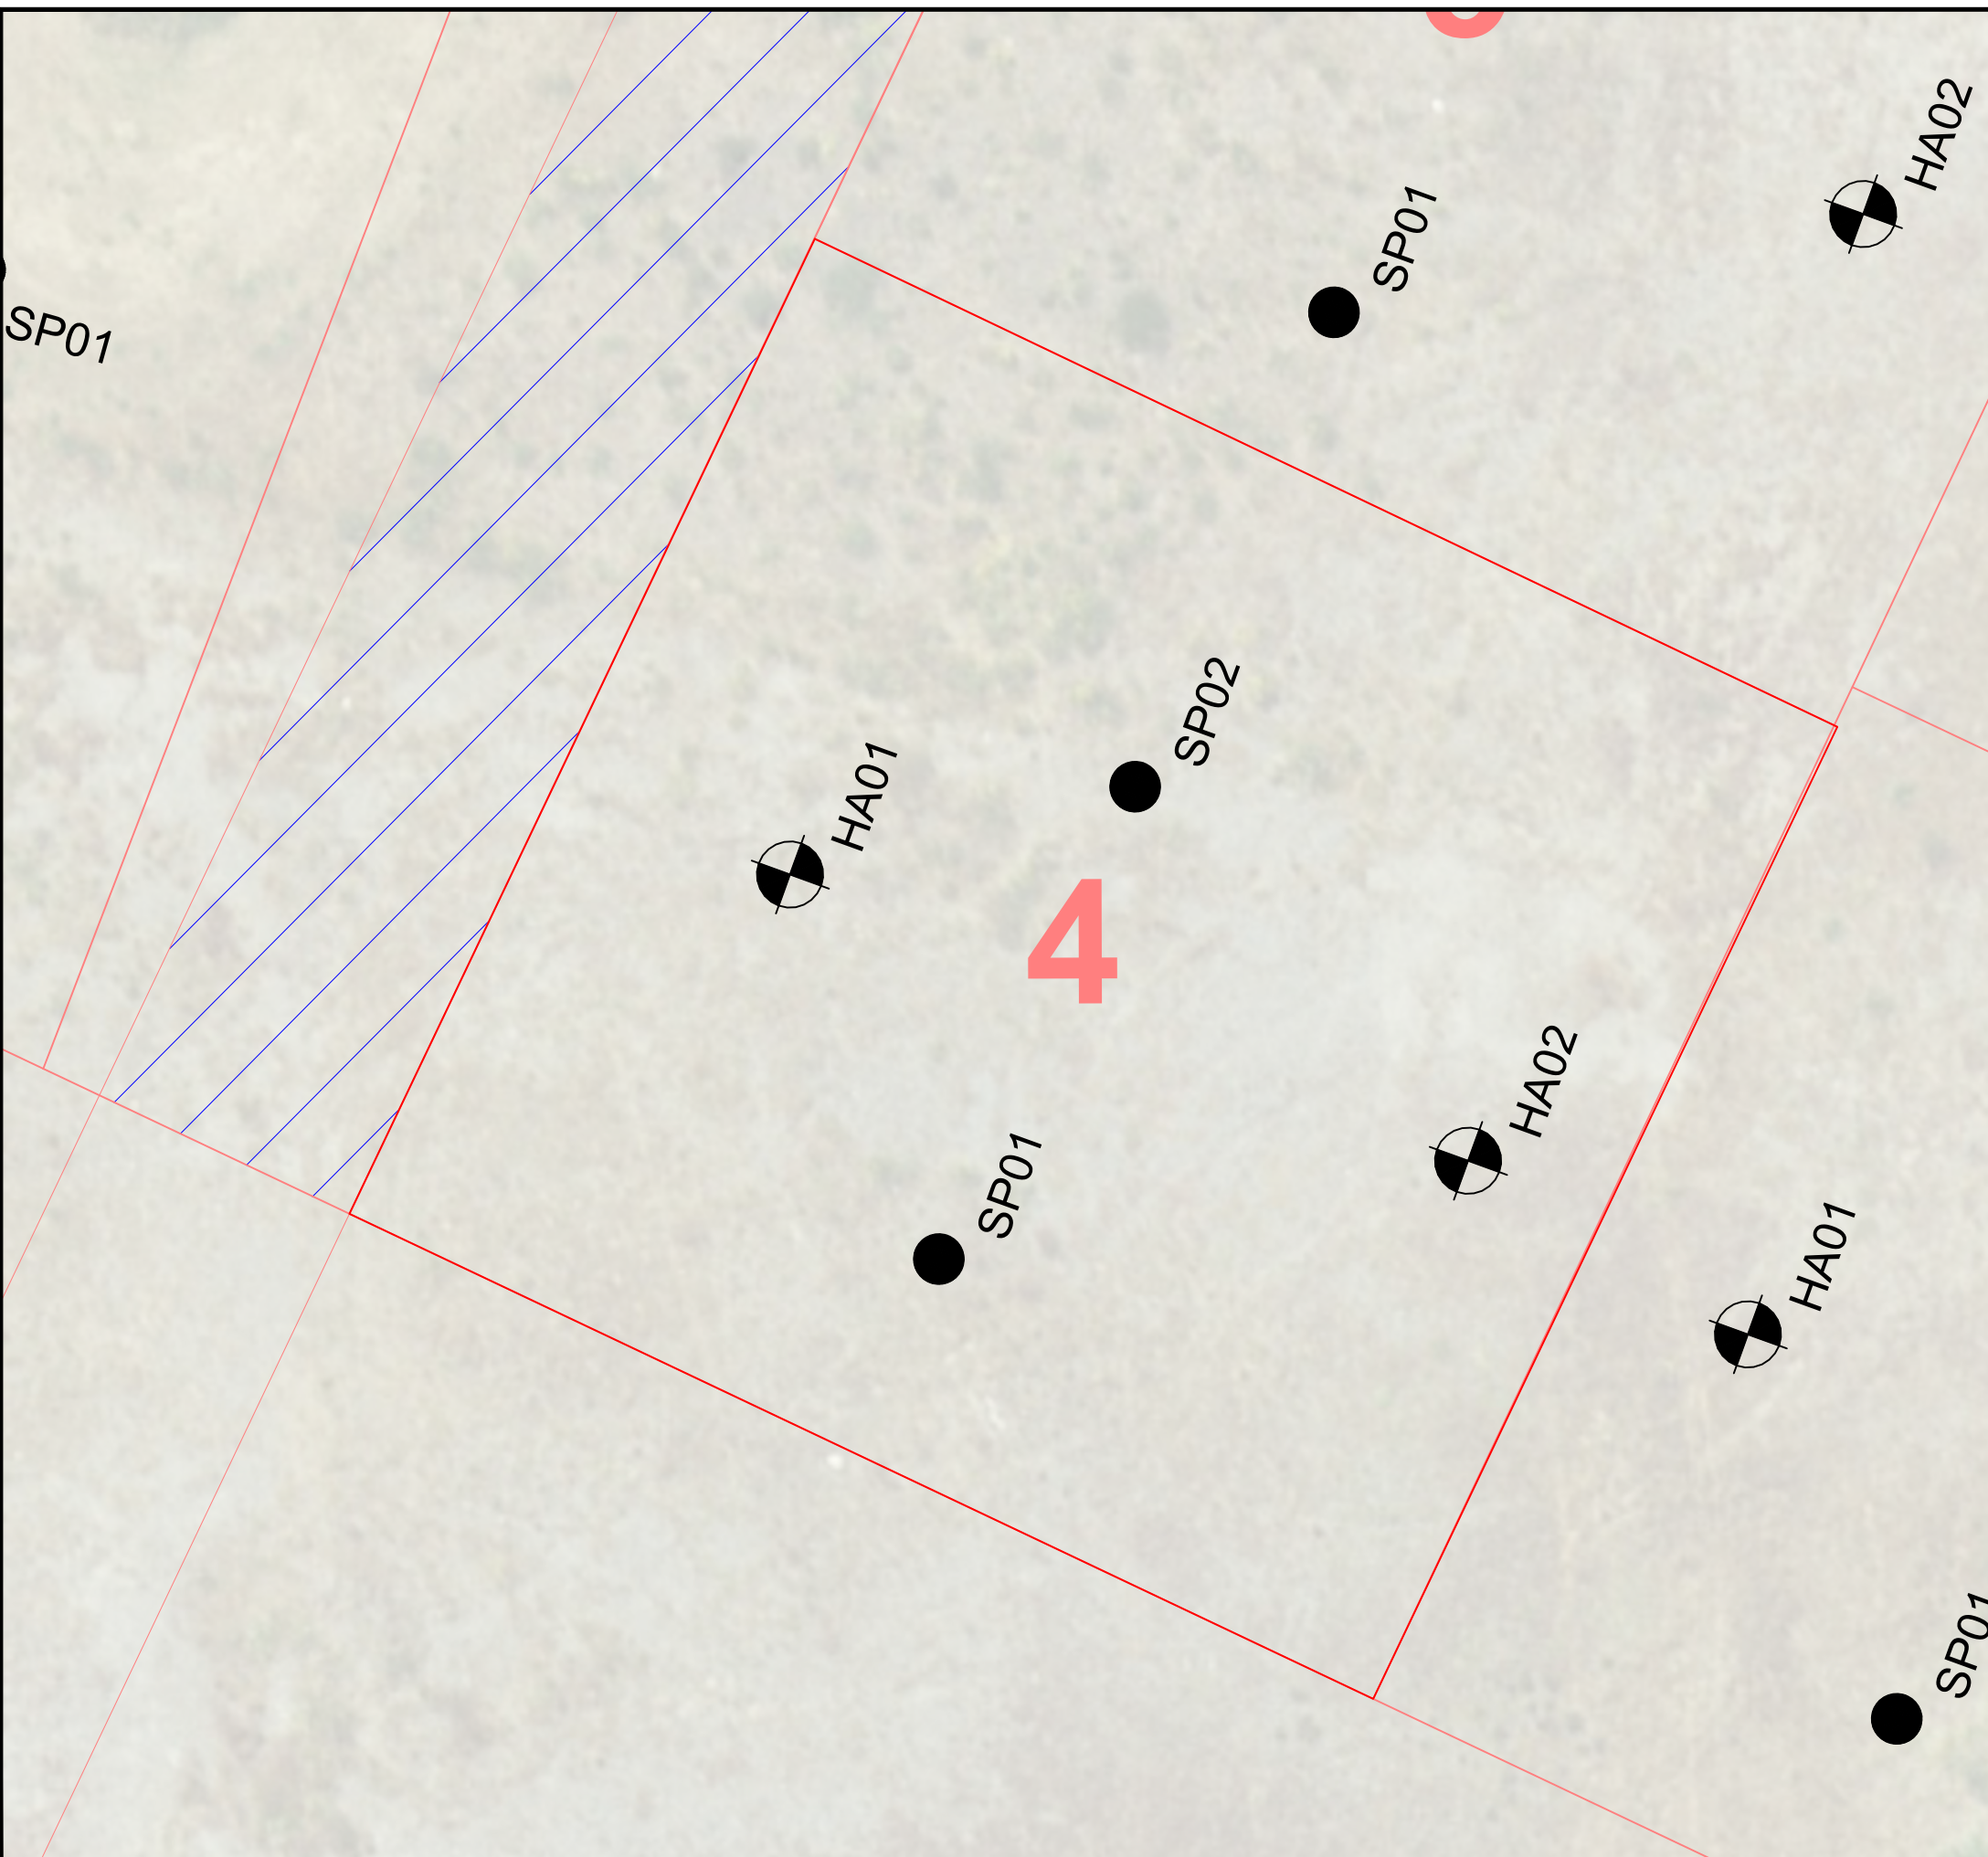
LandTech investigated the site on 8 June 2023, conducting two hand augers with corresponding Scala Penetrometer tests (SPs) and two additional SPs. The locations of the hand auger and SPs were measured using inferred lot boundaries and are approximate only. The test locations are shown on our LandTech *Test Location Plan*, Drawing No. Lot 4/ TLP, attached to this report.

HA01 LandTech Consulting Ltd. augerhole locations, drilled 08 June 2023
-

SP01 LandTech Consulting Ltd. DCP test location, tested 08 June 2023
-

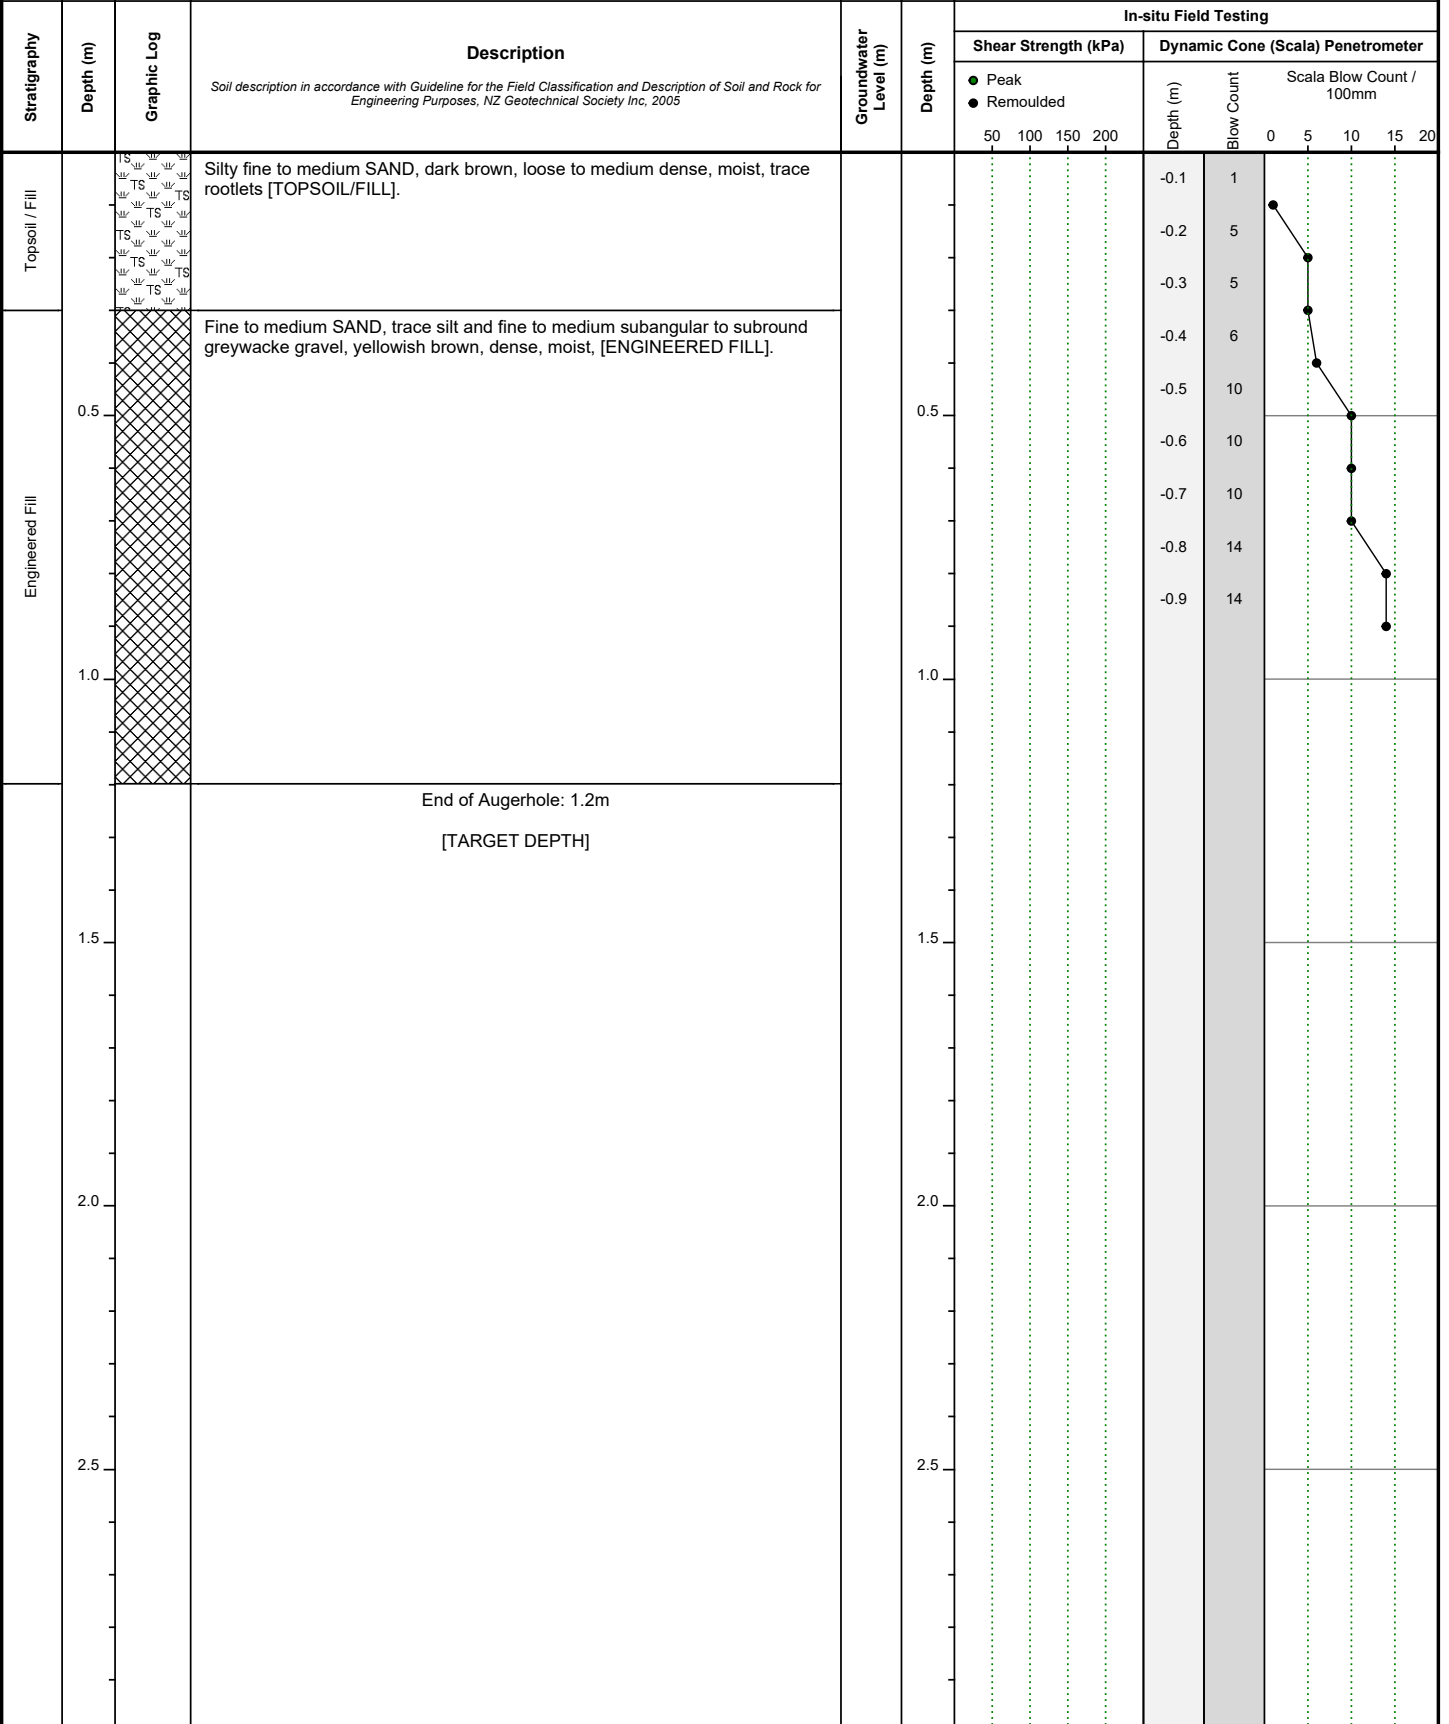
Augerhole No.: Lot 4 - HA01

Topsoil was encountered within the hand augers from the ground surface to depths between 0.3m to 0.4m, which was typically a dark brown silty sand material. Engineered fill was encountered below the topsoil to the base of auger holes, which was a compacted yellowish brown sand material with a trace of silt and gravel. The hand augers were terminated at 1.2m depth below ground level to avoid damage to the geotextile layer which was installed at 1.5m depth below ground level. Groundwater was not encountered during testing.

Project No.: LTC21220-A Coordinates: NZTM2000: E1576416.93, N5182983.45 Logged By: KP
 Drill Type: 50mm Hand Auger Reduced Level: 2.83m (LVD1937) Shear Vane No.:
 Date Started: 08-Jun-23 Ground Conditions: Near level, Topsoil. Calibration Factor:
 Date Finished: 08-Jun-23 Groundwater Level (m): Not Encountered Calibration Date:

Target depth achieved. In-situ testing in accordance with the following standards:
 Scala Penetrometer Testing: NZS 4402:1988, Test 6.5.2, Dynamic Cone Penetrometer
 Shear Vane Testing: Guideline for Hand Held Shear Vane Test, NZGS, August 2001

All foundations must be embedded to a minimum depth of 0.4m below ground level, where an Ultimate Bearing Capacity of 200kPa and a strength reduction factor of (ϕ_s) 0.5 is available. Foundations excavations should expose engineered fill of appropriate bearing capacity. All topsoil and unsuitable materials should be removed below foundations and floor slab areas, and where required layers of compacted hardfill should be placed to the underside of foundations.

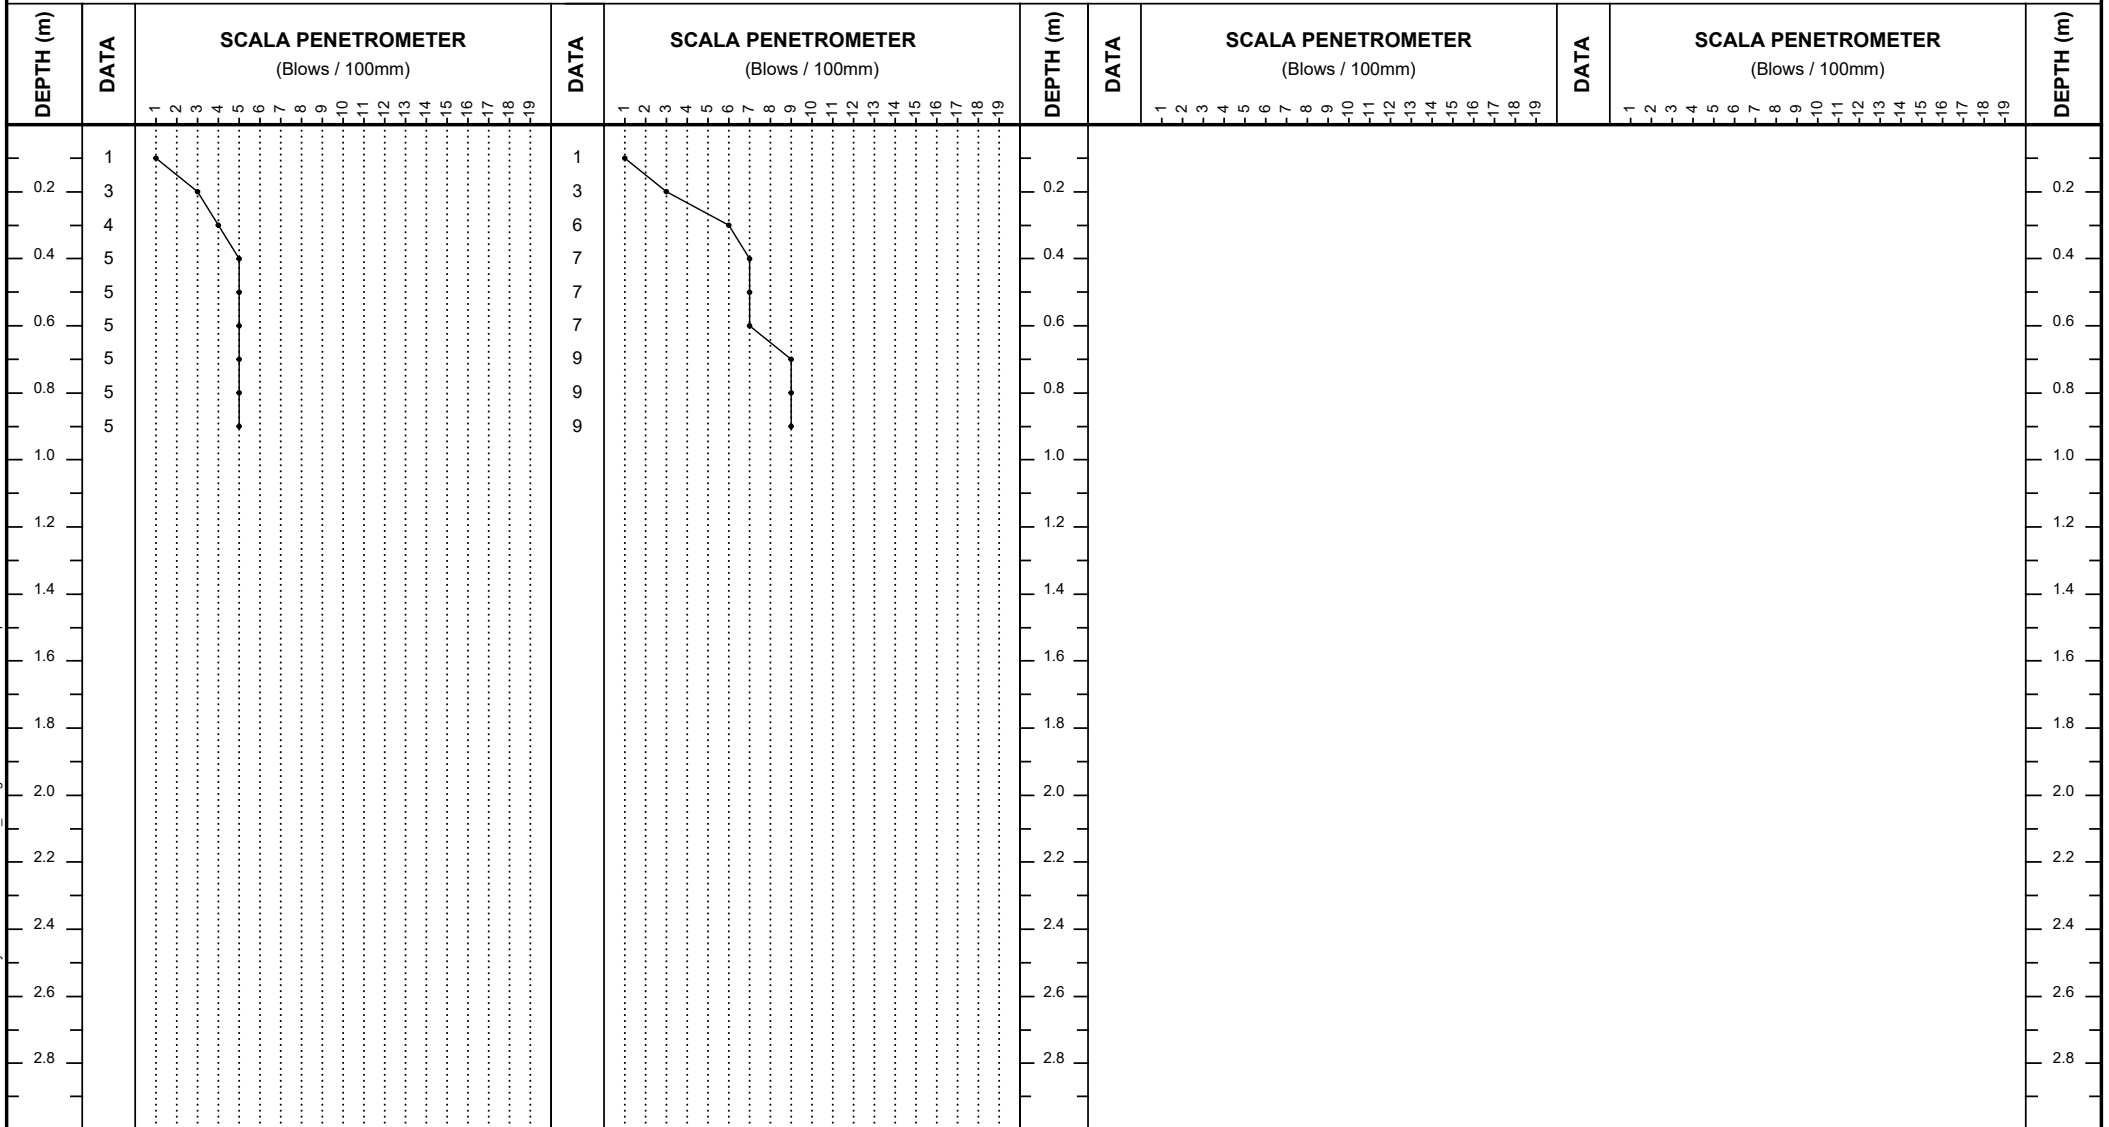
Lot 4 - SP01

SPs at each of the four locations returned results between 4 and 14 blows per 100mm penetration below the topsoil and within the engineered fill layer. SPs were terminated at 0.9m depth to confirm near surface bearing capacities, and to avoid damage to the geogrids and geotextile. In addition, the density of the engineered fill and bearing capacity of its underlying subgrade have been confirmed via extensive geotechnical inspection and fill compaction testing during subdivision earthworks.

Tested By: KP
 Ground Conditions: Near level, Topsoil.
 Coordinates: NZTM2000 E 1576419.59
 N 5182976.59
 Test Date: 08-Jun-23

Tested By: KP
 Ground Conditions: Near level, Topsoil.
 Coordinates: NZTM2000 E 1576423.10
 N 5182985.12
 Test Date: 08-Jun-23
