Date: 30 August 2023  
Project No: LTC21220-A  
Revision: B

**RE: SHALLOW SOIL TEST REPORT  
FUTURE RESIDENTIAL FOUNDATIONS  
LOT 9, 115 EUREKA STREET, ARANUI**

**Test Location Plan**  
 Lot 9, 115 Eureka Street,  
 ARANUI, CHRISTCHURCH

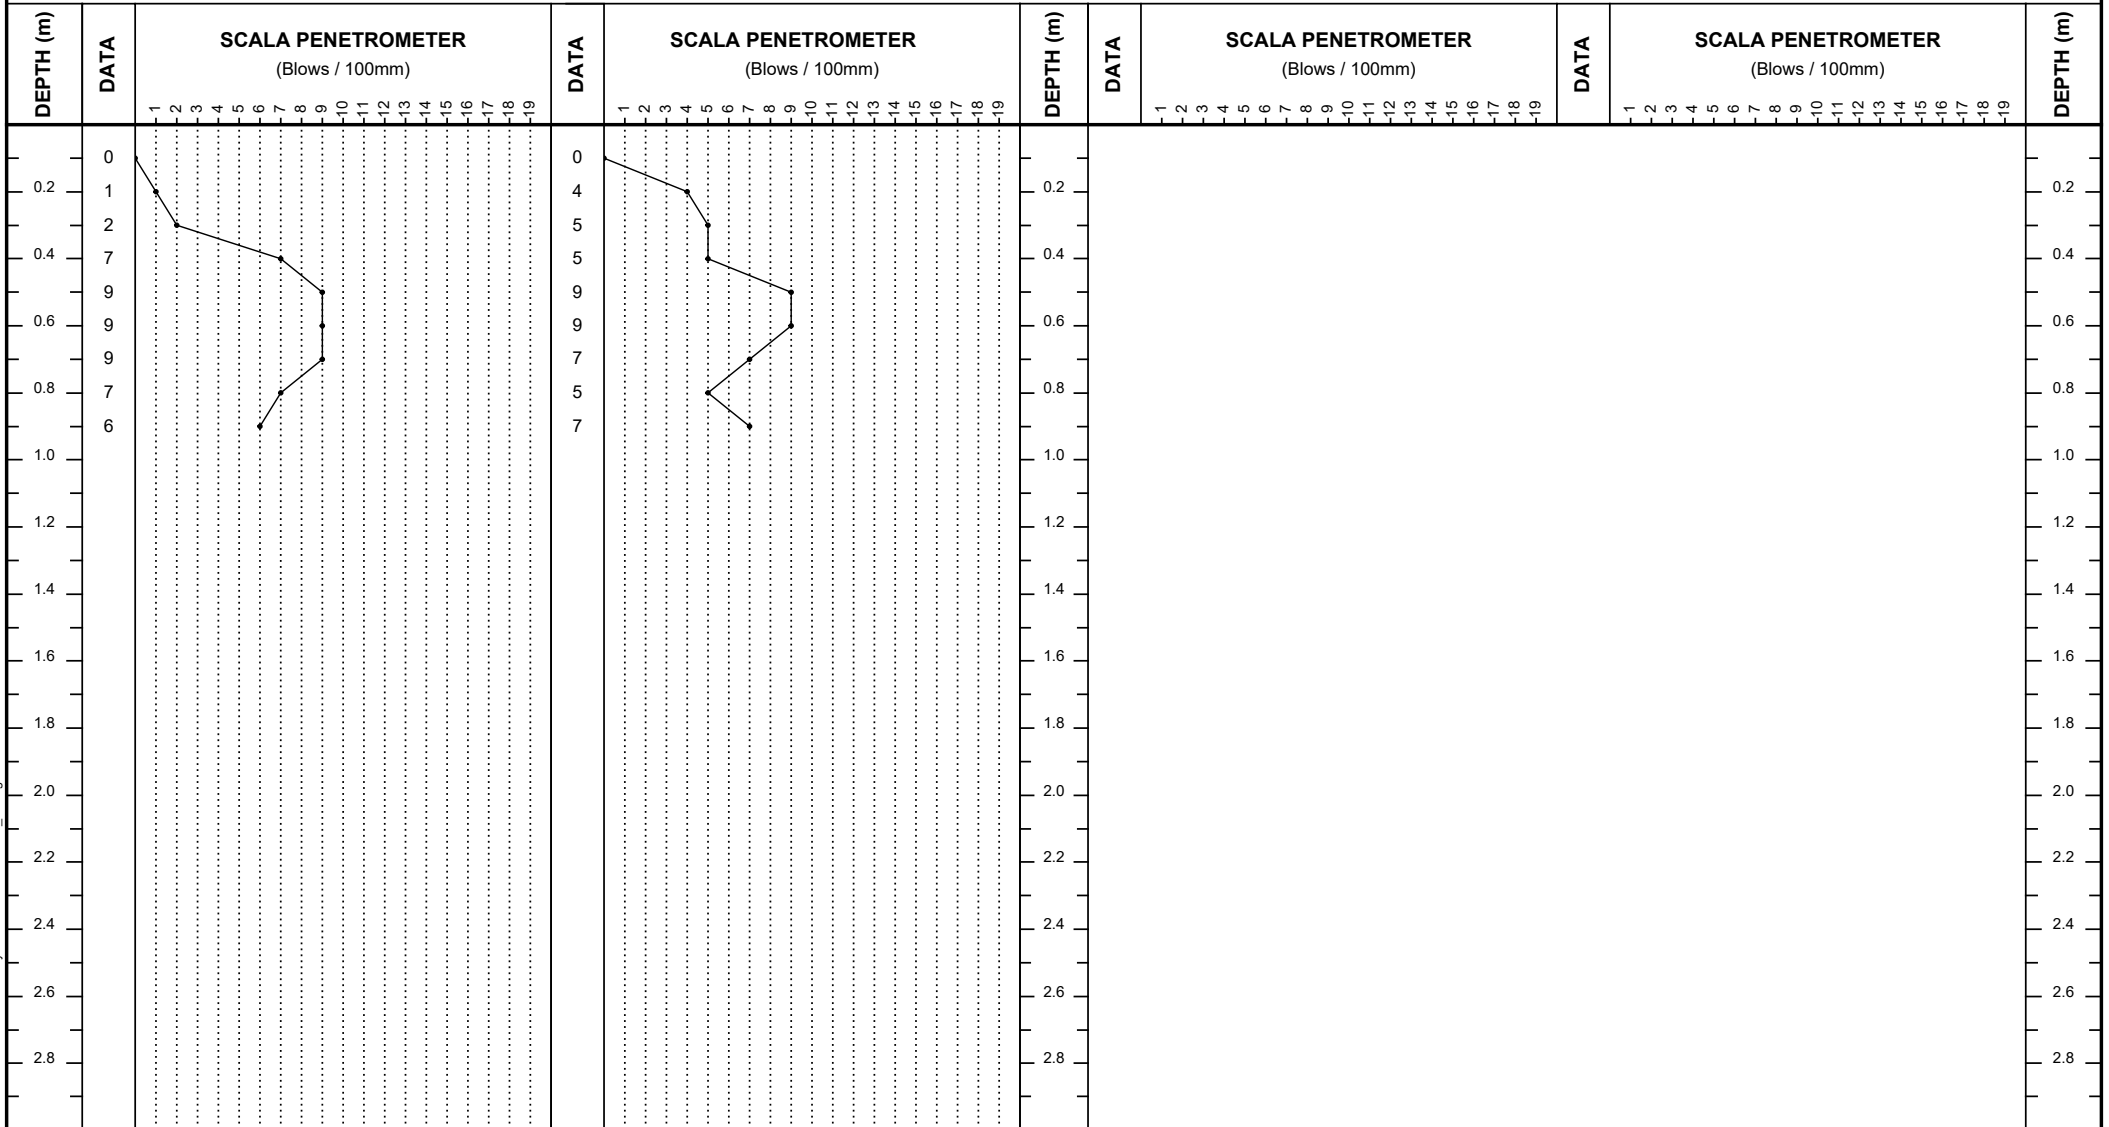
**LOT 9- SP01**

SPs at each of the four locations returned results between 2 and 12 blows per 100mm penetration below the topsoil and within the engineered fill layer. SPs were terminated at 0.9m depth to confirm near surface bearing capacities, and to avoid damage to the geogrids and geotextile. In addition, the density of the engineered fill and bearing capacity of its underlying subgrade have been confirmed via extensive geotechnical inspection and fill compaction testing during subdivision earthworks.

Tested By: KY  
 Ground Conditions: Near level, Topsoil.  
 Coordinates: NZTM2000 E 1576388.92  
 N 5183034.08  
 Test Date: 01-Jun-23

Tested By: KY  
 Ground Conditions: Near level, Topsoil.  
 Coordinates: NZTM2000 E 1576380.06  
 N 5183037.08  
 Test Date: 01-Jun-23

Our SP testing was carried out in accordance with NZS 4402:1988, Test 6.5.2, *Dynamic Cone Penetrometer*. The SP results are also attached.
