Date: 30 August 2023  
Project No: LTC21220-A  
Revision: B

**RE: SHALLOW SOIL TEST REPORT  
FUTURE RESIDENTIAL FOUNDATIONS  
LOT 22, 115 EUREKA STREET, ARANUI**

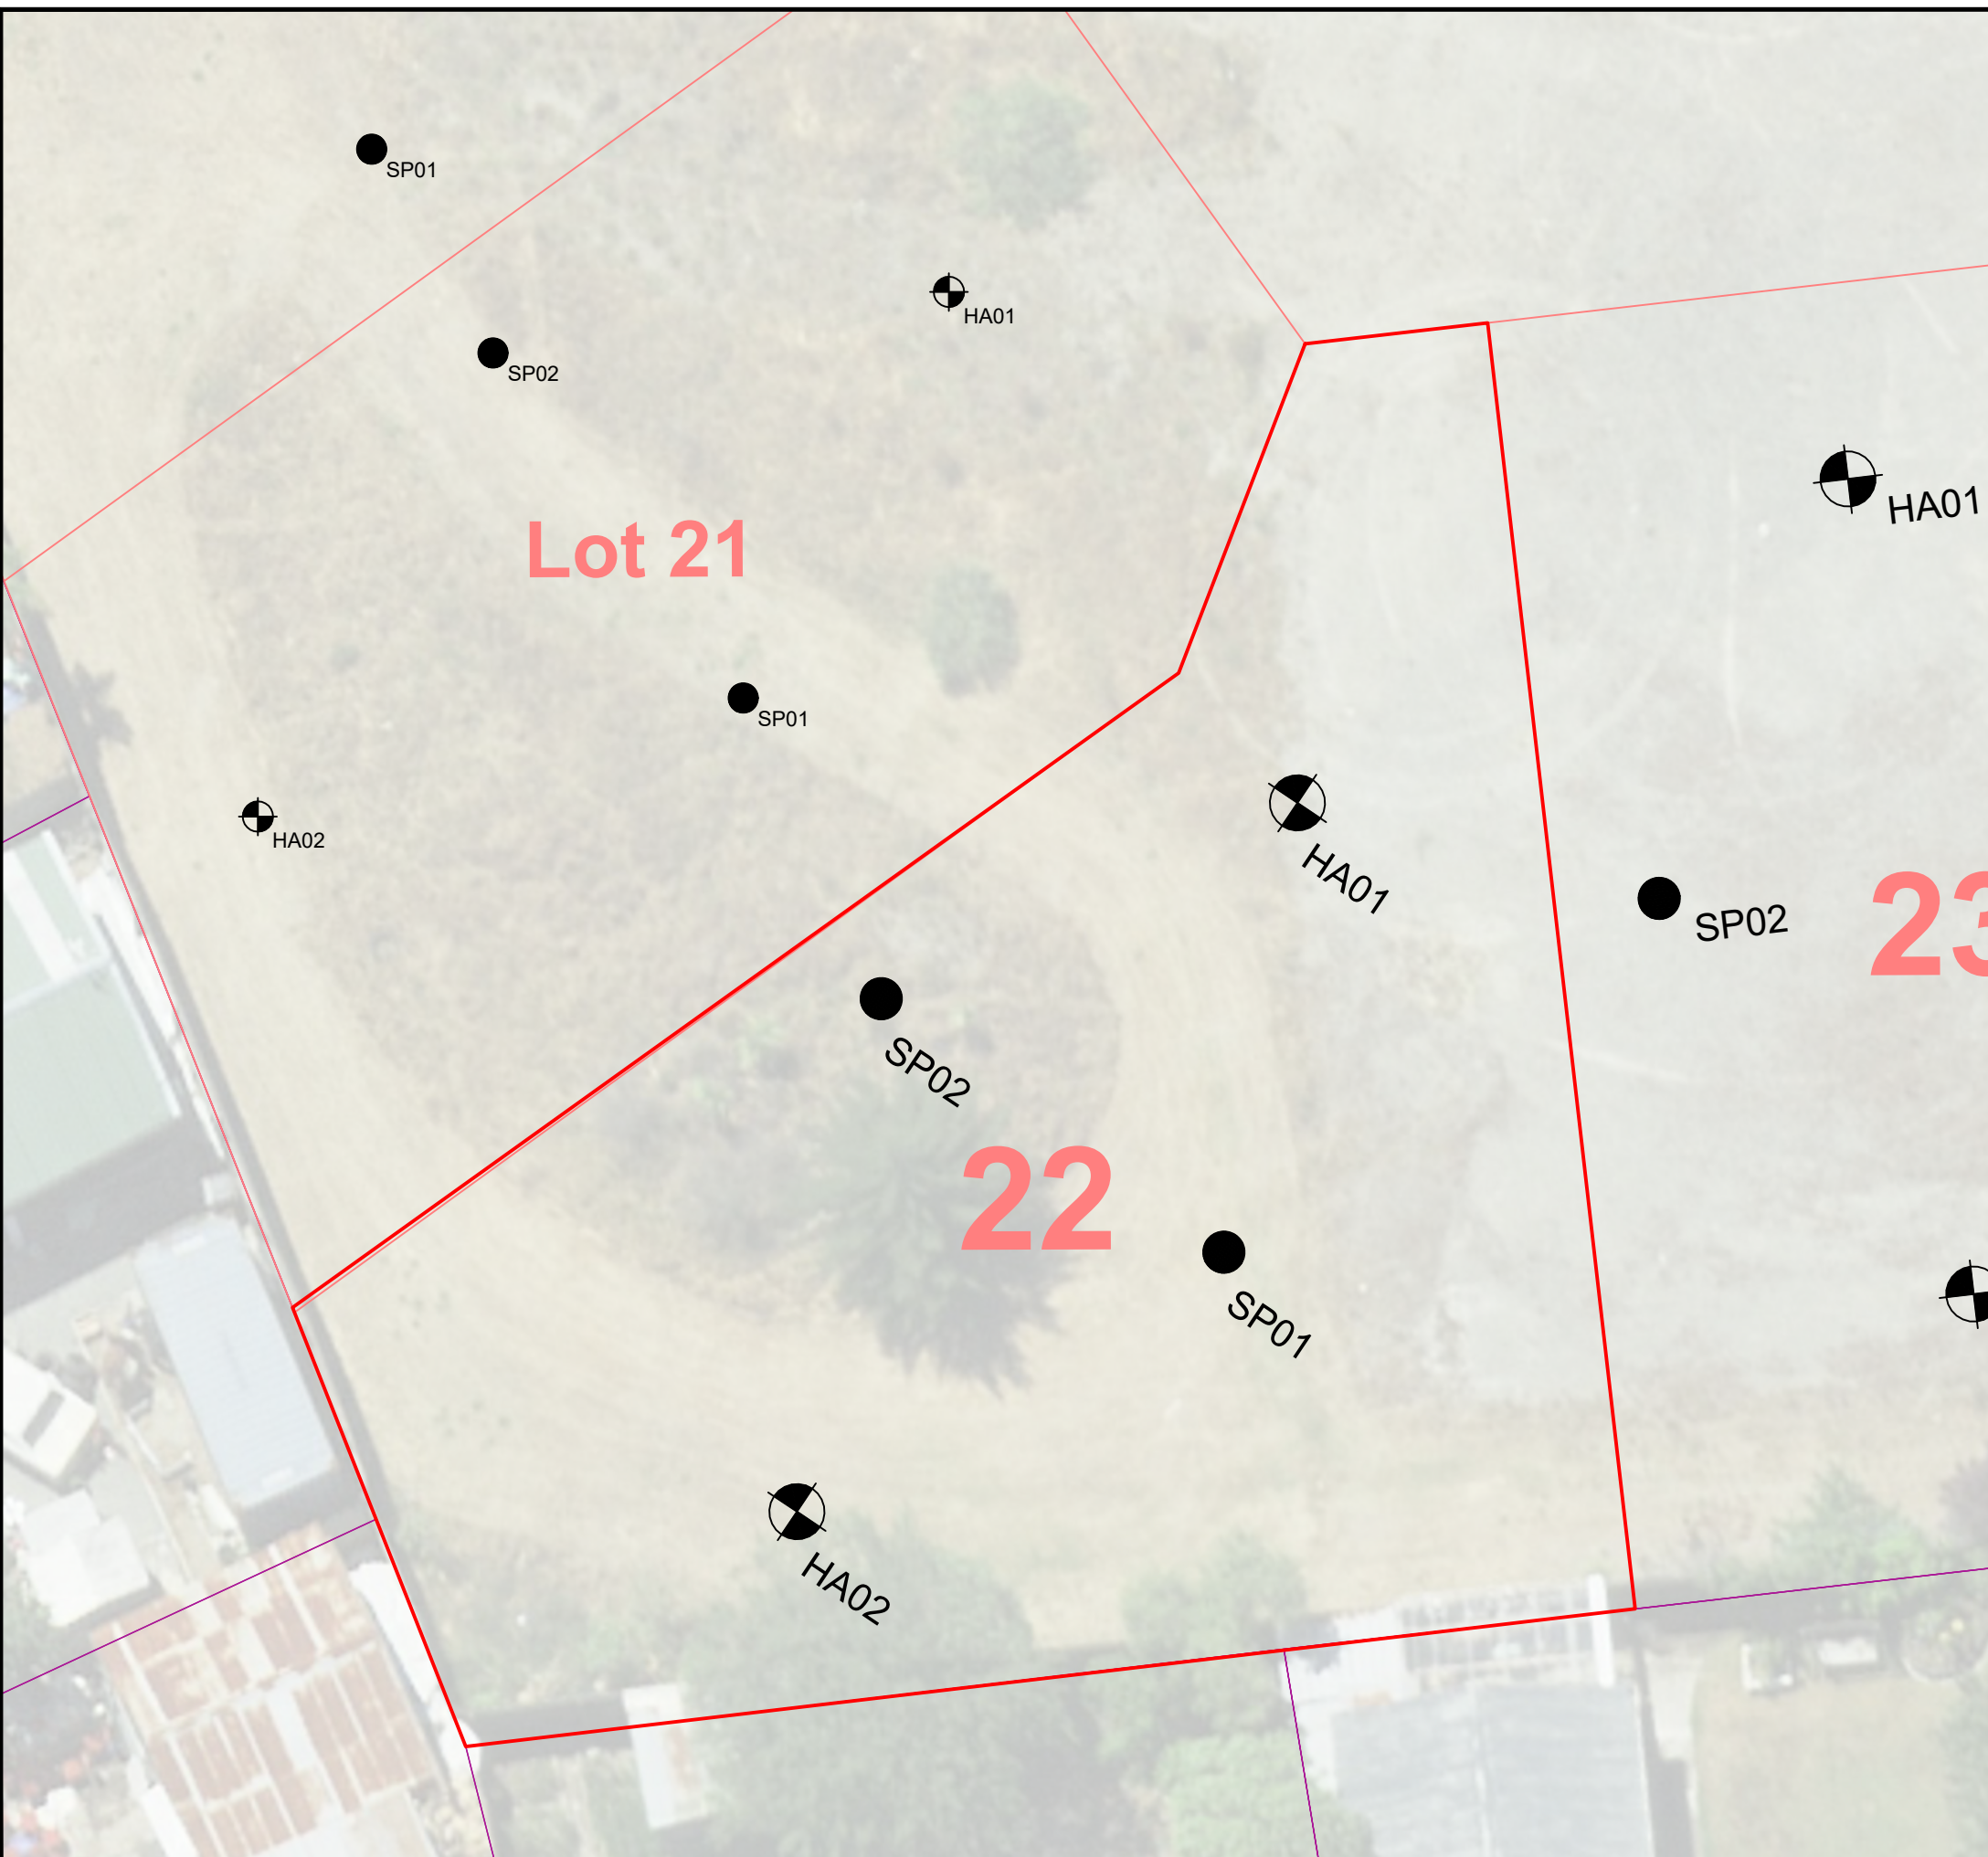
**KEY:**

Locations of features approximate only  
 Original sheet size A3  
 Boundary information on this *Test Location Plan* adapted from LINZ website: [www.data.linz.govt.nz](http://www.data.linz.govt.nz) (accessed 23 March 2023)  
 Location of proposed lot boundaries adapted from Davie Lovell-Smith drawing titled: Proposed Subdivision, dated May 2021

LandTech investigated the site on 23 March 2023, conducting two hand augers with corresponding Scala Penetrometer tests (SPs) and two additional SPs. The locations of the hand auger and SPs were measured using inferred lot boundaries and are approximate only. The test locations are shown on our LandTech *Test Location Plan*, Drawing No. Lot 22/ TLP, attached to this report.

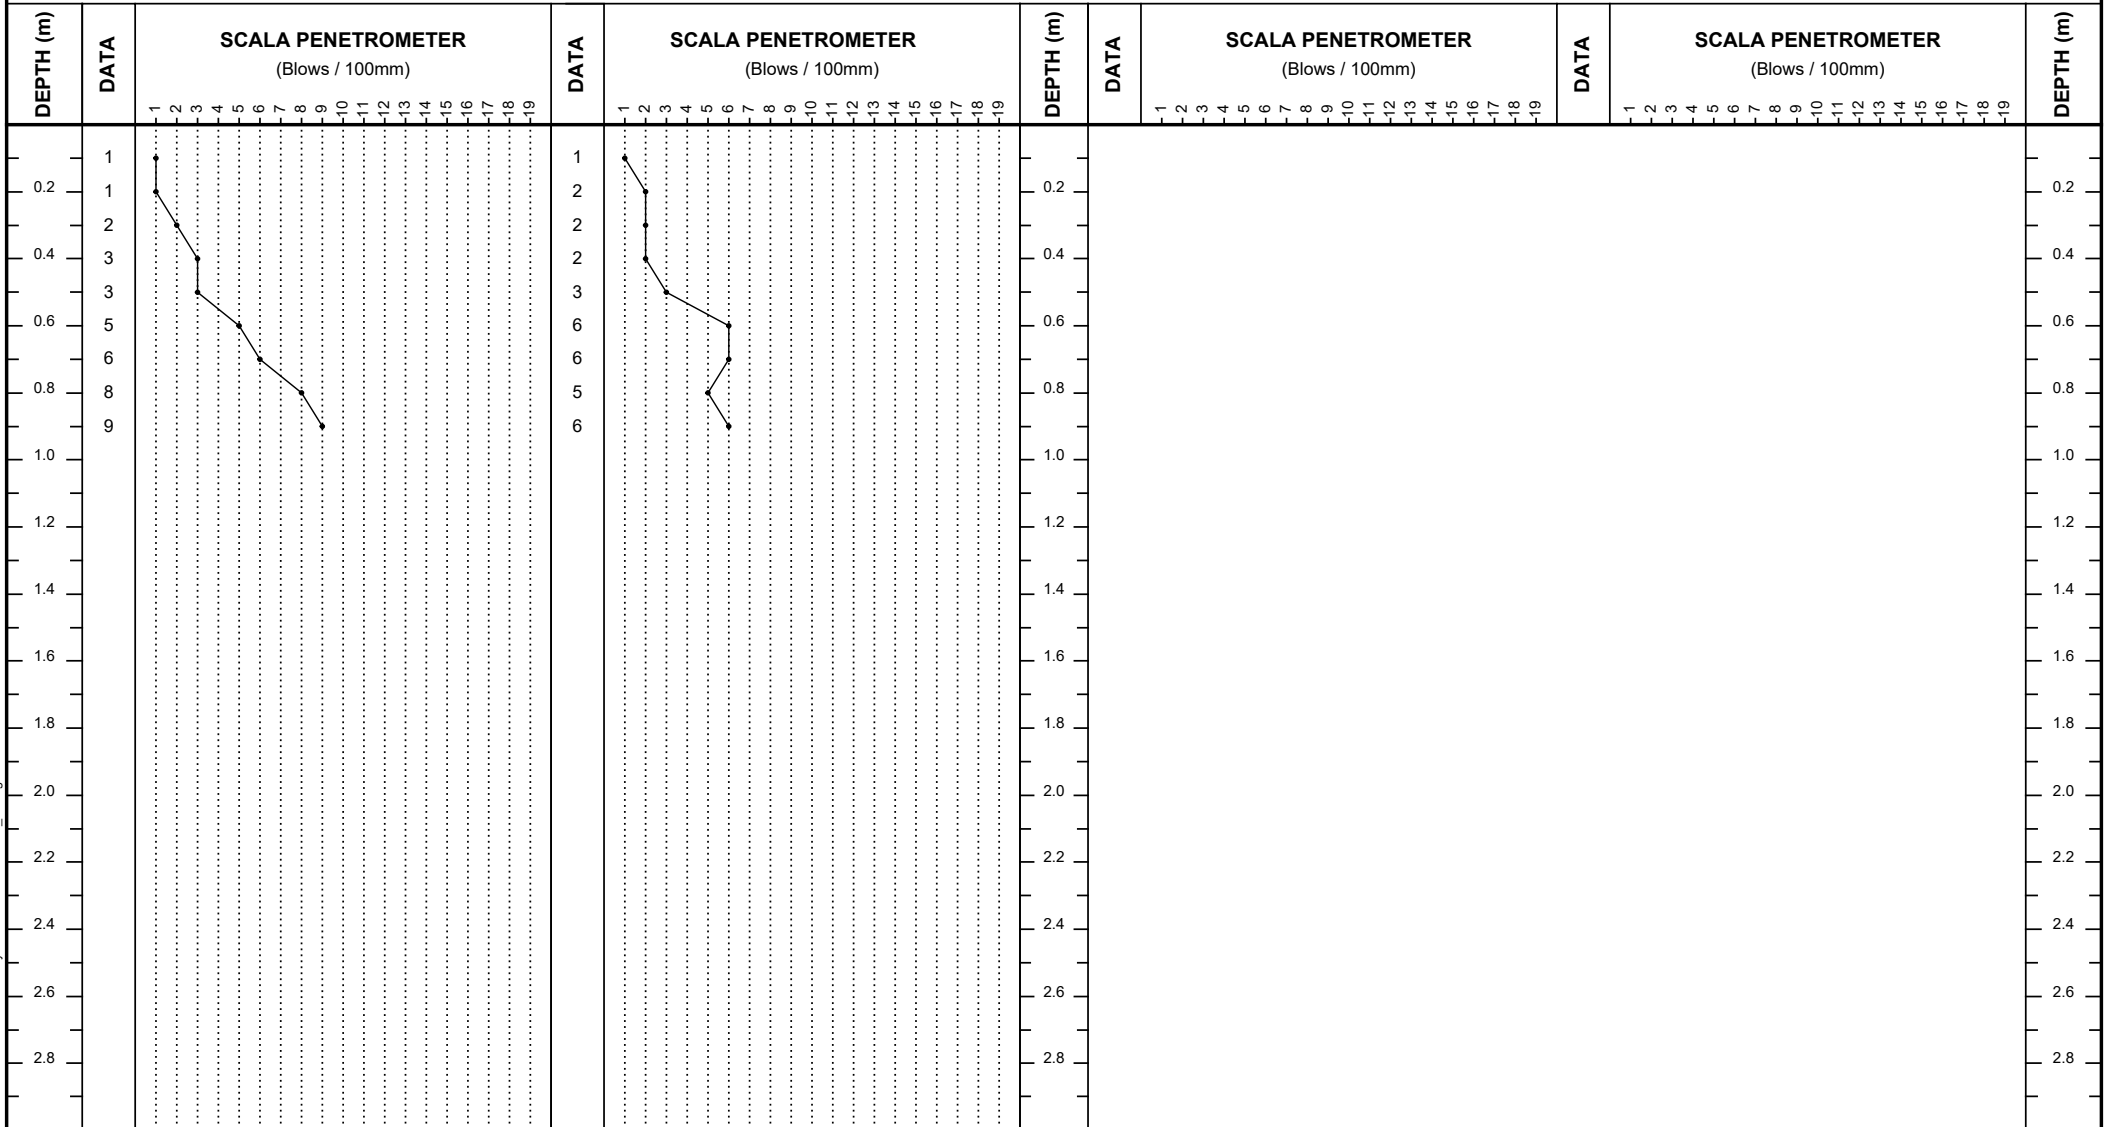
Tested By: JM  
 Ground Conditions: Near level, Topsoil.  
 Coordinates: NZTM2000 E 1576292.32  
 N 5182956.12  
 Test Date: 23-Mar-23

Tested By: JM  
 Ground Conditions: Near level, Topsoil.  
 Coordinates: NZTM2000 E 1576284.88  
 N 5182961.63  
 Test Date: 23-Mar-23

SPs at each of the four locations returned results between 2 and 9 blows per 100mm penetration below the topsoil and within the engineered fill layer. SPs were terminated at 0.9m depth to confirm near surface bearing capacities, and to avoid damage to the geogrids and geotextile. In addition, the density of the engineered fill and bearing capacity of its underlying subgrade have been confirmed via extensive geotechnical inspection and fill compaction testing during subdivision earthworks.
