Date: 16 May 2023  
Project No: LTC21220-A

**RE: SHALLOW SOIL TEST REPORT  
FUTURE RESIDENTIAL FOUNDATIONS  
LOT 33, 115 EUREKA STREET, ARANUI**

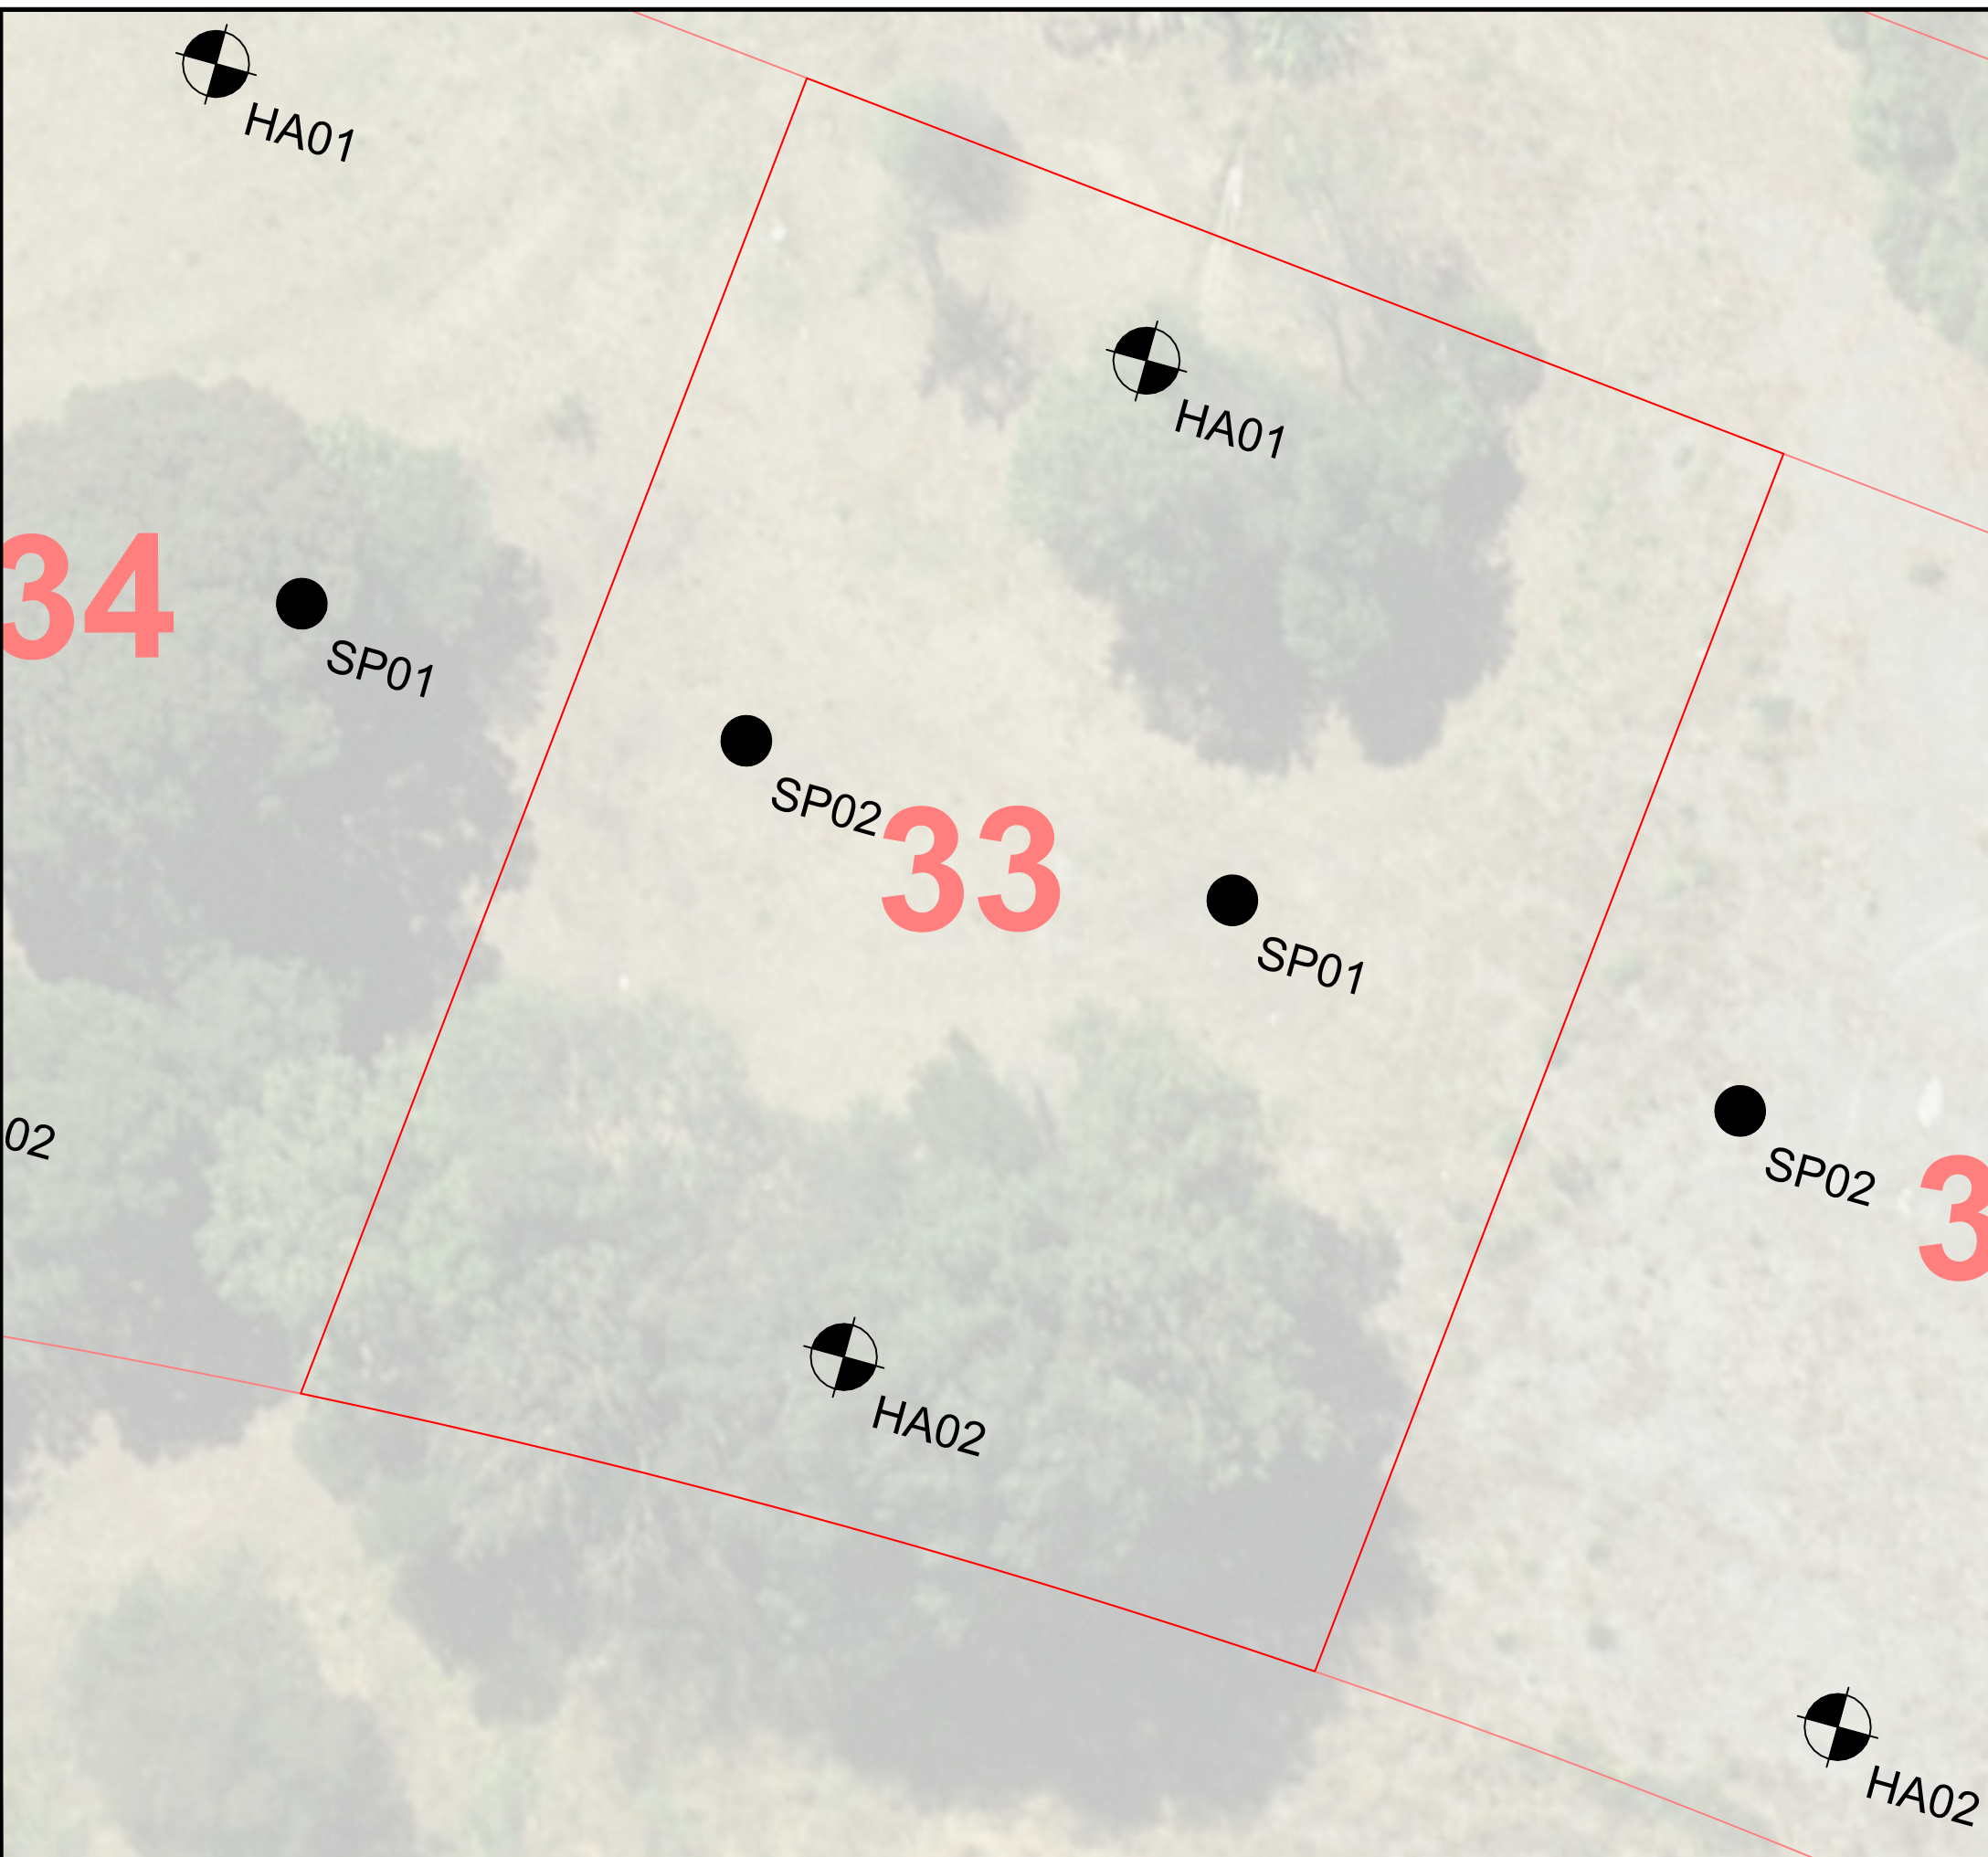
HA01 LandTech Consulting Ltd. augerhole locations, drilled 12 May 2023
-

SP01 LandTech Consulting Ltd. DCP test location, tested 12 May 2023
-

LandTech investigated the site on 12 May 2023, conducting two hand augers with corresponding Scala Penetrometer tests (SPs) and two additional SPs. The locations of the hand auger and SPs were measured using inferred lot boundaries and are approximate only. The test locations are shown on our LandTech *Test Location Plan*, Drawing No. Lot 33/ TLP, attached to this report.

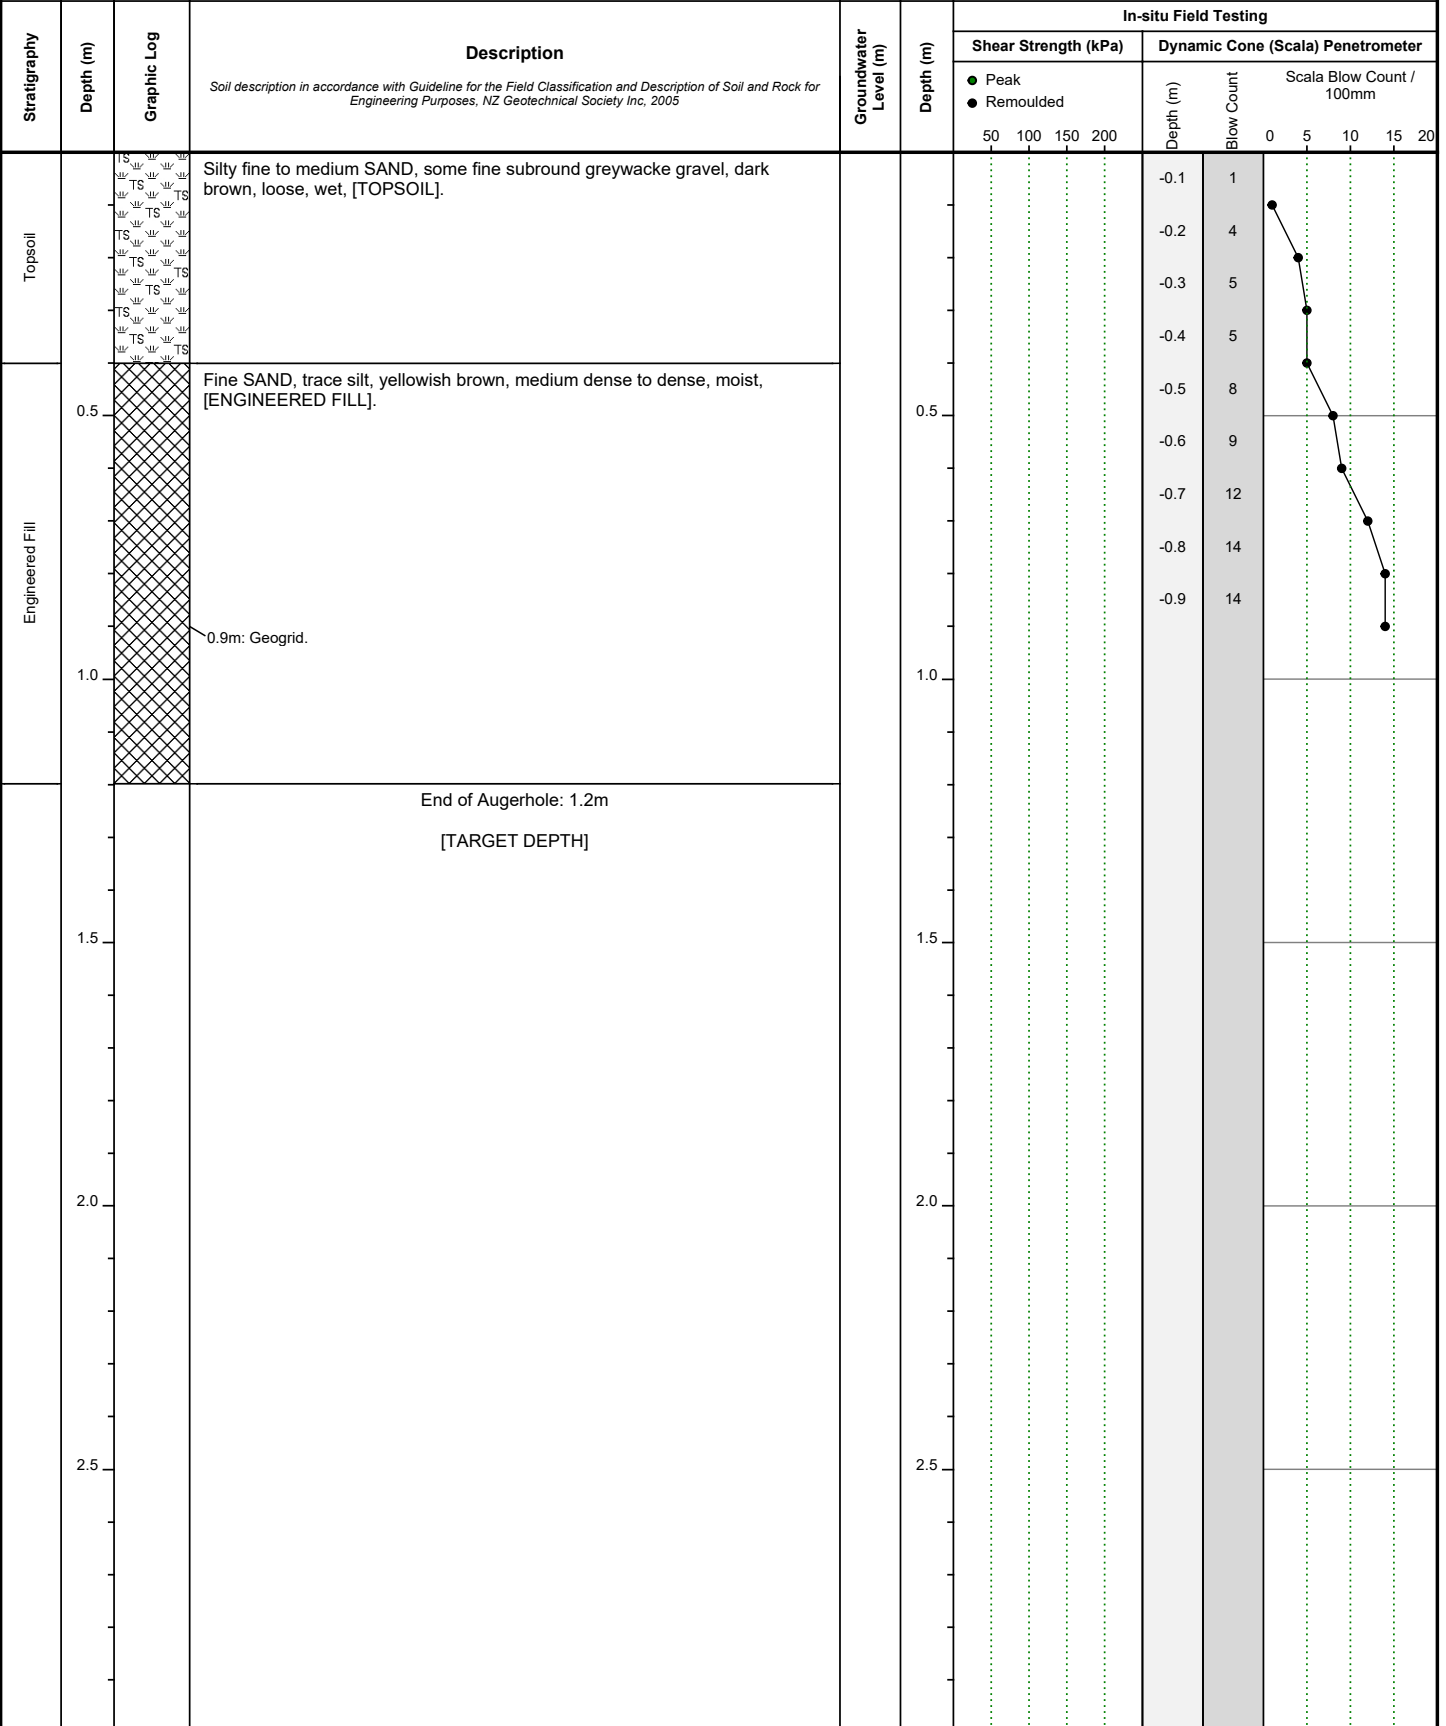
**Project No.:** LTC21220-A      **Coordinates:** NZTM2000: E1576382.81, N5183010.86      **Logged By:** KY  
**Drill Type:** 50mm Hand Auger      **Reduced Level:** 2.83m (LVD1937)      **Shear Vane No.:**  
**Date Started:** 12-May-23      **Ground Conditions:** Near level, Topsoil.      **Calibration Factor:**  
**Date Finished:** 12-May-23      **Groundwater Level (m):** Not Encountered      **Calibration Date:**

Target depth achieved.      In-situ testing in accordance with the following standards:  
 Scala Penetrometer Testing: NZS 4402:1988, Test 6.5.2, Dynamic Cone Penetrometer  
 Shear Vane Testing: Guideline for Hand Held Shear Vane Test, NZGS, August 2001

Soil types and conditions within the hand augers were logged by LandTech technical staff in accordance with New Zealand Geotechnical Society *Guideline for the Description of Soil and Rock for Engineering Purposes* (2005). The hand auger logs for each hole are attached.

Topsoil was encountered within the hand augers from the ground surface to 0.4m depth, which was typically a dark brown silty sand material with some gravel. Engineered fill was encountered below the topsoil to the base of auger holes, which was a compacted yellowish brown sand material with a trace of silt. The hand augers were terminated at 1.2m depth below ground level to avoid damage to the geotextile layer which was installed at 1.5m depth below ground level. Groundwater was not encountered during testing.

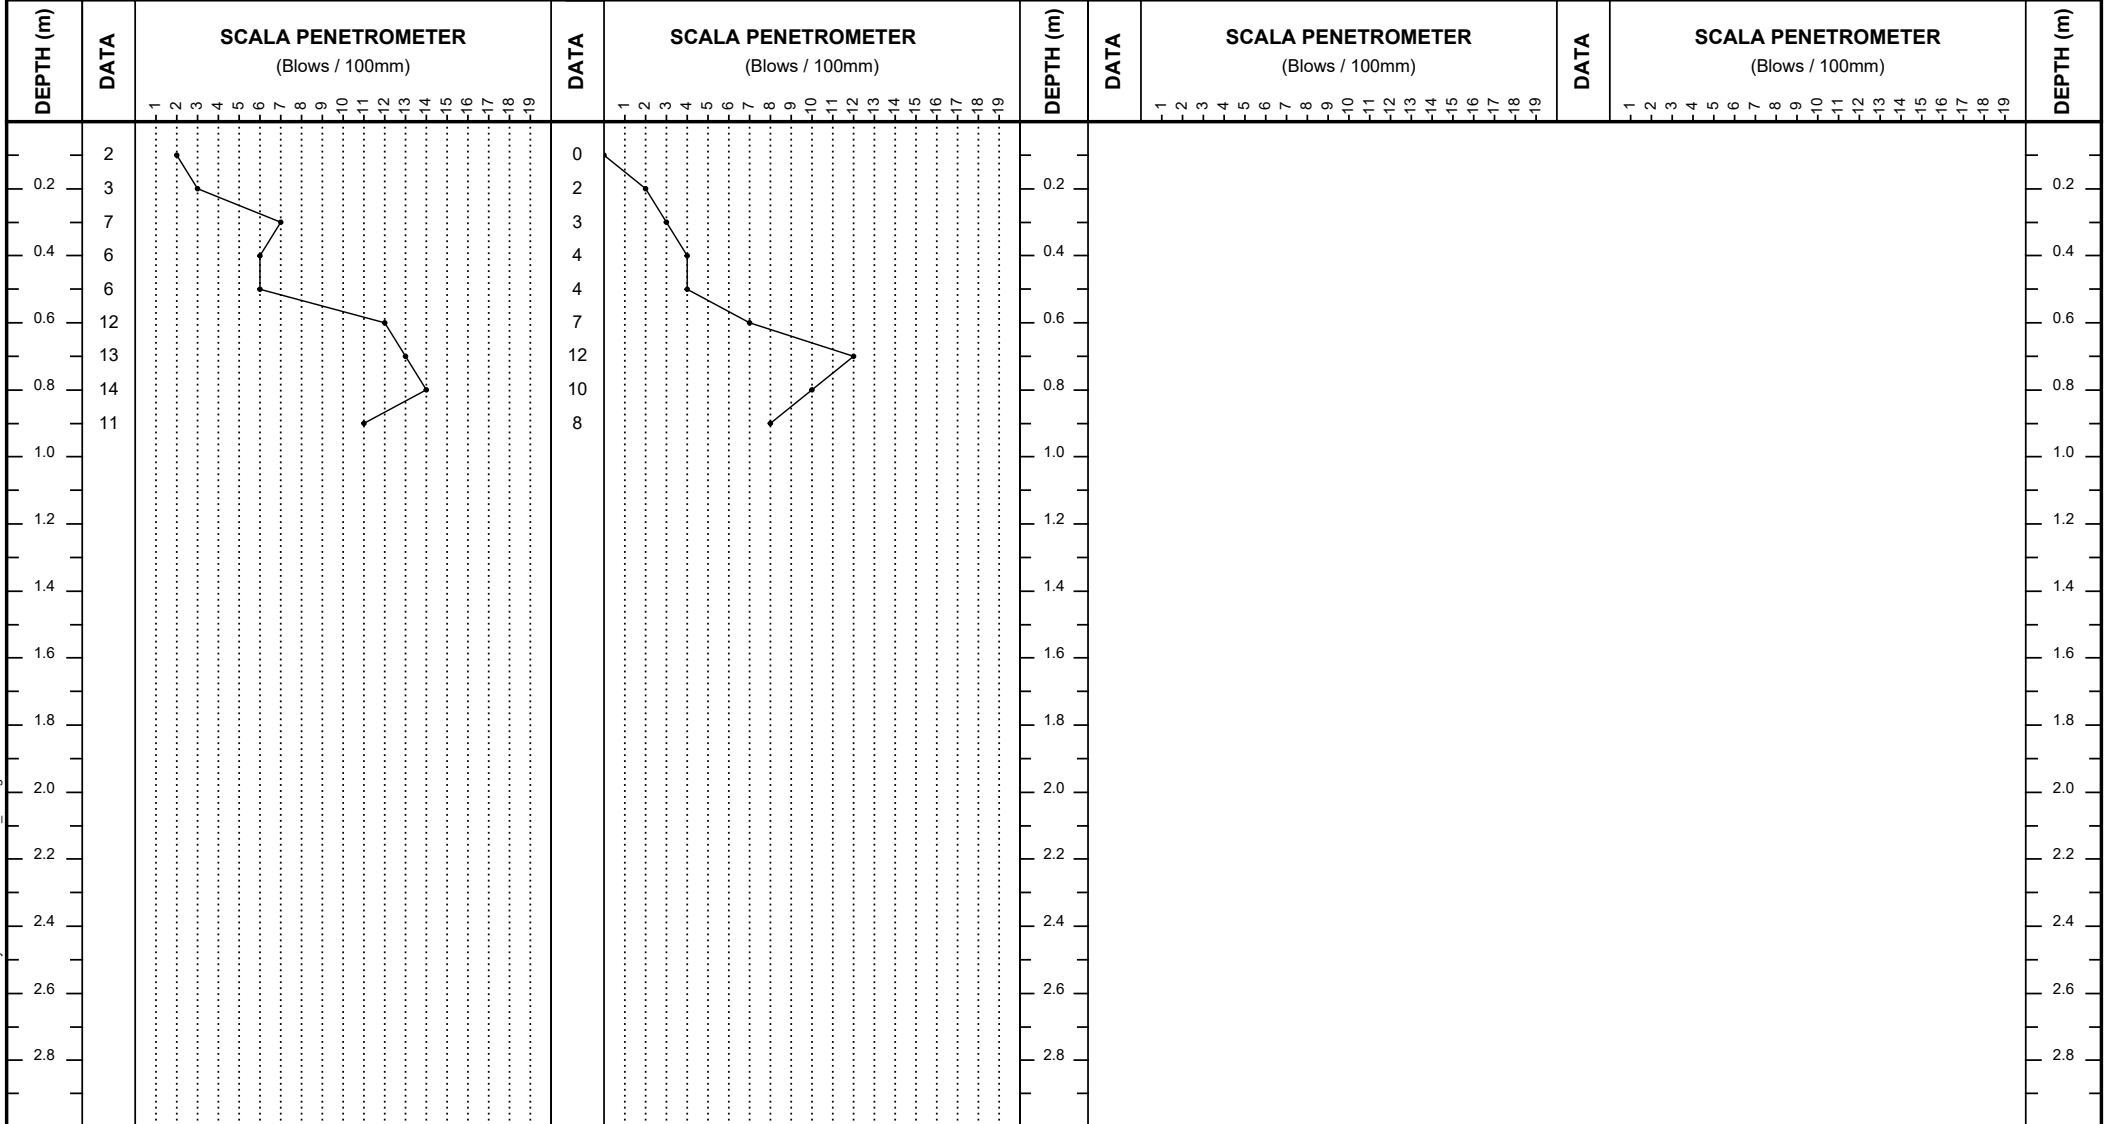
Tested By: KY  
 Ground Conditions: Near level, Topsoil.  
 Coordinates: NZTM2000 E 1576384.35  
 N 5183000.95  
 Test Date: 12-May-23

Tested By: KY  
 Ground Conditions: Near level, Topsoil.  
 Coordinates: NZTM2000 E 1576375.40  
 N 5183003.98  
 Test Date: 12-May-23

Our SP testing was carried out in accordance with NZS 4402:1988, Test 6.5.2, *Dynamic Cone Penetrometer*. The SP results are also attached.

SPs at each of the four locations returned results between 4 and 14 blows per 100mm penetration below the topsoil and within the engineered fill layer. SPs were terminated at 0.9m depth to confirm near surface bearing capacities, and to avoid damage to the geogrids and geotextile. In addition, the density of the engineered fill and bearing capacity of its underlying subgrade have been confirmed via extensive geotechnical inspection and fill compaction testing during subdivision earthworks.
